MICROCHIP PIC32MX330/350/370/430/450/470

PIC32MX330/350/370/430/450/470 Family Silicon Errata and Data Sheet Clarification

The PIC32MX330/350/370/430/450/470 family devices that you have received conform functionally to the current Device Data Sheet (DS60001185C), except for the anomalies described in this document.

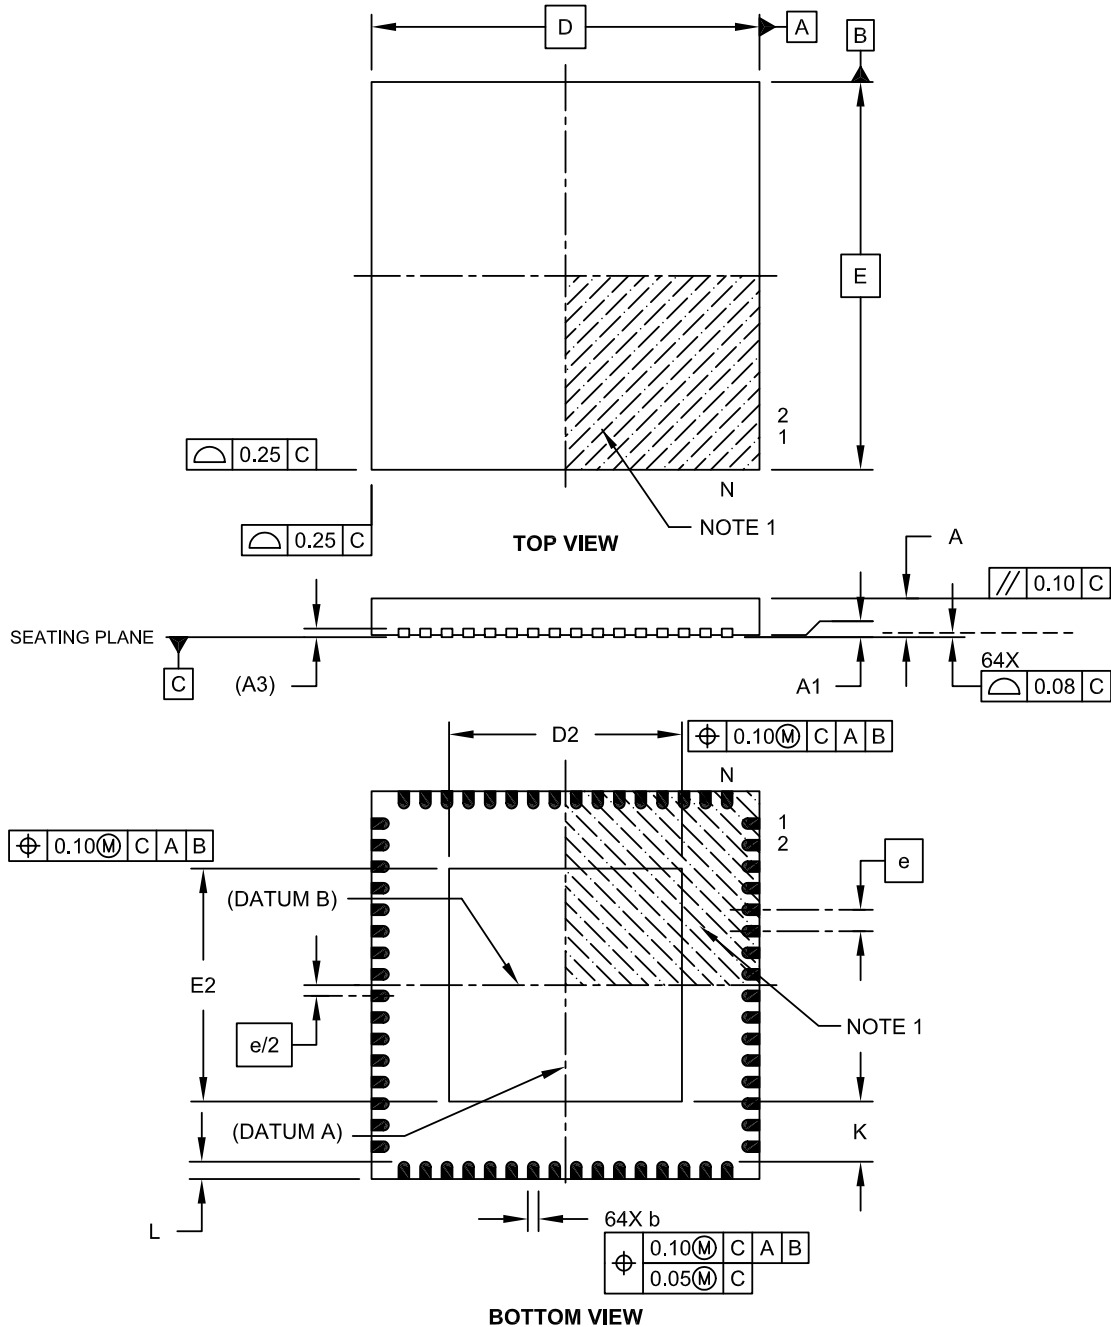
FIGURE 1:

The 64-Lead QFN package detail drawings in the data sheet are incorrect. Figure 1 through Figure 5 show the correct drawings.

64-Lead Plastic Quad Flat, No Lead Package (MR) – 9x9x0.9 mm Body with 5.40 x 5.40 Exposed Pad [QFN]

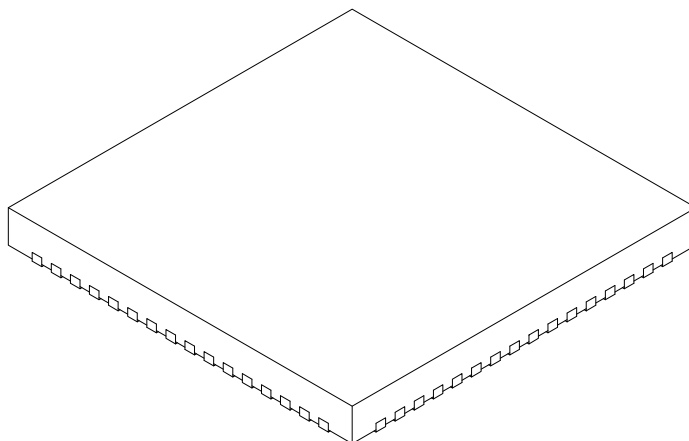
FIGURE 2:

64-Lead Plastic Quad Flat, No Lead Package (MR) – 9x9x0.9 mm Body with 5.40 x 5.40 Exposed Pad [QFN]

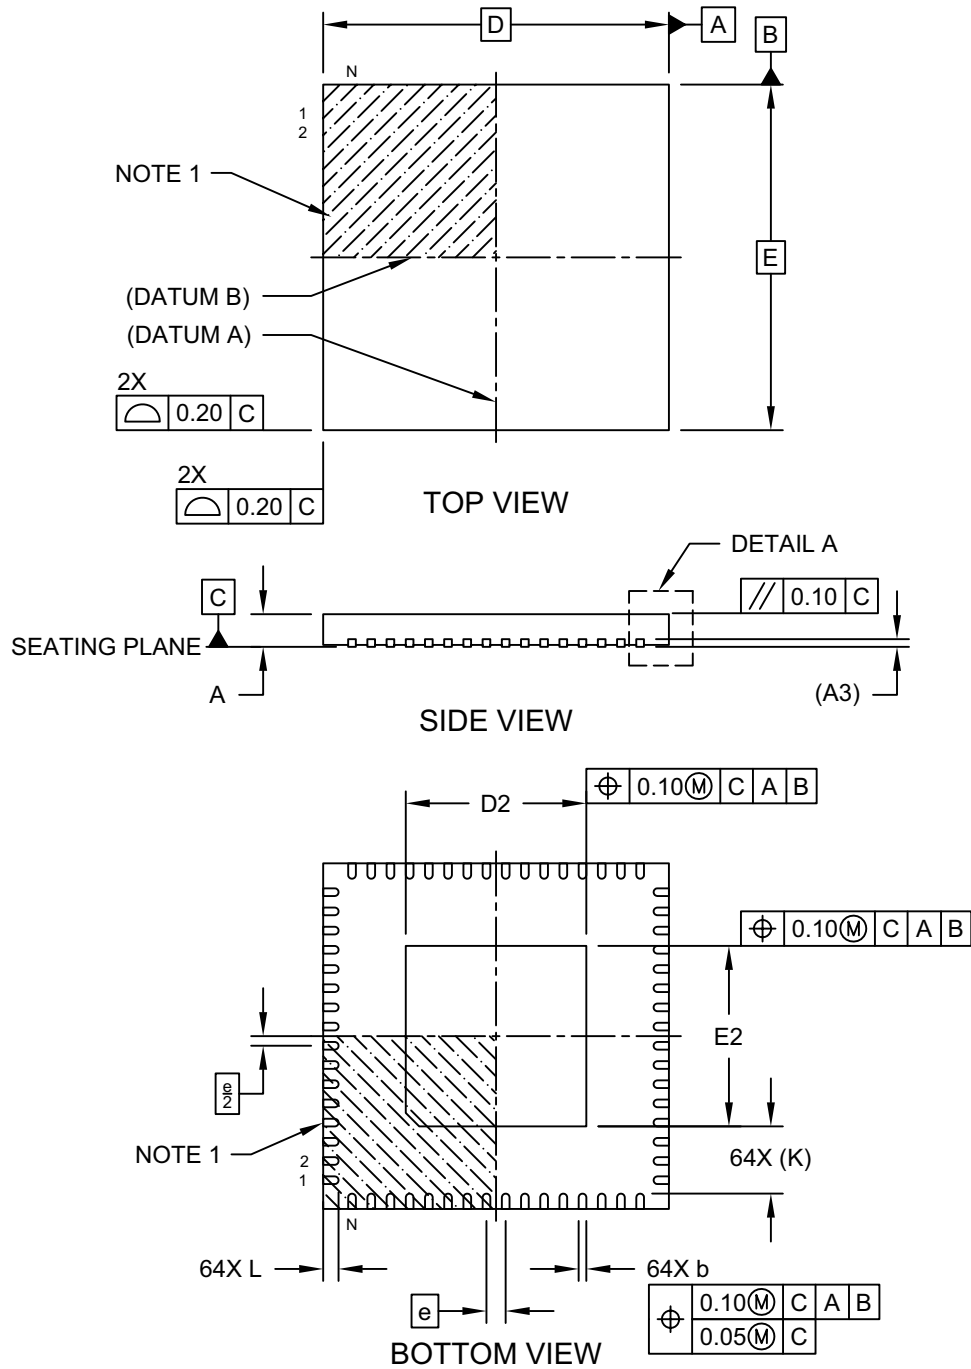
FIGURE 3:

64-Terminal Plastic Quad Flat Pack, No Lead (RG) 9x9x0.9 mm Body [QFN] Saw Singulated

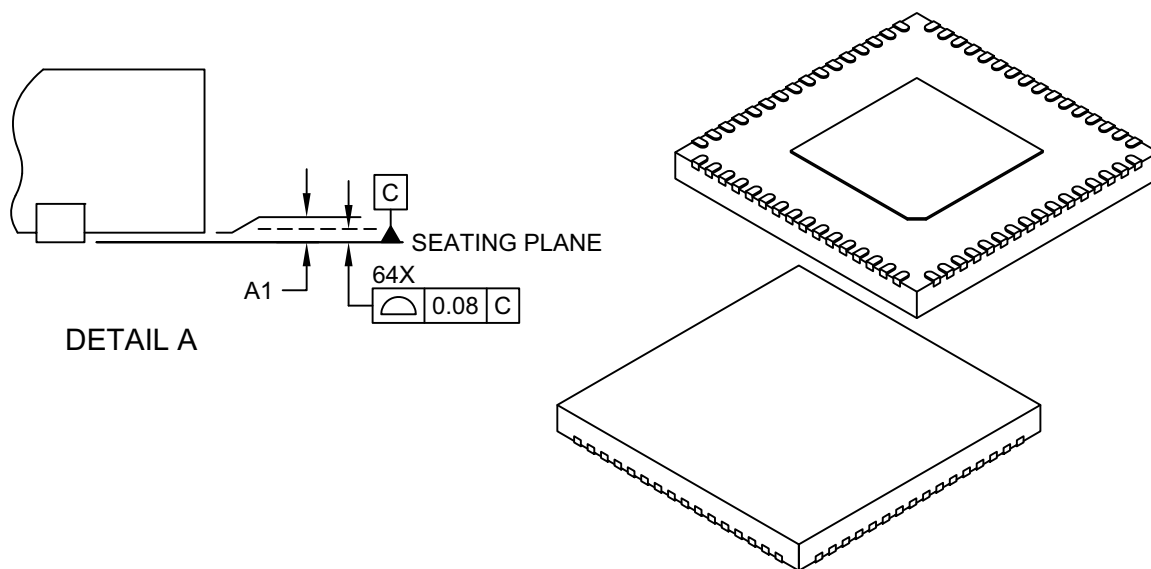
64-Terminal Plastic Quad Flat Pack, No Lead (RG) 9x9x0.9 mm Body [QFN] Saw Singulated

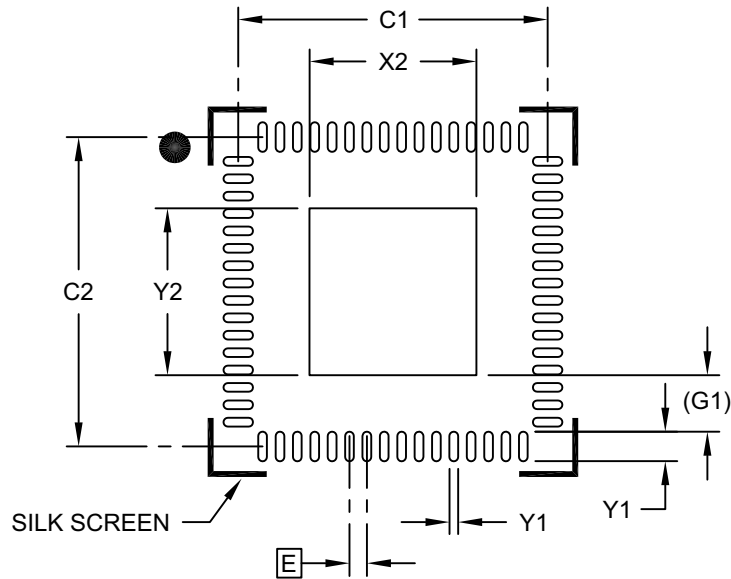
64-Lead Very Thin Plastic Quad Flat, No Lead Package (RG) - 9x9x1.0 mm Body [QFN] 4.7x4.7 mm Exposed Pad
