KSZ8081/KSZ8091 Silicon Errata and Data Sheet Clarification

This document describes known silicon errata for the KSZ8081/KSZ8091 family of devices, which includes the following:

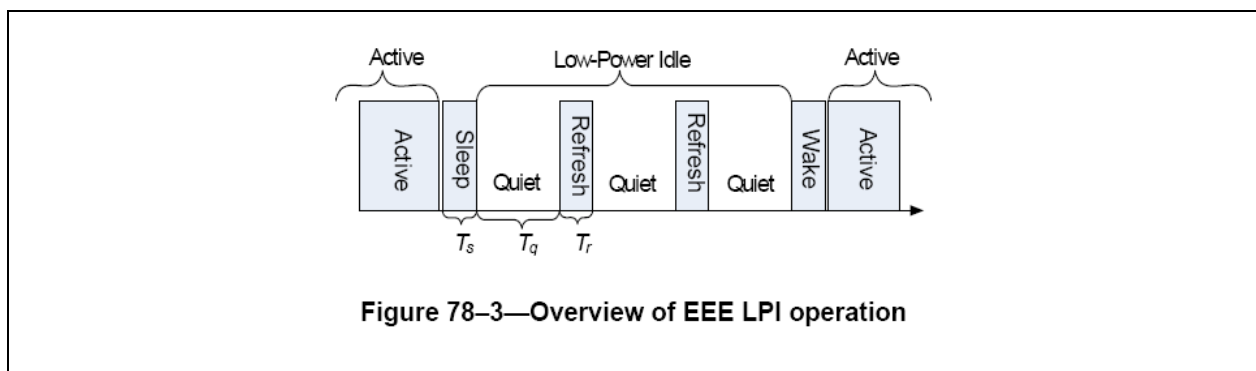
FIGURE 2: OVERVIEW OF EEE LPI OPERATION

In 100BASE-TX EEE mode, the link partner may drop link or loss packet when the local MAC/PHY (device) starts to transmit the “Wake” signal immediately following the “Sleep”/“Refresh” signal to exit Low-Power Idle mode and return to Active mode.

Many EEE PHY link partners require a short “Quiet” (T_q) duration after receiving the “Sleep”/“Refresh” signal. Without this short T_q wait time, that is not specified in the IEEE 802.3az Standard, link drop or packet loss can occur.

100BASE-TX EEE Mode does not work properly. Link drops and packet losses can occur randomly.

None. Do not enable 100BASE-TX EEE Mode.

This anomaly will not be fixed in a future revision of the device.
