dsPIC33EVXXXGM00X/10X Family Silicon Errata and Data Sheet Clarification

The dsPIC33EVXXXGM00X/10X family devices that you have received conform functionally to the current Device Data Sheet (DS70005144E), except for the anomalies described in this document.

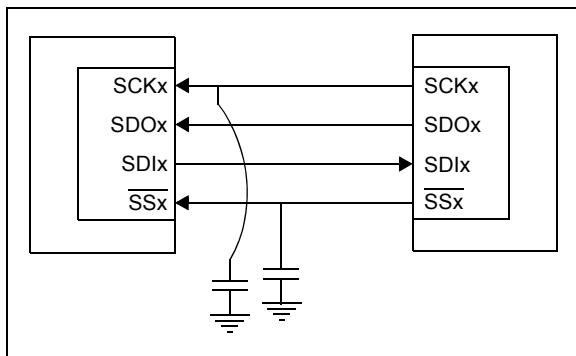
FIGURE 1:

When the SPIx module is configured in SPIx Slave mode (MSTEN bit (SPIxCON1<5>) = 0), the frame slave (FRMEN bit (SPIxCON2<15>) = 1) and the SPIFSD bit (SPIxCON2<14>) = 1), in Standard Buffer mode with the Clock Polarity Select bit, CKP = 0, the data is not transmitted in both 8-bit and 16-bit mode, but the data is being received correctly.

Adding a capacitance on the signal, as shown in Figure 1, will help the data to be received properly.

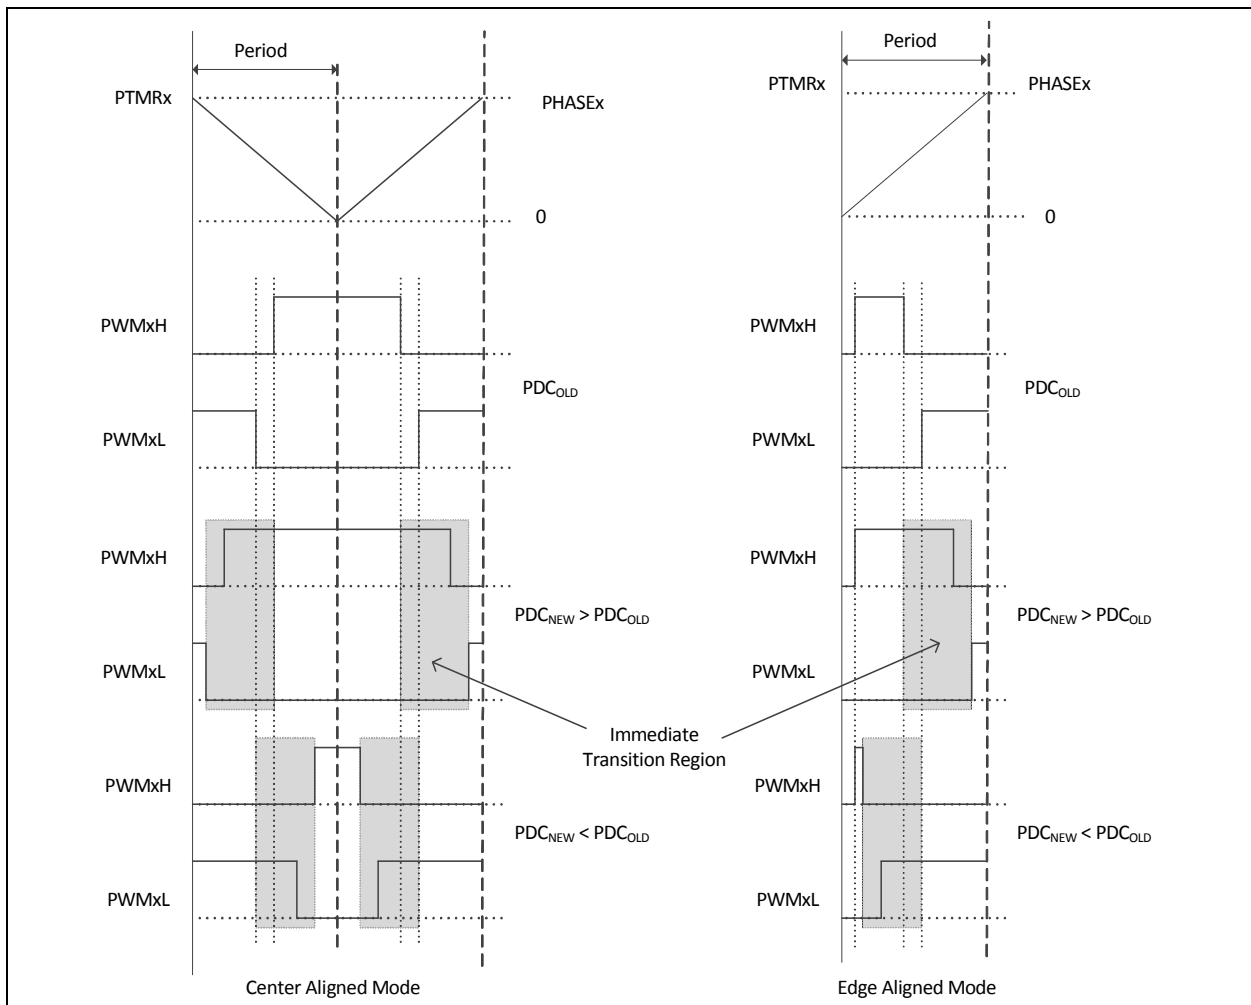
**FIGURE 2: TIMING DIAGRAMS FOR CENTER-ALIGNED AND EDGE-ALIGNED MODES**

The PWM generator may not assert dead time on the edges of transitions. This has been observed when all of the following conditions are present:

time base, will determine if the PWMxH and PWMxL outputs make an immediate transition. PWMxH and PWMxL outputs make an immediate transition if the Duty Cycle register is written with a new value, PDC<sub>NEW</sub>, at a point of time when the PWM time base is counting a value that is in between PDC<sub>NEW</sub> and PDC<sub>OLD</sub>. Additionally, writing to the Duty Cycle register, close to the instant of time where dead time is being applied, may result in a reduced dead time effective on the PWMxH and PWMxL transition edges.

In [Figure 2](#), if the duty cycle write occurred in the shaded box, then PWMxH and PWMxL will make an immediate transition without dead time.

However, in most applications, the duty cycle update timing can be controlled using the TRIGx trigger or Special Event Trigger, such that the above mentioned conditions are avoided altogether.

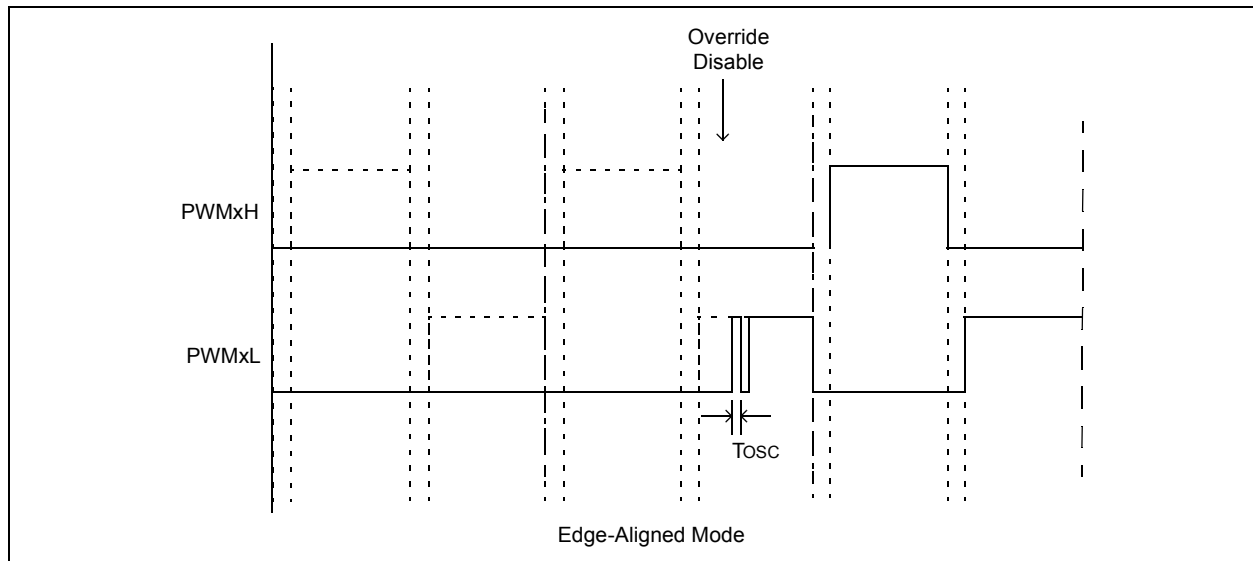
**FIGURE 3: ILLUSTRATION OF 1 T<sub>osc</sub> GLITCH WHEN PWM OVERRIDE IS TURNED OFF**

In Complementary mode after the PWM module is enabled (PTEN = 1), if the PWM override is turned off, a 1 T<sub>osc</sub> glitch will be present on the rising edge of either the PWMxH or PWMxL pins, whichever occurs first, as shown in Figure 3.

The glitch will be present on PWMxH/PWMxL every time the override state is changed from override enabled to override disabled. The width of this glitch is equal to 1 T<sub>osc</sub> when PCLKDIV<2:0> (PTCON2<2:0>) = 000. Increasing the PWMx input clock prescaler setting will increase the width of the glitch accordingly.

Since the width of the glitch is just 1 T<sub>osc</sub> at higher values of F<sub>osc</sub>, the glitch may not be visible on the PWMxH/PWMxL pins due to pin and PCB trace capacitances.

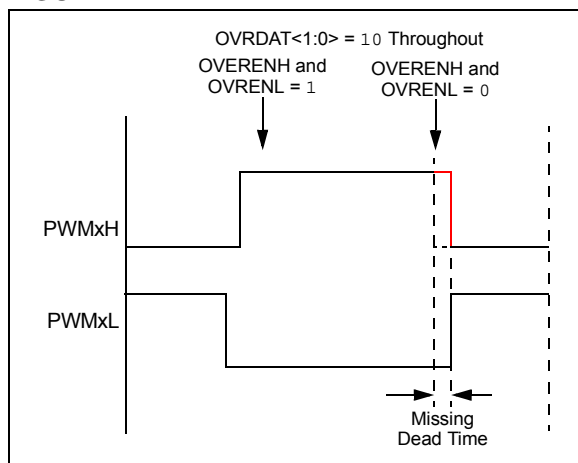
FIGURE 4:

In Complementary Output mode, the expected dead time between transitions of the PWMxH and PWMxL outputs may not be asserted when the following occurs:

- Output override synchronization is configured to occur on the CPU clock boundary (IOCONx<0> = 0);
- Both PWMxH and PWMxL overrides are enabled prior to the event (OVRENH and OVRENL are both '1'), and
- Both overrides are disabled (OVRENH and OVRENL are both '0') at the instant the dead time should be asserted (Figure 4). This has been observed in both Center-Aligned and Edge-Aligned modes.

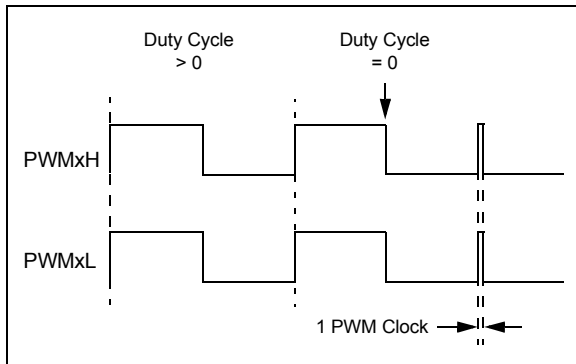
FIGURE 5:

In the Redundant Output mode (IOCONx<11:10> = 10) and Push-Pull Output mode (IOCONx<11:10> = 01) with Immediate Update disabled (PWMCONx<0> = 0), when the Duty Cycle register is updated from a non-zero value to zero, a glitch pulse of a width equal to 1 PWM clock will appear at the next PWM period boundary, as shown in Figure 5, for the Redundant Output mode. Here, the Duty Cycle register refers to the PDCx register if PWMCONx<8> = 0 or the MDC register if PWMCONx<8> = 1.

If the application requires a zero duty cycle output, there are two possible work around methods:

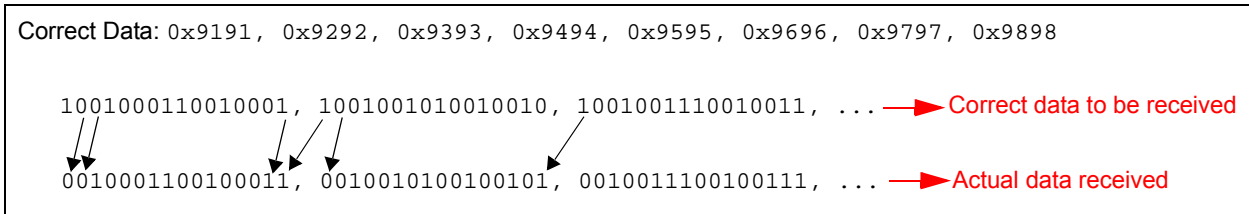
**FIGURE 6:**

Received data of the SPI is sampled one clock cycle late for the following conditions:

For example, the correct data that should be received is 0x9191, 0x9292, 0x9393, 0x9494, 0x9595, 0x9696, 0x9797, 0x9898, but the actual data received is 0x2323, 0x2525, 0x2727, 0x2929, 0x2B2B, 0x2D2D, 0x2F2F, 0x3130 (Figure 6).

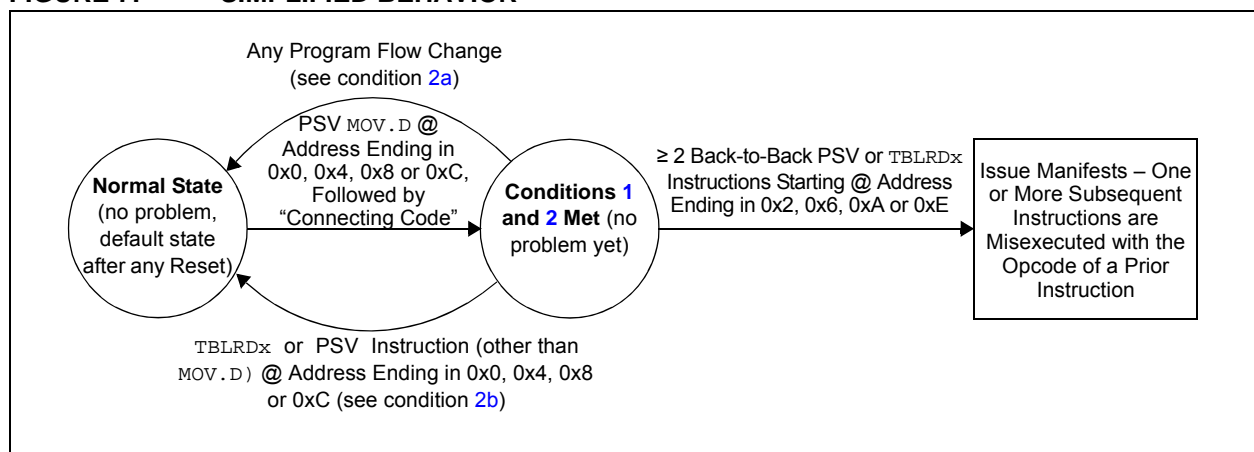
**FIGURE 7: SIMPLIFIED BEHAVIOR**

When two or more data Flash read instructions (via Program Space Visibility (PSV) read or table read) are executed back-to-back, one or more subsequent instructions can be misexecuted when all of the conditions in [Table 6](#) occur.

[Figure 7](#) provides an example of the effective behavior.

1. All instances of PSV `MOV.D` can be replaced with two PSV `MOV` instructions instead. Non-PSV `MOV.D` instructions acting on RAM/SFRs do not need to be modified; or
2. If not already present, a program flow change instruction (such as `BRA $+2`) can be inserted above back-to-back data Flash read sequences; or
3. Back-to-back data Flash read instruction sequences can be broken up by inserting a non-Flash read instruction (such as a `NOP`), in between the Flash read instructions; or
4. The alignment of the code can be shifted to avoid the required opcode location addresses.
