Product Change Notification - SYST-18KHMV915

ERRATA - dsPIC33EVXXXGM00X/10X Family Silicon Errata and Data Sheet Clarification

Description of Change: Adds silicon issue 48 (I/O).

dsPIC33EVXXXGM00X/10X Family Silicon Errata and Data Sheet Clarification

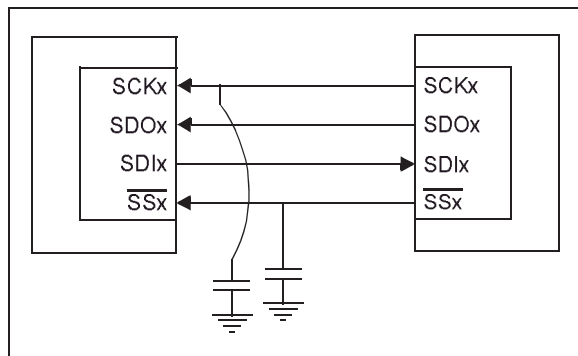
FIGURE 1:

When the SPIx module is configured in SPIx Slave mode (MSTEN bit (SPIxCON1<5>) = 0), the frame slave (FRMEN bit (SPIxCON2<15>) = 1) and the SPIFSD bit (SPIxCON2<14>) = 1), in Standard Buffer mode with the Clock Polarity Select bit, CKP = 0, the data is not transmitted in both 8-bit and 16-bit mode, but the data is being received correctly.

Adding a capacitance on the signal, as shown in Figure 1, will help the data to be received properly.

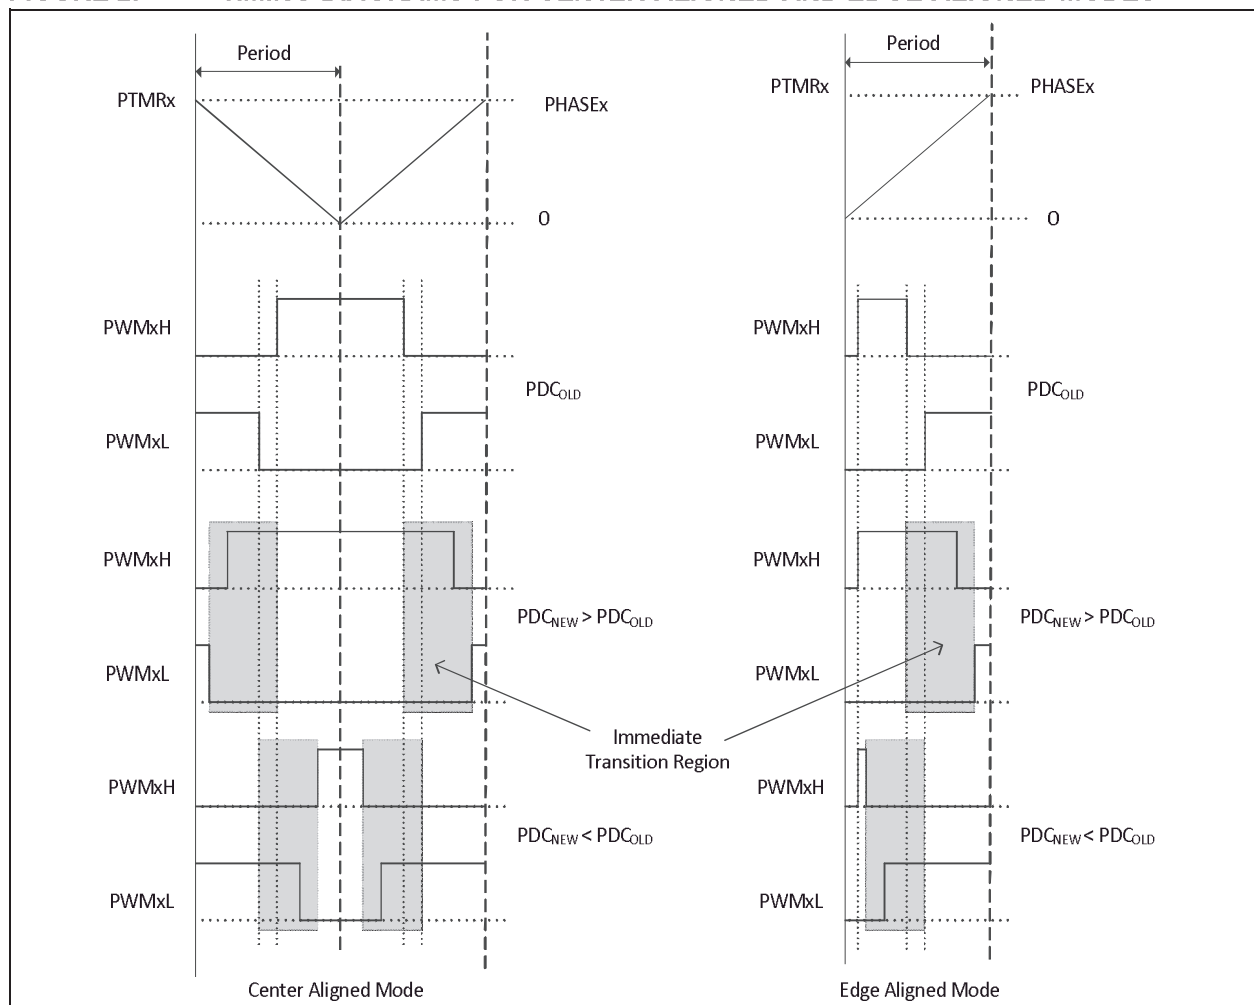
FIGURE 2: TIMING DIAGRAMS FOR CENTER-ALIGNED AND EDGE-ALIGNED MODES

The PWM generator may not assert dead time on the edges of transitions. This has been observed when all of the following conditions are present:

In [Figure 2](#), if the duty cycle write occurred in the shaded box, then PWMxH and PWMxL will make an immediate transition without dead time.

However, in most applications, the duty cycle update timing can be controlled using the TRIGx trigger or Special Event Trigger, such that the above mentioned conditions are avoided altogether.

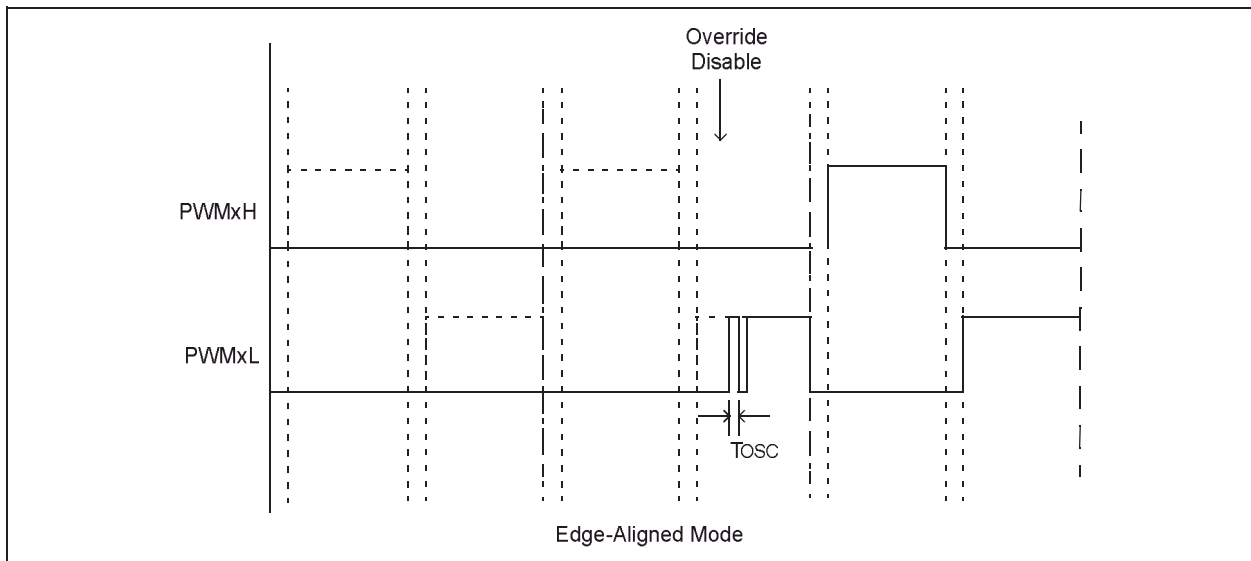
FIGURE 3: ILLUSTRATION OF 1 TOSC GLITCH WHEN PWM OVERRIDE IS TURNED OFF

In Complementary mode after the PWM module is enabled ($PTEN = 1$), if the PWM override is turned off, a one TOSC glitch will be present on the rising edge of either the PWMxH or PWMxL pins, whichever occurs first, as shown in Figure 3.

The glitch will be present on PWMxH/PWMxL every time the override state is changed from override enabled to override disabled. The width of this glitch is equal to one TOSC when $PCLKDIV<2:0>$ ($PTCON2<2:0>$) = 000. Increasing the PWMx input clock prescaler setting will increase the width of the glitch accordingly.

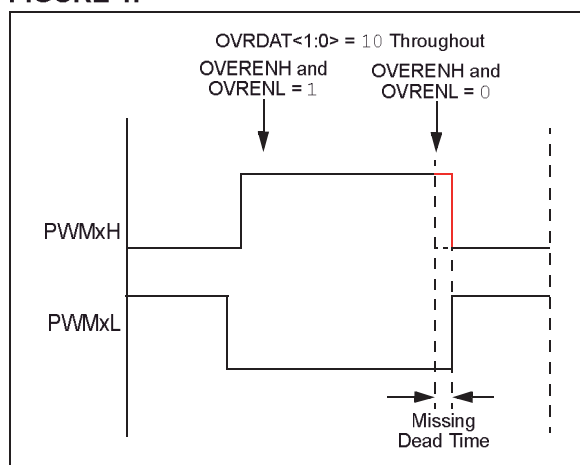
FIGURE 4:

- Output override synchronization is configured to occur on the CPU clock boundary (IOCONx<0> = 0);
- Both PWMxH and PWMxL overrides are enabled prior to the event (OVRENH and OVRENL are both '1'), and
- Both overrides are disabled (OVRENH and OVRENL are both '0') at the instant the dead time should be asserted (Figure 4). This has been observed in both Center-Aligned and Edge-Aligned modes.

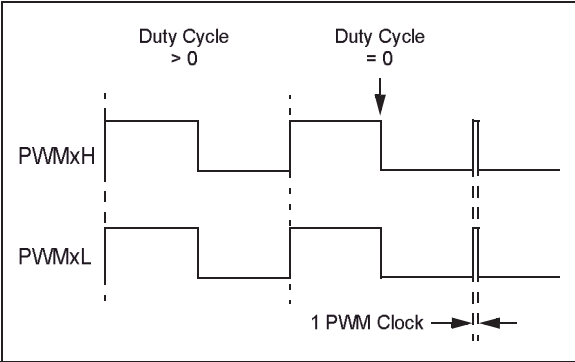
FIGURE 5:

In the Redundant Output mode (IOCONx<11:10> = 10) and Push-Pull Output mode (IOCONx<11:10> = 01) with Immediate Update disabled (PWMCONx<0> = 0), when the Duty Cycle register is updated from a non-zero value to zero, a glitch pulse of a width equal to one PWM clock will appear at the next PWM period boundary, as shown in Figure 5, for the Redundant Output mode. Here, the Duty Cycle register refers to the PDCx register if PWMCONx<8> = 0 or the MDC register if PWMCONx<8> = 1.

If the application requires a zero duty cycle output, there are two possible work around methods:

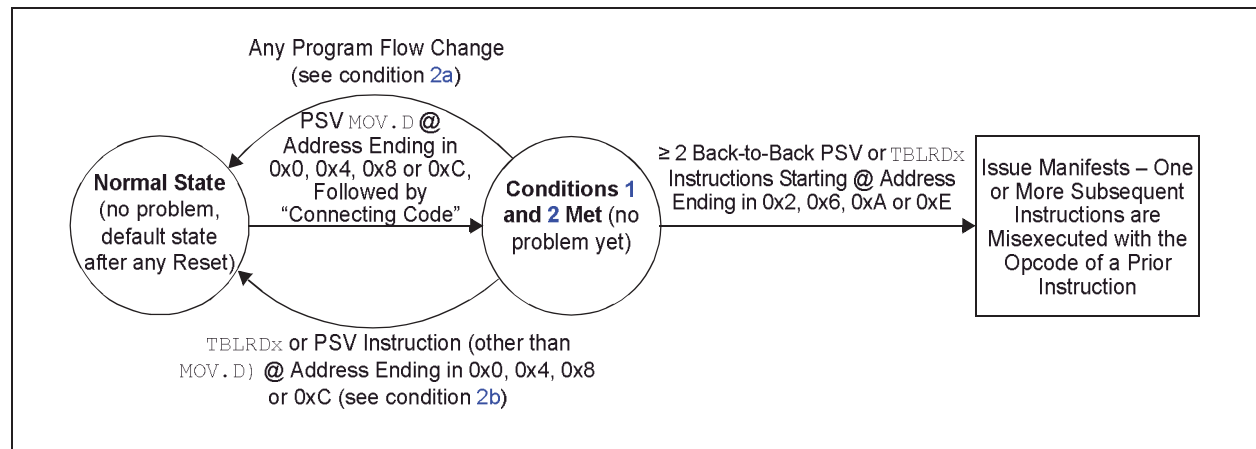
FIGURE 7: SIMPLIFIED BEHAVIOR

When two or more data Flash read instructions (via Program Space Visibility (PSV) read or table read) are executed back-to-back, one or more subsequent instructions can be misexecuted when all of the conditions in [Table 6](#) occur.

[Figure 7](#) provides an example of the effective behavior.

1. All instances of PSV MOV.D can be replaced with two PSV MOV instructions instead. Non-PSV MOV.D instructions acting on RAM/SFRs do not need to be modified; or
2. If not already present, a program flow change instruction (such as BRA \$+2) can be inserted above back-to-back data Flash read sequences; or
3. Back-to-back data Flash read instruction sequences can be broken up by inserting a non-Flash read instruction (such as a NOP), in between the Flash read instructions; or
4. The alignment of the code can be shifted to avoid the required opcode location addresses.
