Product Change Notification - SYST-04GTSX528

ERRATA - PIC32MK Motor Control and General Purpose Errata and Data Sheet Clarification

PIC32MK General Purpose and Motor Control (GP/MC) Silicon Errata and Data Sheet Clarification

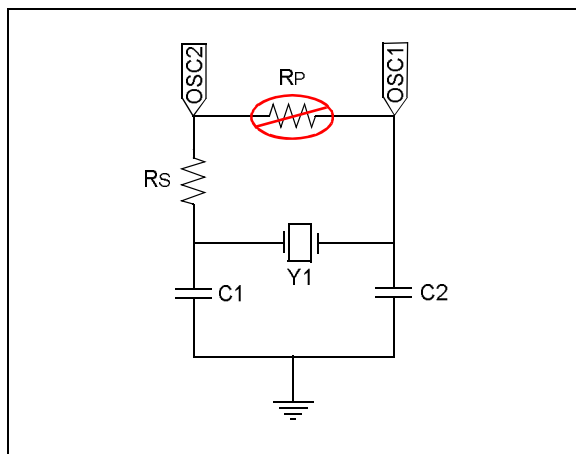
FIGURE 1: Posc CRYSTAL CIRCUIT

The Posc supports only specific crystal operation, as provided in [Table 1](#).

The Primary Oscillator (Posc) has been characterized to operate at 8 MHz and 12 MHz when the circuit shown in [Figure 1](#) is implemented and the operating conditions provided in [Table 1](#) are met.

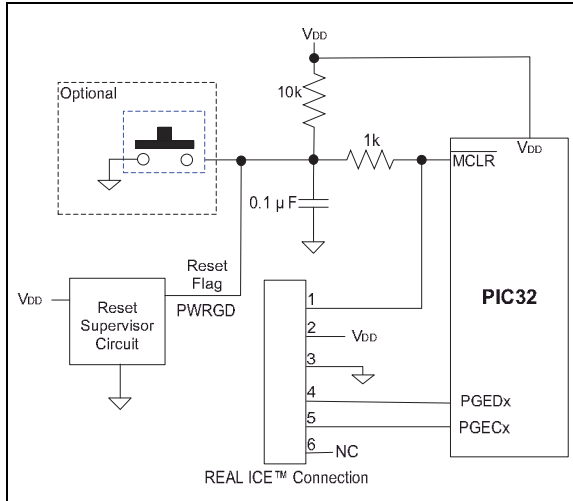
**FIGURE 2: RESET SUPERVISOR
CIRCUIT**

On a BOR event, $V_{POR} < V_{DD} < V_{BOR}$, a Reset is not generated when the BOR threshold is reached. System clocks will stop with all I/O pins functions frozen in their present state until either VDD falls to V_{POR} or VDD returns to above V_{BOR} . The user must assess if this VDD brown-out condition and the resulting frozen I/O pin state has an adverse effect on their application (UART, PWM, I/O, OC, etc.).

If the application can sustain frozen I/O states for ~2.1 ms (UART, CAN, I/O, etc.), the application must enable the Deep Sleep Watchdog Timer and Clock Fail Monitor, based on the details provided in [Table 3](#) and [Table 4](#). If implemented correctly, after ~2.1 ms, a valid internal reset state is entered and the I/O pins are set to the device default Reset state.
