Product Change Notification - SYST-14YTT0745

ERRATA - dsPIC33EVXXXGM00X/10X Family Silicon Errata and Data Sheet Clarification

dsPIC33EVXXXGM00X/10X Family Silicon Errata and Data Sheet Clarification

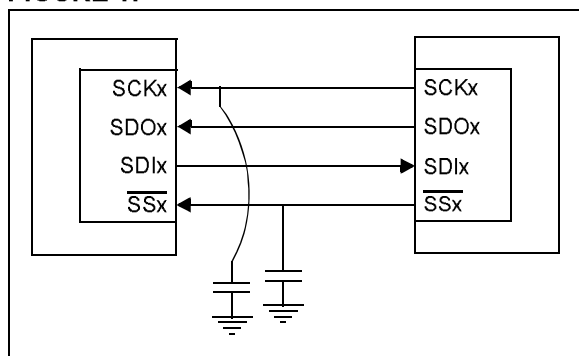
FIGURE 1:

When the SPIx module is configured in SPIx Slave mode (MSTEN bit (SPIxCON1[5]) = 0), the frame slave (FRMEN bit (SPIxCON2[15]) = 1) and the SPIFSD bit (SPIxCON2[14]) = 1), in Standard Buffer mode with the Clock Polarity Select bit, CKP = 0, the data is not transmitted in both 8-bit and 16-bit mode, but the data is being received correctly.

Adding a capacitance on the signal, as shown in Figure 1, will help the data to be received properly.

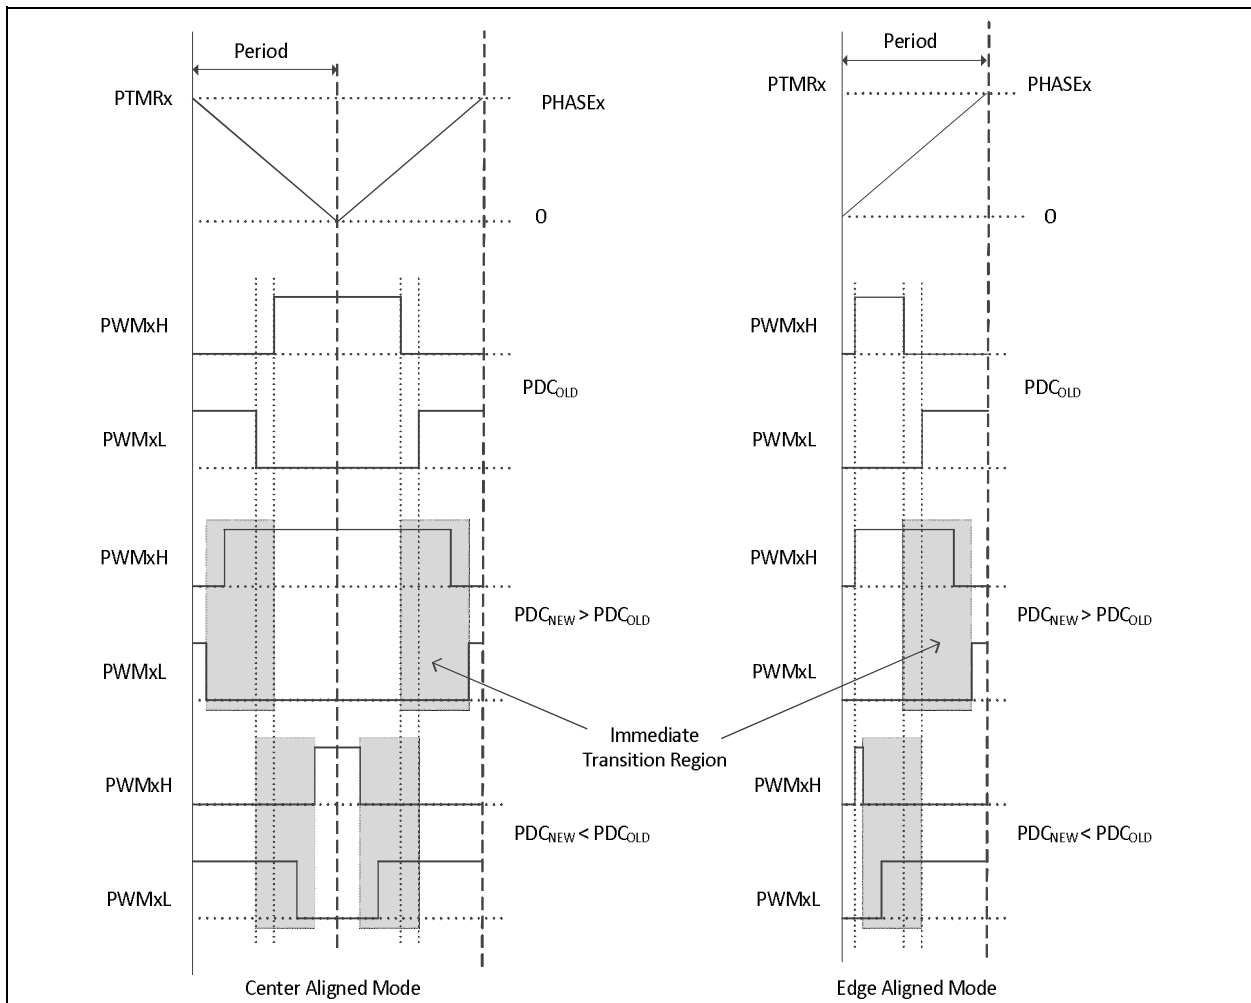
FIGURE 2: TIMING DIAGRAMS FOR CENTER-ALIGNED AND EDGE-ALIGNED MODES

The PWM generator may not assert dead time on the edges of transitions. This has been observed when all of the following conditions are present:

In [Figure 2](#), if the duty cycle write occurred in the shaded box, then PWMxH and PWMxL will make an immediate transition without dead time.

However, in most applications, the duty cycle update timing can be controlled using the TRIGx trigger or Special Event Trigger, such that the above mentioned conditions are avoided altogether.

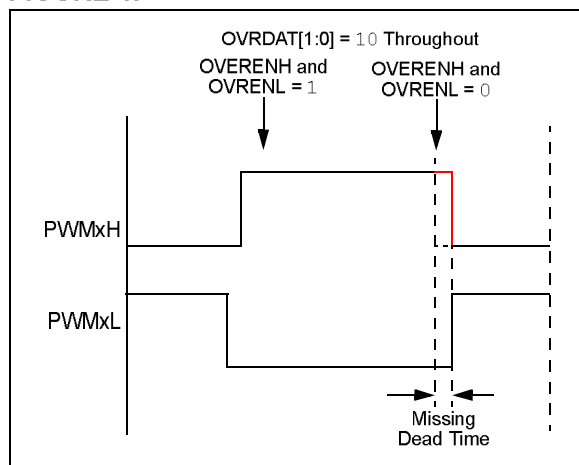
FIGURE 4:

- Output override synchronization is configured to occur on the CPU clock boundary (IOCONx[0] = 0);
- Both PWMxH and PWMxL overrides are enabled prior to the event (OVRENH and OVRENL are both '1'), and
- Both overrides are disabled (OVRENH and OVRENL are both '0') at the instant the dead time should be asserted (Figure 4). This has been observed in both Center-Aligned and Edge-Aligned modes.

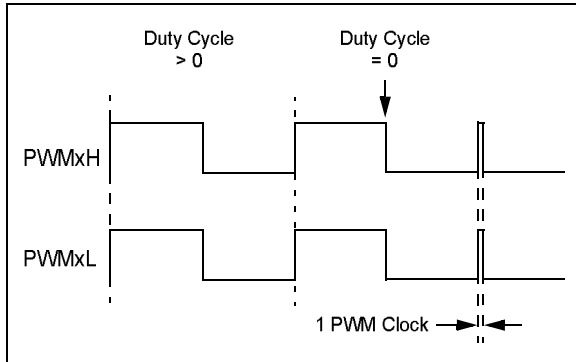
FIGURE 5:

In the Redundant Output mode (IOCONx[11:10] = 10) and Push-Pull Output mode (IOCONx[11:10] = 01) with Immediate Update disabled (PWMCONx[0] = 0), when the Duty Cycle register is updated from a non-zero value to zero, a glitch pulse of a width equal to one PWM clock will appear at the next PWM period boundary, as shown in Figure 5, for the Redundant Output mode. Here, the Duty Cycle register refers to the PDCx register if PWMCONx[8] = 0 or the MDC register if PWMCONx[8] = 1.

If the application requires a zero duty cycle output, there are two possible work around methods:

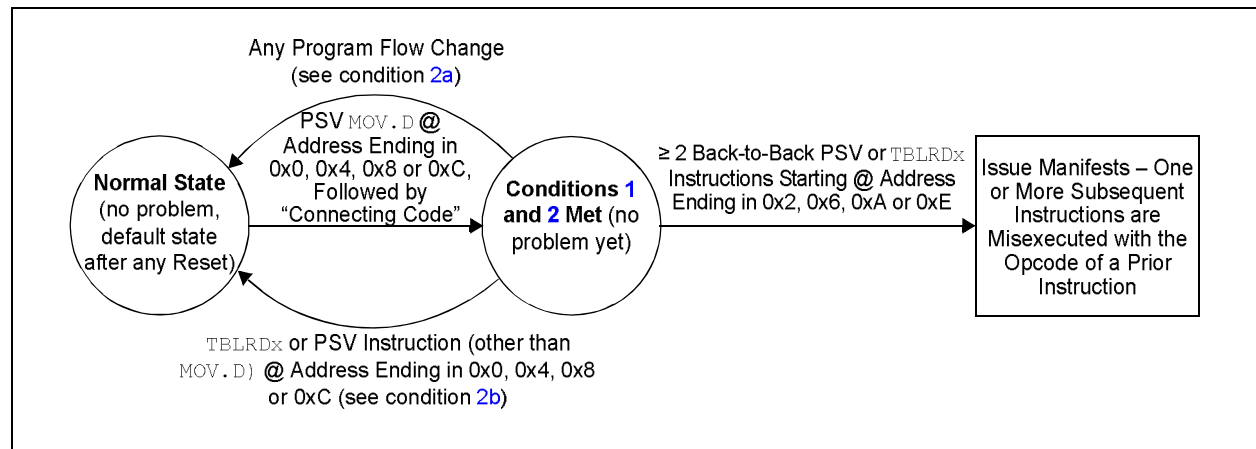
FIGURE 7: SIMPLIFIED BEHAVIOR

When two or more data Flash read instructions (via Program Space Visibility (PSV) read or table read) are executed back-to-back, one or more subsequent instructions can be misexecuted when all of the conditions in [Table 6](#) occur.

[Figure 7](#) provides an example of the effective behavior.

1. All instances of PSV MOV.D can be replaced with two PSV MOV instructions instead. Non-PSV MOV.D instructions acting on RAM/SFRs do not need to be modified; or
2. If not already present, a program flow change instruction (such as BRA \$+2) can be inserted above back-to-back data Flash read sequences; or
3. Back-to-back data Flash read instruction sequences can be broken up by inserting a non-Flash read instruction (such as a NOP), in between the Flash read instructions; or
4. The alignment of the code can be shifted to avoid the required opcode location addresses.
