Product Change Notification - SYST-02IJUE127

ERRATA - PIC32MK Motor Control and General Purpose Errata and Data Sheet Clarification

PIC32MK General Purpose and Motor Control (GP/MC) Silicon Errata and Data Sheet Clarification

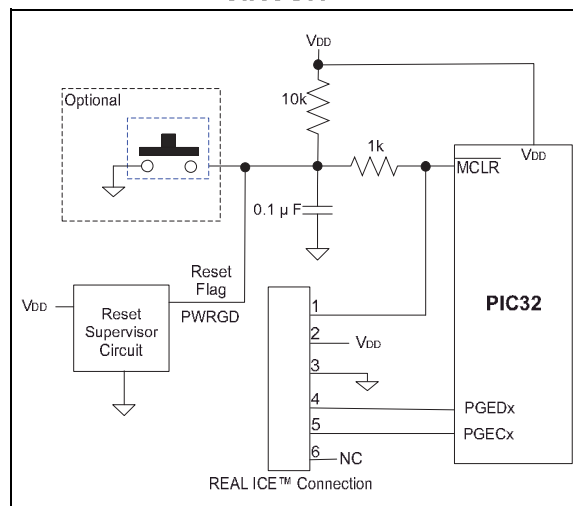
FIGURE 2: RESET SUPERVISOR CIRCUIT

On a BOR event, $V_{POR} < V_{DD} < V_{BOR}$, a Reset is not generated when the BOR threshold is reached. System clocks will stop with all I/O pins functions frozen in their present state until either V_{DD} falls to V_{POR} or V_{DD} returns to above V_{BOR} . The user must assess if this V_{DD} brown-out condition and the resulting frozen I/O pin state has an adverse effect on their application (UART, PWM, I/O, OC, etc.).

If the application can sustain frozen I/O states for ~2.1 ms (UART, CAN, I/O, etc.), the application must enable the Deep Sleep Watchdog Timer and Clock Fail Monitor, based on the details provided in Table 3 and Table 4. If implemented correctly, after ~2.1 ms, a valid internal reset state is entered and the I/O pins are set to the device default Reset state.
