Product Change Notification - SYST-19YAHF127

ERRATA - dsPIC33CK256MP508 Family Silicon Errata and Data Sheet Clarification

dsPIC33CK256MP508 Family Silicon Errata and Data Sheet Clarification

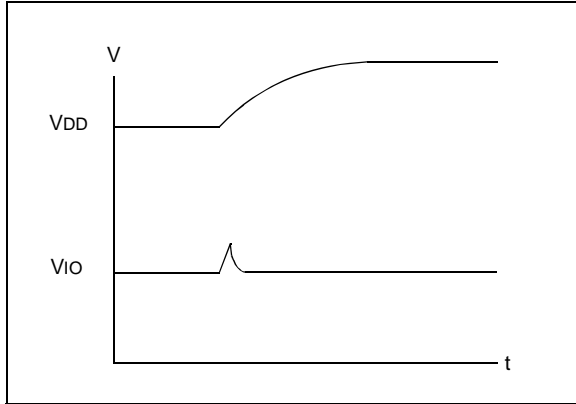
FIGURE 1-1: I/O RAMP

During a fast device power-up when the VDD ramp is less than 4 mS, the I/O pins may drive up to 100 μ A current for a duration of up to 10 μ S (Figure 1-1).

Example applications affected may include complementary power switches, where a transient current shoot-through might occur. High-voltage applications with complementary switches should power the high-voltage 200 μ Sec later than powering the dsPIC[®] device to avoid the current shoot-through. This behavior is specific to each device and not affected by aging.

1. Slow down the VDD ramp time (greater than 4 mS for VDD to ramp 0V to 3.3V).
2. Ensure the circuitry that is connected to the pins can endure this pulse.
