Product Change Notification - SYST-13IXOV452

ERRATA - PIC32MK Motor Control and General Purpose Errata and Data Sheet Clarification

PIC32MK General Purpose and Motor Control (GP/MC) Silicon Errata and Data Sheet Clarification

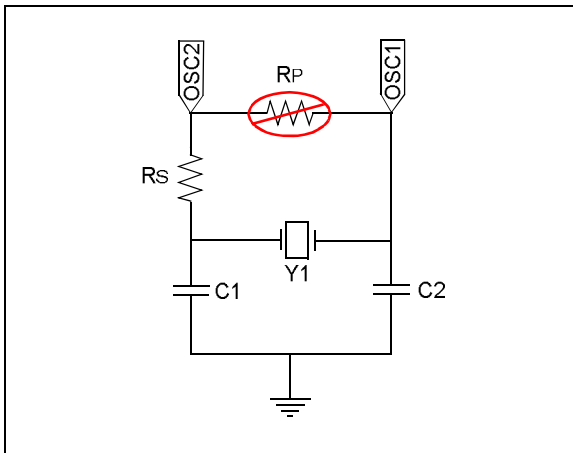
FIGURE 1: Posc CRYSTAL CIRCUIT

1. Module: Primary Oscillator

The Posc supports only specific crystal operation, as provided in [Table 1](#).

The Primary Oscillator (Posc) has been characterized to operate at 8 MHz and 12 MHz when the circuit shown in [Figure 1](#) is implemented and the operating conditions provided in [Table 1](#) are met.

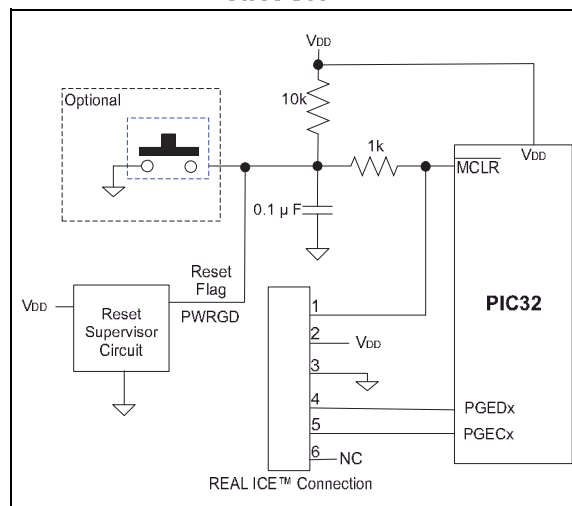
FIGURE 2: RESET SUPERVISOR CIRCUIT

On a BOR event, $V_{POR} < V_{DD} < V_{BOR}$, a Reset is not generated when the BOR threshold is reached. System clocks will stop with all I/O pins functions frozen in their present state until either V_{DD} falls to V_{POR} or V_{DD} returns to above V_{BOR} . The user must assess if this V_{DD} brown-out condition and the resulting frozen I/O pin state has an adverse effect on their application (UART, PWM, I/O, OC, etc.).

If the application can sustain frozen I/O states for ~2.1 ms (UART, CAN, I/O, etc.), the application must enable the Deep Sleep Watchdog Timer and Clock Fail Monitor, based on the details provided in Table 3 and Table 4. If implemented correctly, after ~2.1 ms, a valid internal reset state is entered and the I/O pins are set to the device default Reset state.
