Product Change Notification - SYST-11ALNE662

ERRATA - dsPIC33CH512MP508 Family Silicon Errata and Data Sheet Clarification

dsPIC33CH512MP508 Family Silicon Errata and Data Sheet Clarification

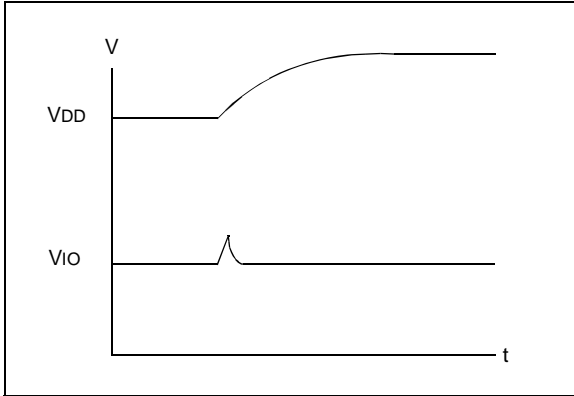
FIGURE 1-1: I/O RAMP

During a fast device power-up, when the VDD ramp is less than 4 mS, the I/O pins may drive up to 100 μ A current for a duration of up to 10 μ S (Figure 1-1).

Example applications affected may include complementary power switches, where a transient current shoot-through might occur. High-voltage applications with complementary switches should power the high-voltage 200 μ Sec later than powering the dsPIC[®] device to avoid the current shoot-through. This behavior is specific to each device and not affected by aging.

1. Slow down the VDD ramp time (greater than 4 mS for VDD to ramp 0V to 3.3V).
2. Ensure the circuitry that is connected to the pins can endure this pulse.
