## Product Change Notification - SYST-21EDWO528

ERRATA - PIC32MX1XX/2XX/5XX 64/100-pin Family Silicon Errata and Data Sheet Clarification

## PIC32MX1XX/2XX/5XX 64/100-pin Family Silicon Errata and Data Sheet Clarification

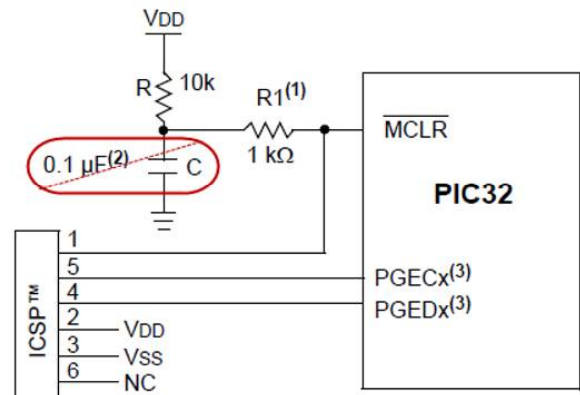
## 17. Module: I/O Port - Initial Pin State

On power-up depending on the VDD ramp rate, the I/O pins can be in an active random output driving state if  $\overline{\text{MCLR}}$  is active until a BOR event.

If, not using an external reset supervisor IC or equivalent, remove the  $\overline{\text{MCLR}}$  capacitor as shown below, and retain the  $\overline{\text{MCLR}}$  Pull-up resistor.

If using an external reset supervisor IC or equivalent, increase the value of the VCAP capacitor to  $\geq 47 \mu\text{F}$  ceramic or solid tantalum capacitor with an ESR  $\leq 1 \text{ ohm}$ .
