Product Change Notification - SYST-21DDQK199

ERRATA - PIC32MX320/340/360/440/460 Family Silicon Errata and Data Sheet Clarification

PIC32MX534/564/664/764 Family Silicon Errata and Data Sheet Clarification

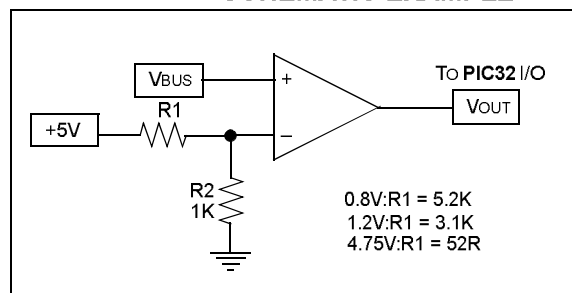
FIGURE 1: EXTERNAL COMPARATOR SCHEMATIC EXAMPLE

When the USB model is configured for OTG operation, it may not recognize all required OTG voltage levels on VBUS pin.

Use external comparator circuit to detect OTG specific voltage levels on VBUS pin.
