## Product Change Notification / SYST-25QUDS815

ERRATA - PIC32MZ Embedded Connectivity with Floating Point Unit (EF) Family Silicon Errata

## PIC32MZ Embedded Connectivity with Floating Point Unit (EF) Family Silicon Errata and Data Sheet Clarification

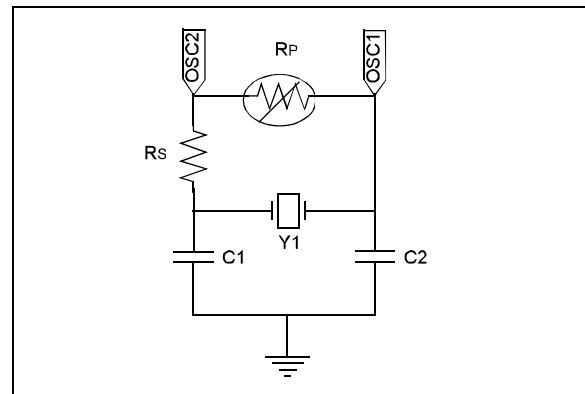
**FIGURE 1: Posc CRYSTAL CIRCUIT**

The Primary Oscillator (Posc) has been characterized to operate at 8 MHz, 12 MHz, and 24 MHz when the circuit in [Figure 1](#) is implemented, and the operating conditions listed in [Table 3](#) are met.
