Product Change Notification / SYST-230UGH321

ERRATA - dsPIC33CH128MP508 Family Silicon Errata and Datasheet Clarification

dsPIC33CH128MP508 Family Silicon Errata and Data Sheet Clarification

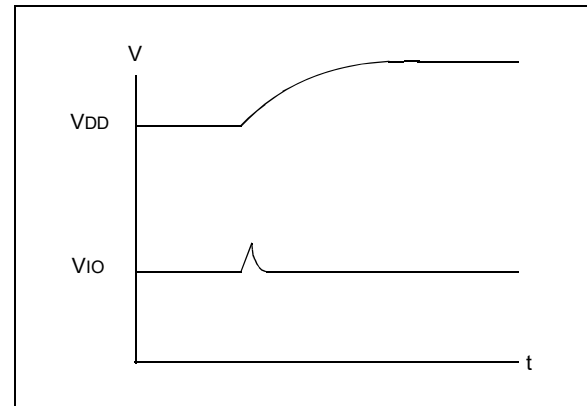
FIGURE 1: I/O RAMP

During a fast device power-up, when the V_{DD} ramp is less than 4 mS, the I/O pins may drive up to 100 μ A current for a duration of up to 10 μ S (Figure 1).

Example applications affected may include complementary power switches, where a transient current shoot-through might occur.

1. Slow down the V_{DD} ramp time (greater than 4 mS for V_{DD} to ramp 0V to 3.3V).
2. Ensure the circuitry that is connected to the pins can endure this pulse.

High-voltage applications with complementary switches should power the high-voltage 200 μ Sec later than powering the dsPIC[®] device to avoid the current shoot-through. This behavior is specific to each device and not affected by aging.

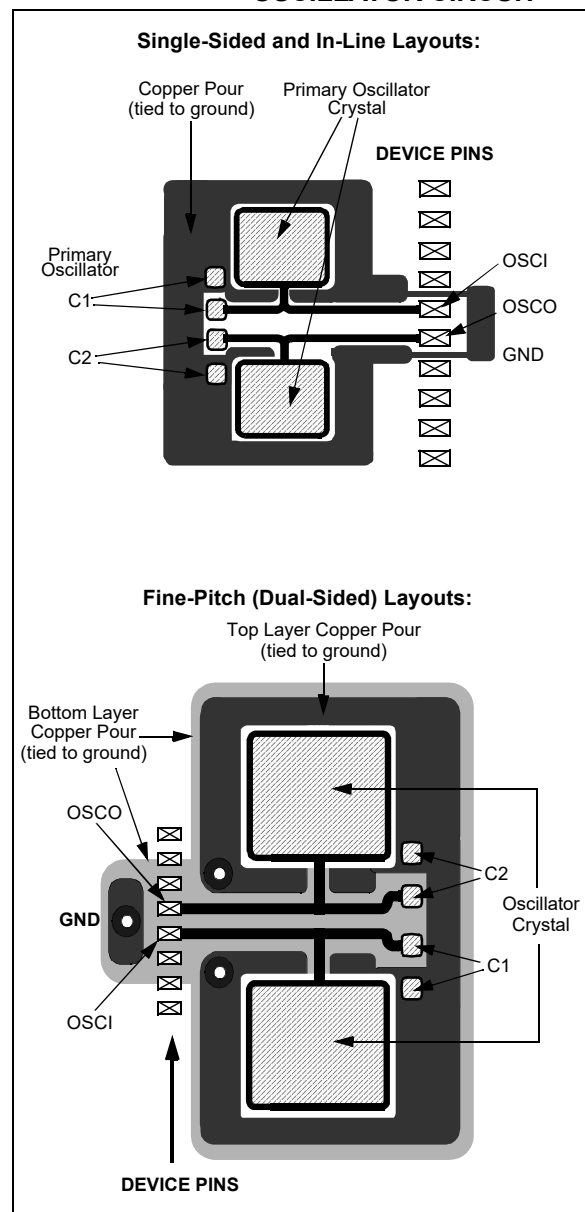
FIGURE 2-2: SUGGESTED PLACEMENT OF THE OSCILLATOR CIRCUIT

When the Primary Oscillator (POSC) circuit is used to connect a crystal oscillator, special care and consideration is needed to ensure proper operation. The POSC circuit should be tested across the environmental conditions that the end product is intended to be used. The load capacitors specified in the crystal oscillator data sheet can be used as a starting point, however, the parasitic capacitance from the PCB traces can affect the circuit and the values may need to be altered to ensure proper start-up and operation.

able solution is to tie the broken guard sections to a mirrored ground layer. In all cases, the guard trace(s) must be returned to ground.
