Product Change Notification / SYST-23ZAVZ977

ERRATA - dsPIC33CH512MP508 Family Silicon Errata and Data Sheet Clarification

dsPIC33CH512MP508 Family Silicon Errata and Data Sheet Clarification

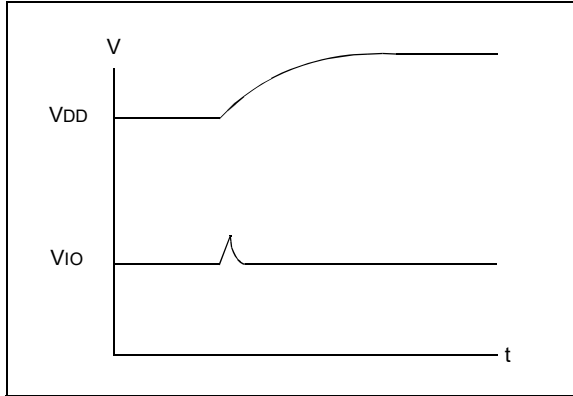
FIGURE 1-1: I/O RAMP

During a fast device power-up, when the VDD ramp is less than 4 mS, the I/O pins may drive up to 100 μ A current for a duration of up to 10 μ S (Figure 1-1).

1. Slow down the VDD ramp time (greater than 4 mS for VDD to ramp 0V to 3.3V).
2. Ensure the circuitry that is connected to the pins can endure this pulse.

Example applications affected may include complementary power switches, where a transient current shoot-through might occur. High-voltage applications with complementary switches should power the high-voltage 200 μ Sec later than powering the dsPIC[®] device to avoid the current shoot-through. This behavior is specific to each device and not affected by aging.

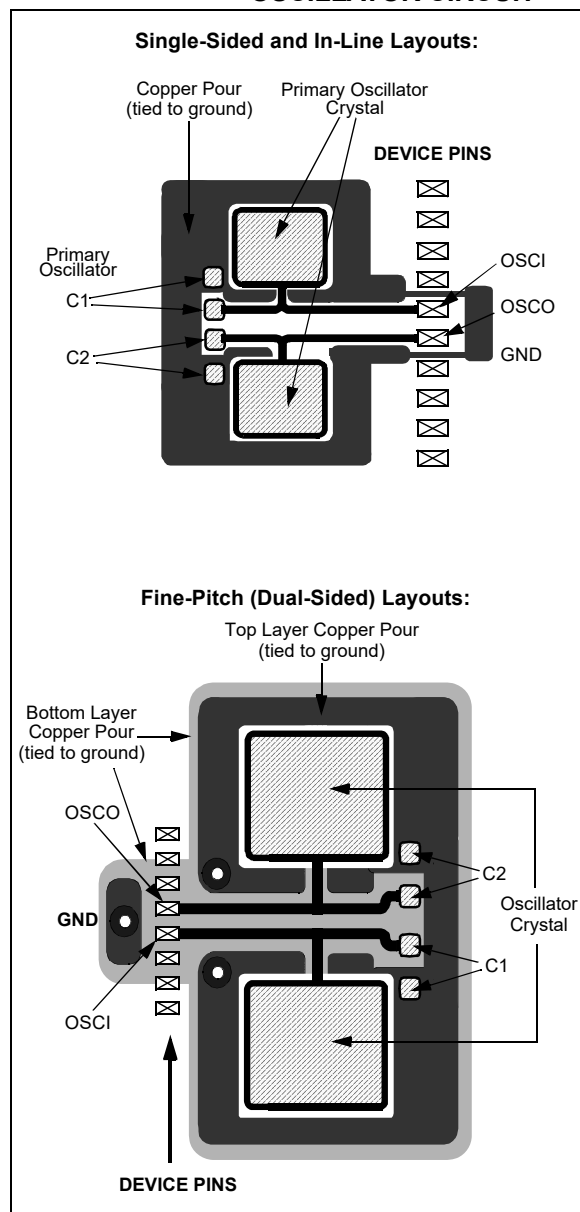
FIGURE 2-2: SUGGESTED PLACEMENT OF THE OSCILLATOR CIRCUIT

Excessive trace length and other physical interaction can lead to poor signal quality. Poorly tuned oscillator circuits can have reduced amplitude, incorrect frequency (runt pulses), distorted waveforms and long start-up times that may result in unpredictable application behavior, such as instruction misexecution, illegal op code fetch, etc. Ensure that the crystal oscillator circuit is at full amplitude and correct frequency before the system begins to execute code. In planning the application’s routing and I/O assignments, ensure that adjacent port pins, and other signals in close proximity to the oscillator, do not have high frequencies, short rise and fall times and other similar noise. For further information on the Primary Oscillator, see Primary Oscillator (POSC).

able solution is to tie the broken guard sections to a mirrored ground layer. In all cases, the guard trace(s) must be returned to ground.
