Errata sheet V1.5 affecting products TC23x_AC

N° 10210AERRA

Subject: TC23x_AC_Errata_Sheet_v1_5

Device TC23x
Marking/Step ES-AC, AC
Package see Data Sheet

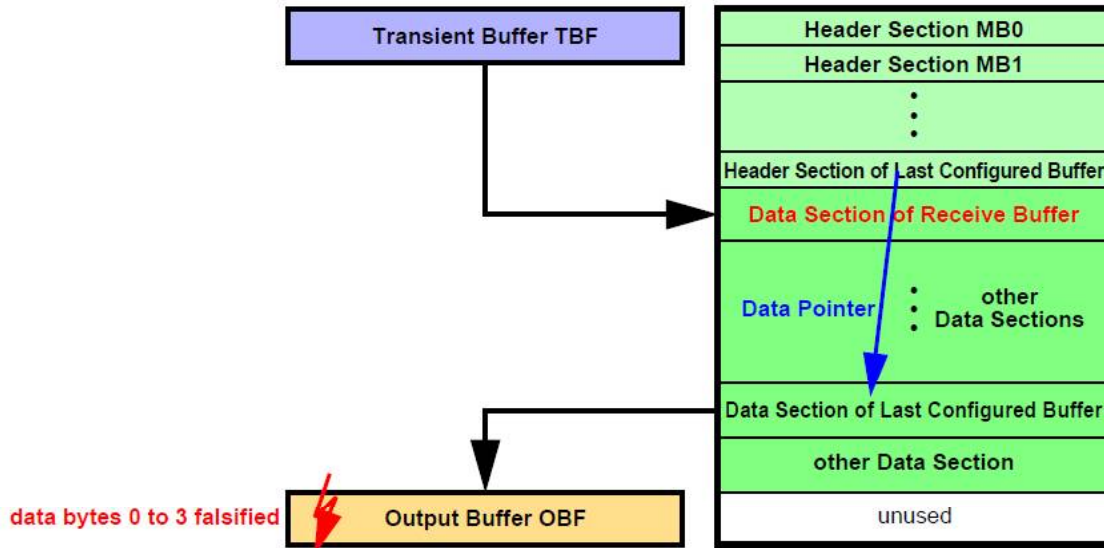
Figure 1 Message buffer transfer from Message RAM to OBF

When the message buffer has its payload configured to maximum length (**PLC** = 127), the OBF word on address 00h (payload data bytes 0 to 3) is overwritten with unexpected data at the end of the transfer.

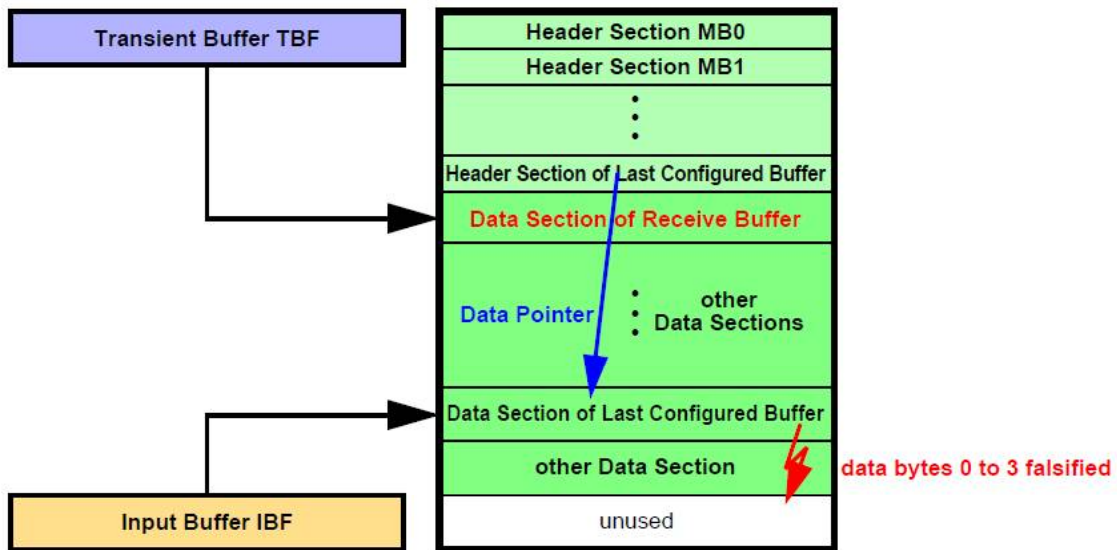
Figure 2 Message buffer transfer from IBF to Message RAM

After the Data Section of the selected message buffer in the Message RAM has been written, one additional write access overwrites the following word in the Message RAM which might be the first word of the next Data Section.

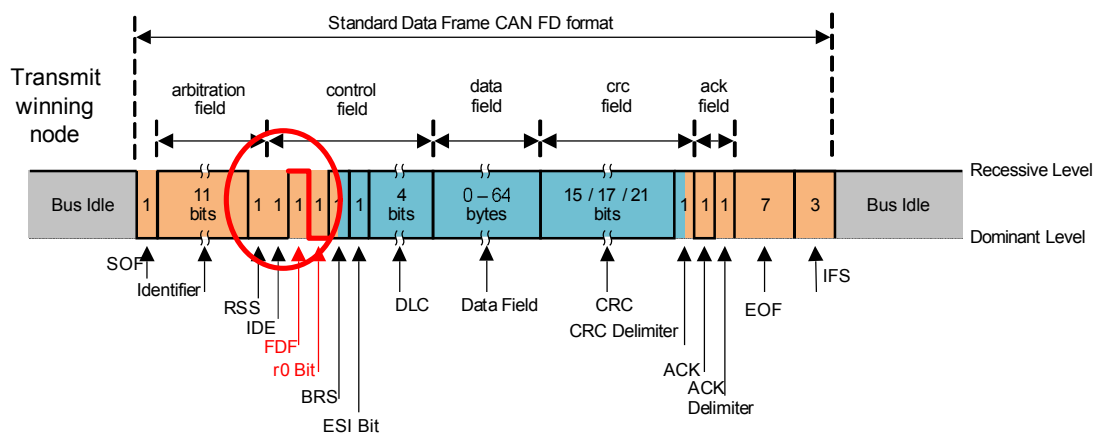
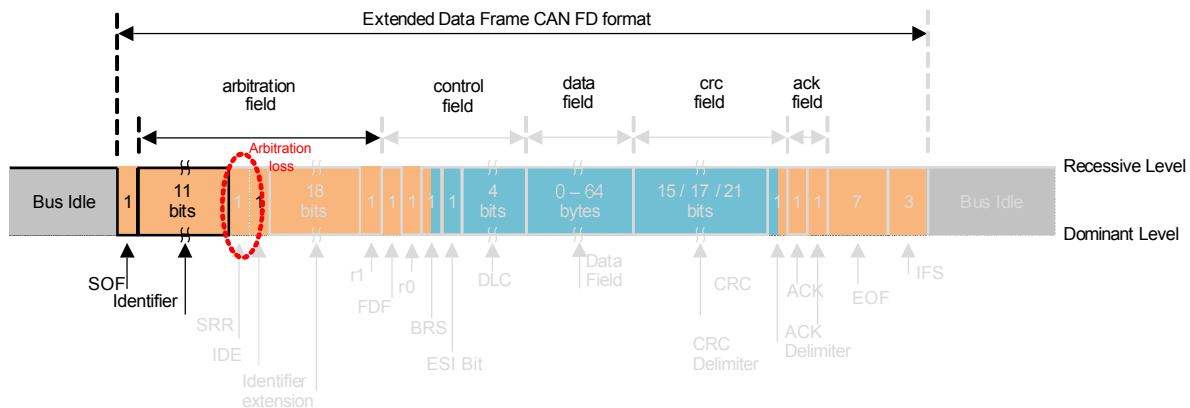
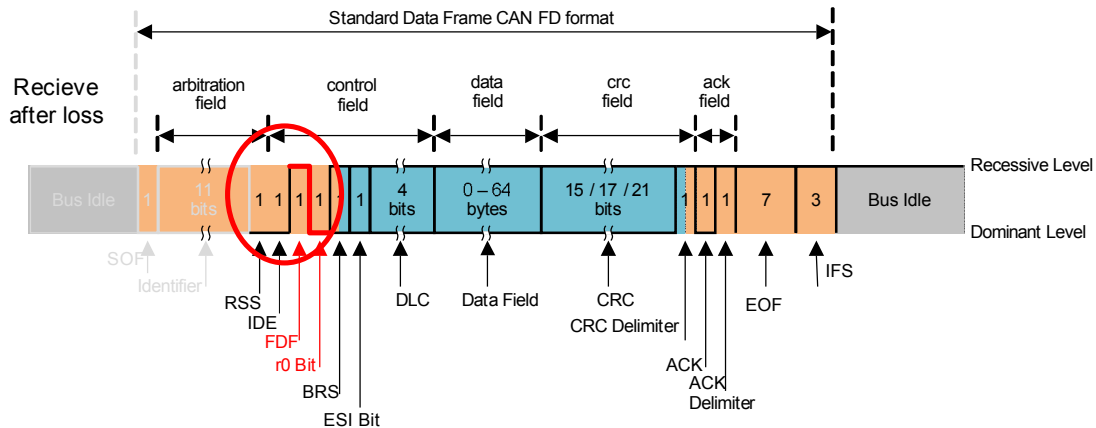
MultiCAN TC.044 CAN FD: Missing Hardsync

The device is producing more error frames within a network than a device with a hardsync at the FDF bit.

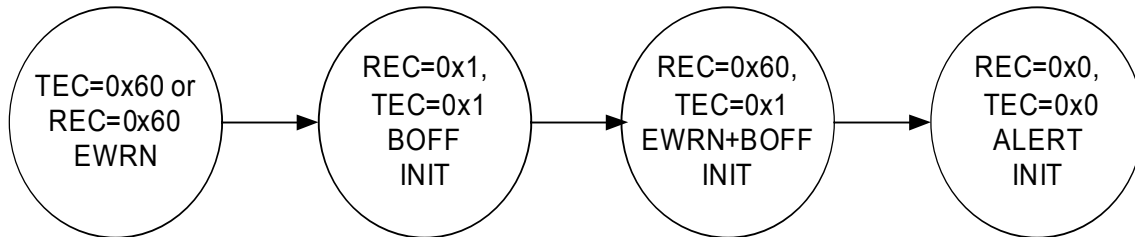
Figure 8 Alert Interrupt Behavior in case of Bus-Off

When the threshold for error warning (EWRN) is reached (default value of Error Warning Level EWRN = 0x60), then the EWRN interrupt is issued. The bus-off (BOFF) status is reached if $TEC > 255$ according to CAN specification, changing the MultiCAN module with REC and TEC to the same value 0x1, setting the INIT bit to 1_B, and issuing the BOFF interrupt. The bus-off recovery phase starts automatically. Every time an idle time is seen, REC is incremented. If REC = 0x60, a combined status EWRN+BOFF is reached. The corresponding interrupt can also be seen as a pre-warning interrupt, that the bus-off recovery phase will be finished soon. When the bus-off recovery phase has finished (128 times idle time have been seen on the bus), EWRN and BOFF are cleared, the ALERT interrupt bit is set and the INIT bit is still set.

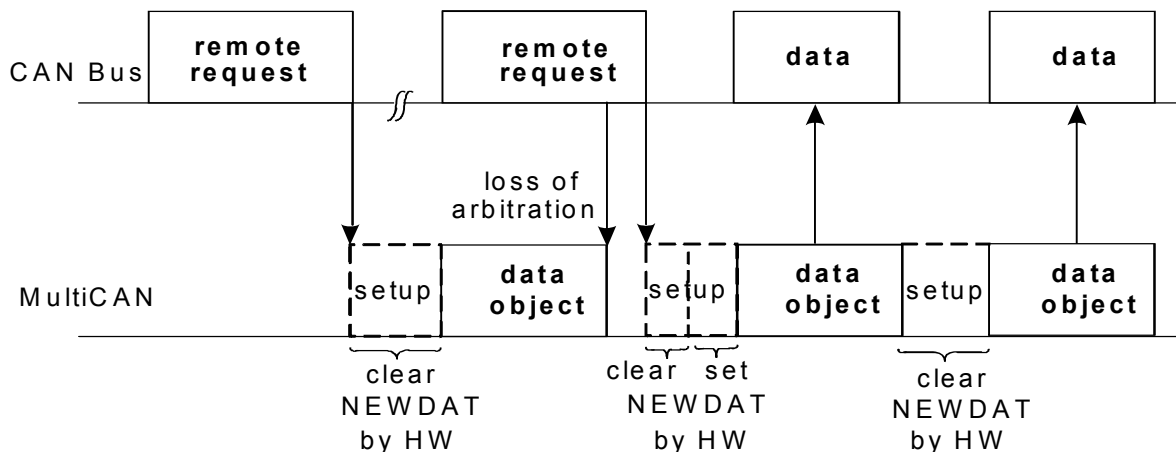
Figure 9 Loss of Arbitration

When the appropriate message object (data frame) triggered by the first remote frame wins the arbitration, it will be sent out and NEWDAT is not reset. This leads to an additional data frame, that will be sent by this message object (clearing NEWDAT).

There will, however, not be more data frames than there are corresponding remote requests.

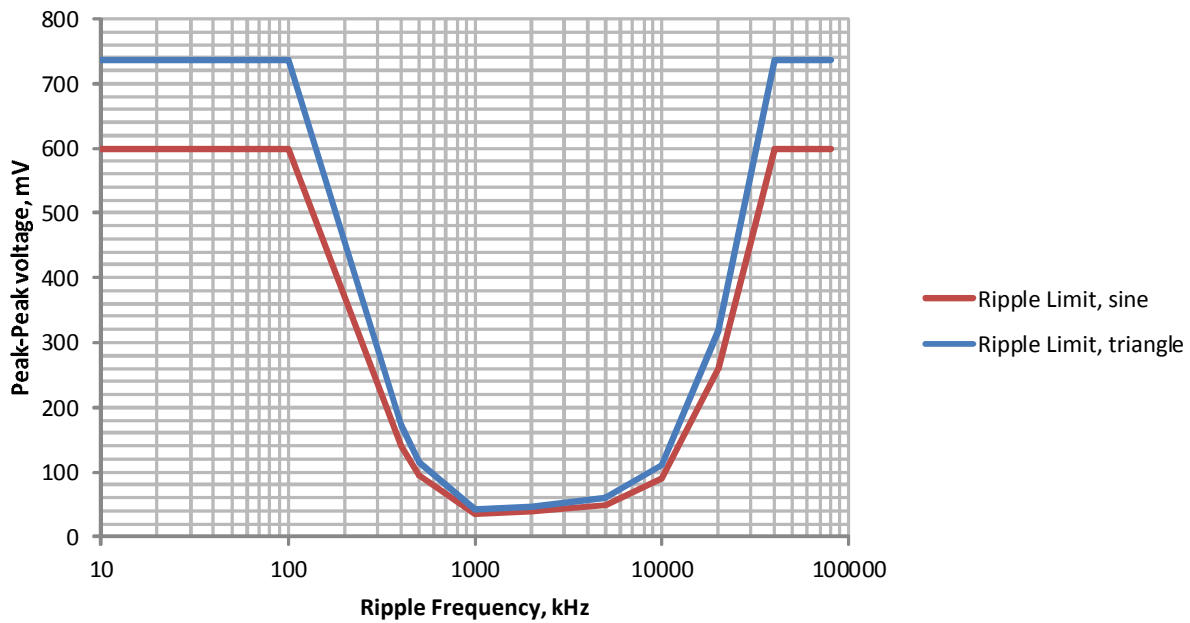
Figure 12 Ripple Voltage vs. Frequency Characteristic

The internal back-up clock is sensitive to specific power supply voltage disturbance/ripple caused by a voltage ripple intrinsic to DC-DC converters. Specific conditions such as insufficient filtering of the ripple may lead to improper behavior of the start-up scheme of the back-up clock, and thus stuck-at state during the start-up of the microcontroller until this condition is removed.

The diagram reflects acceptable ripple level during the cold start of the microcontroller at the respective VDDP3/VEXT/VEVRSB supply of the PMS subsystem, depending on the device and package type, as shown in the following table.

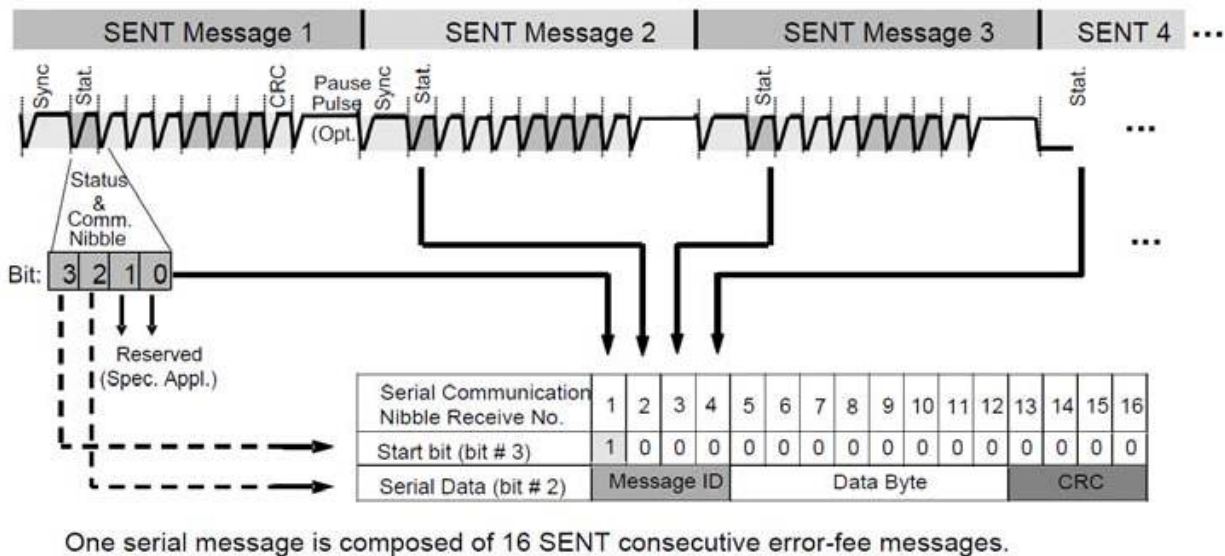
Figure 13 Short Serial Message, Serial Data Encoding over 16 messages

Figure 13 shows a corrected version of this figure.
