## Product Change Notification / SYST-10KFAZ971

ERRATA - dsPIC33CH128MP508 Family Silicon Errata and Datasheet Clarification

## dsPIC33CH128MP508 Family Silicon Errata and Data Sheet Clarification

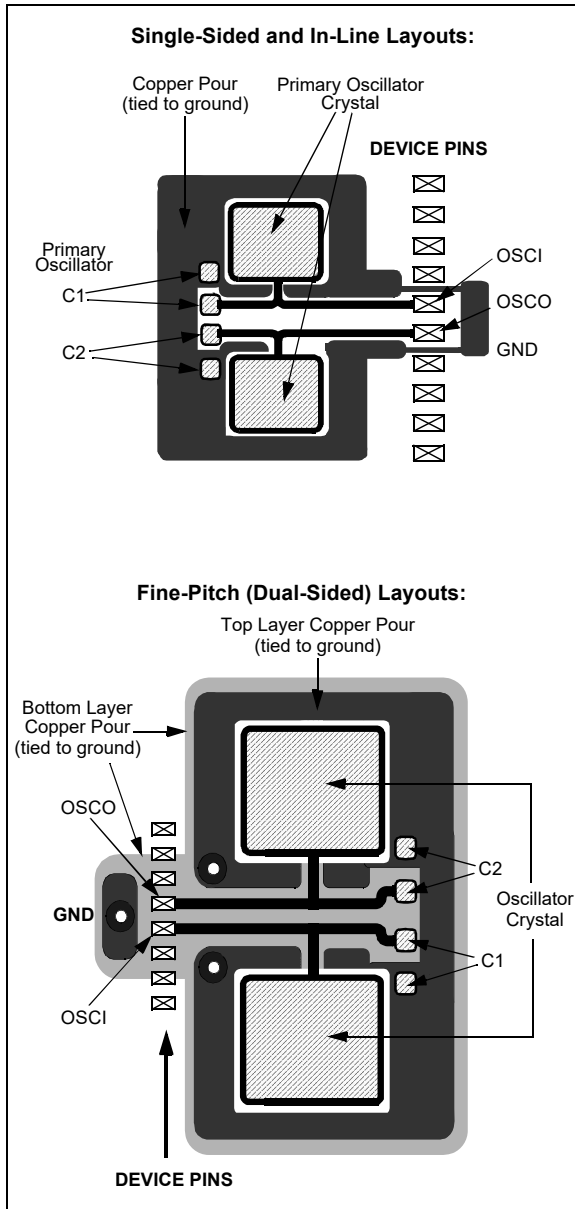
**FIGURE 2-2: SUGGESTED PLACEMENT OF THE OSCILLATOR CIRCUIT**

When the Primary Oscillator (POSC) circuit is used to connect a crystal oscillator, special care and consideration is needed to ensure proper operation. The POSC circuit should be tested across the environmental conditions that the end product is intended to be used. The load capacitors specified in the crystal oscillator data sheet can be used as a starting point, however, the parasitic capacitance from the PCB traces can affect the circuit and the values may need to be altered to ensure proper start-up and operation.

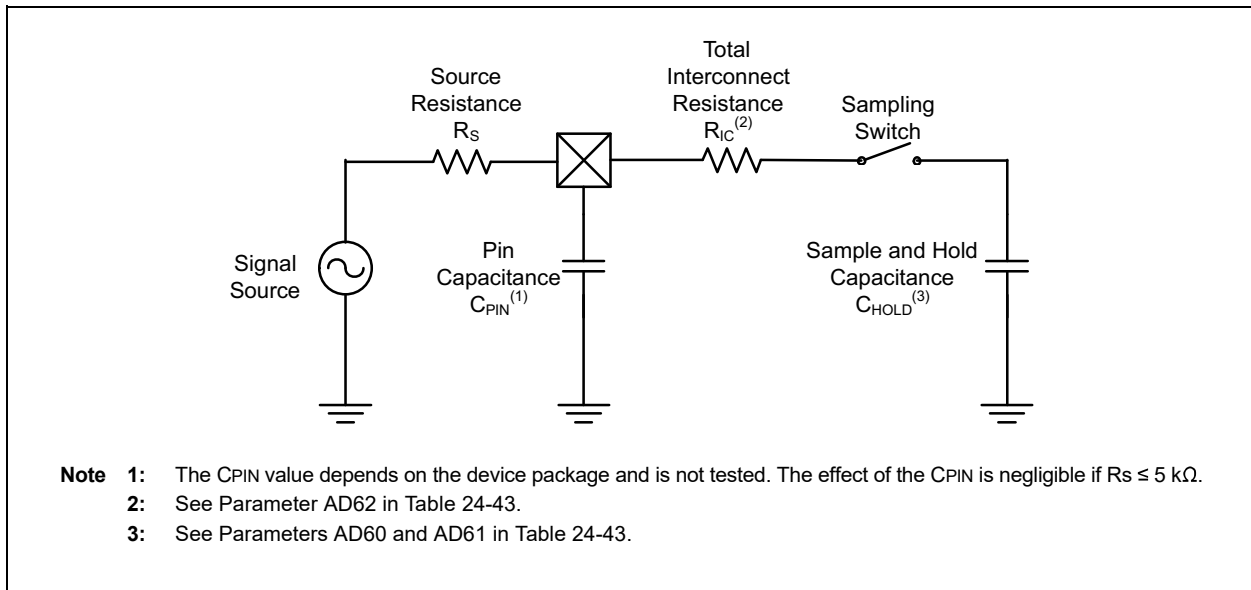
**FIGURE: ADC ANALOG INPUT MODEL**

The analog input model of the ADC is shown in the figure below.

The total acquisition time for the Analog-to-Digital conversion is a function of the Holding Capacitor ( $C_{HOLD}$ ) charge time. For the ADC module to meet its specified accuracy, the Holding Capacitor ( $C_{HOLD}$ ) must be allowed to fully charge to the voltage level on the analog input pin. The Signal Source Impedance ( $R_S$ ) and the Interconnect Impedance ( $R_{IC}$ ) combine to affect the time required to charge the  $C_{HOLD}$ . The total resistance ( $R_S + R_{IC}$ ) must therefore, be small enough to fully charge the Holding Capacitor within the selected sample time.
