Product Change Notification / SYST-04BZVW306

ERRATA - dsPIC33CH512MP508 Family Silicon Errata and Data Sheet Clarification

dsPIC33CH512MP508 Family Silicon Errata and Data Sheet Clarification

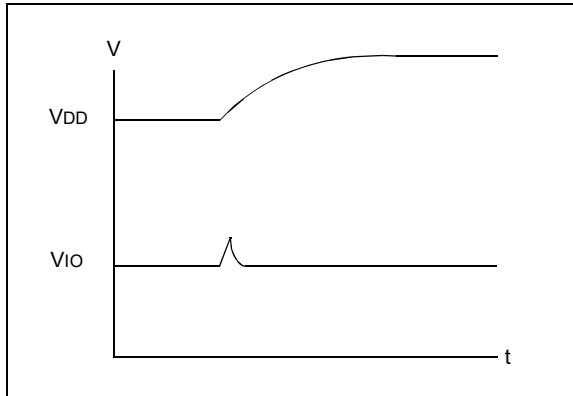
FIGURE 1-1: I/O RAMP

During a fast device power-up, when the VDD ramp is less than 4 mS, the I/O pins may drive up to 100 μ A current for a duration of up to 10 μ S (Figure 1-1).

Example applications affected may include complementary power switches, where a transient current shoot-through might occur. High-voltage applications with complementary switches should power the high-voltage 200 μ Sec later than powering the dsPIC[®] device to avoid the current shoot-through. This behavior is specific to each device and not affected by aging.

1. Slow down the VDD ramp time (greater than 4 mS for VDD to ramp 0V to 3.3V).
2. Ensure the circuitry that is connected to the pins can endure this pulse.

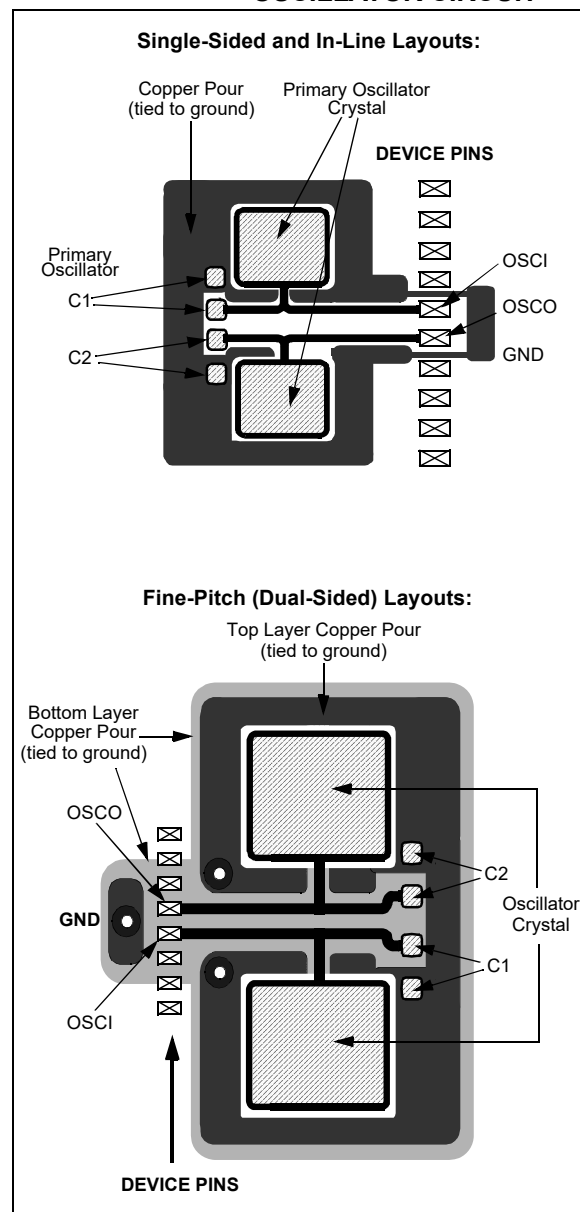
FIGURE 2-2: SUGGESTED PLACEMENT OF THE OSCILLATOR CIRCUIT

When the Primary Oscillator (POSC) circuit is used to connect a crystal oscillator, special care and consideration is needed to ensure proper operation. The POSC circuit should be tested across the environmental conditions that the end product is intended to be used. The load capacitors specified in the crystal oscillator data sheet can be used as a starting point, however, the parasitic capacitance from the PCB traces can affect the circuit and the values may need to be altered to ensure proper start-up and operation.

able solution is to tie the broken guard sections to a mirrored ground layer. In all cases, the guard trace(s) must be returned to ground.

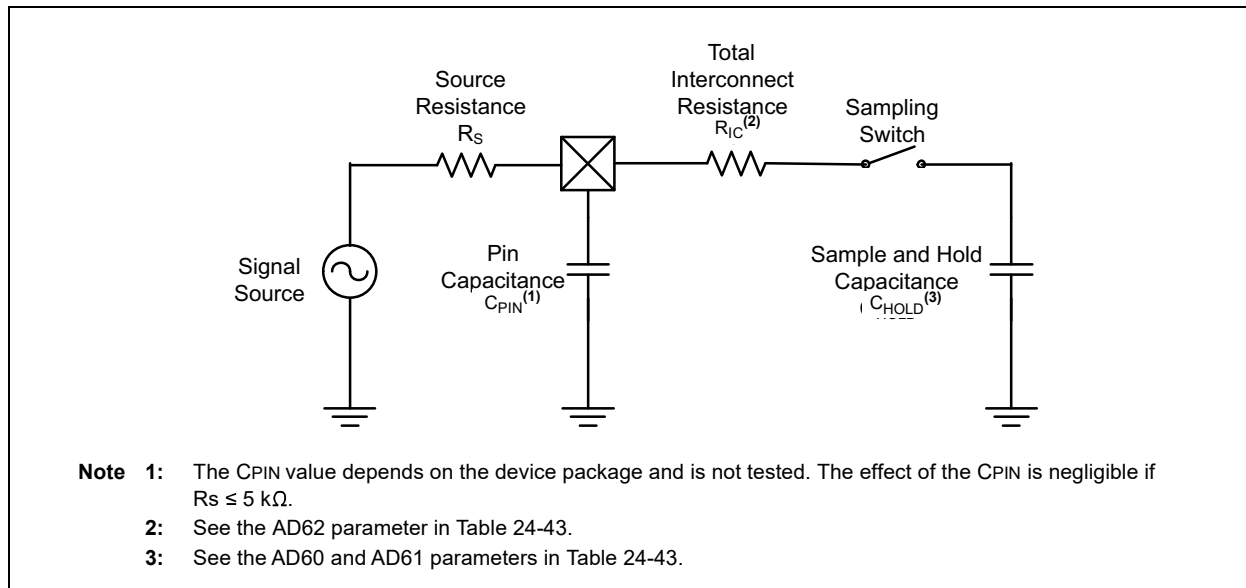
FIGURE: ADC ANALOG INPUT MODEL

The analog input model of the ADC is shown in the figure below.

The total acquisition time for the Analog-to-Digital conversion is a function of the Holding Capacitor (C_{HOLD}) charge time. For the ADC module to meet its specified accuracy, the Holding Capacitor (C_{HOLD}) must be allowed to fully charge to the voltage level on the analog input pin. The Signal Source Impedance (R_S) and the Interconnect Impedance (R_{IC}) combine to affect the time required to charge the C_{HOLD} . The total resistance ($R_S + R_{IC}$) must therefore, be small enough to fully charge the Holding Capacitor within the selected sample time.

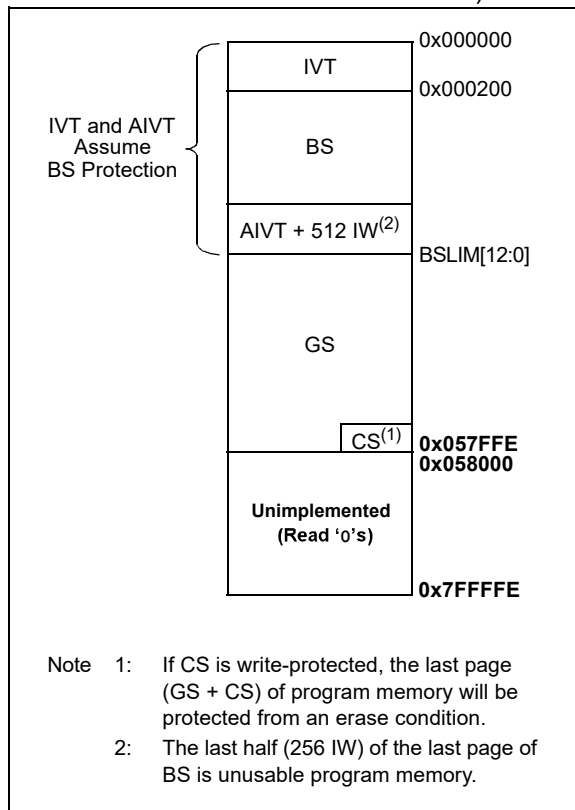
FIGURE 21-4: FLASH SECURITY SEGMENTS (SINGLE PARTITION MODE)

Figure 21-4 has been updated as shown in bold below.

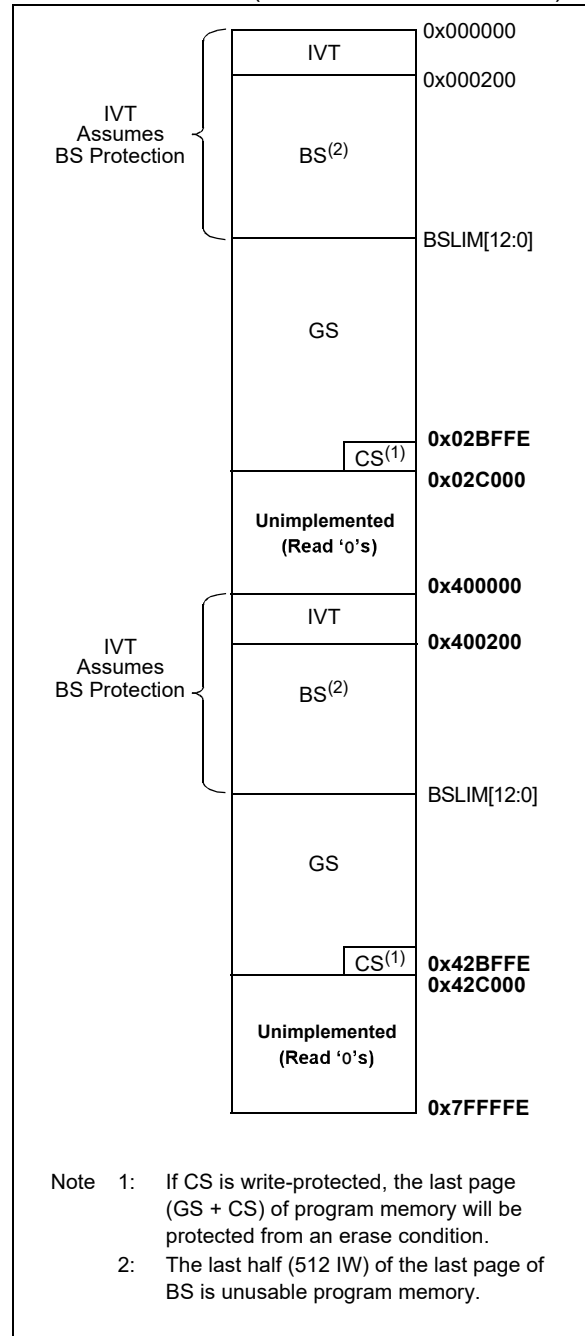
FIGURE 21-5: FLASH SECURITY SEGMENTS (DUAL PARTITION MODE)

Figure 21-5 has been updated as shown in bold below.

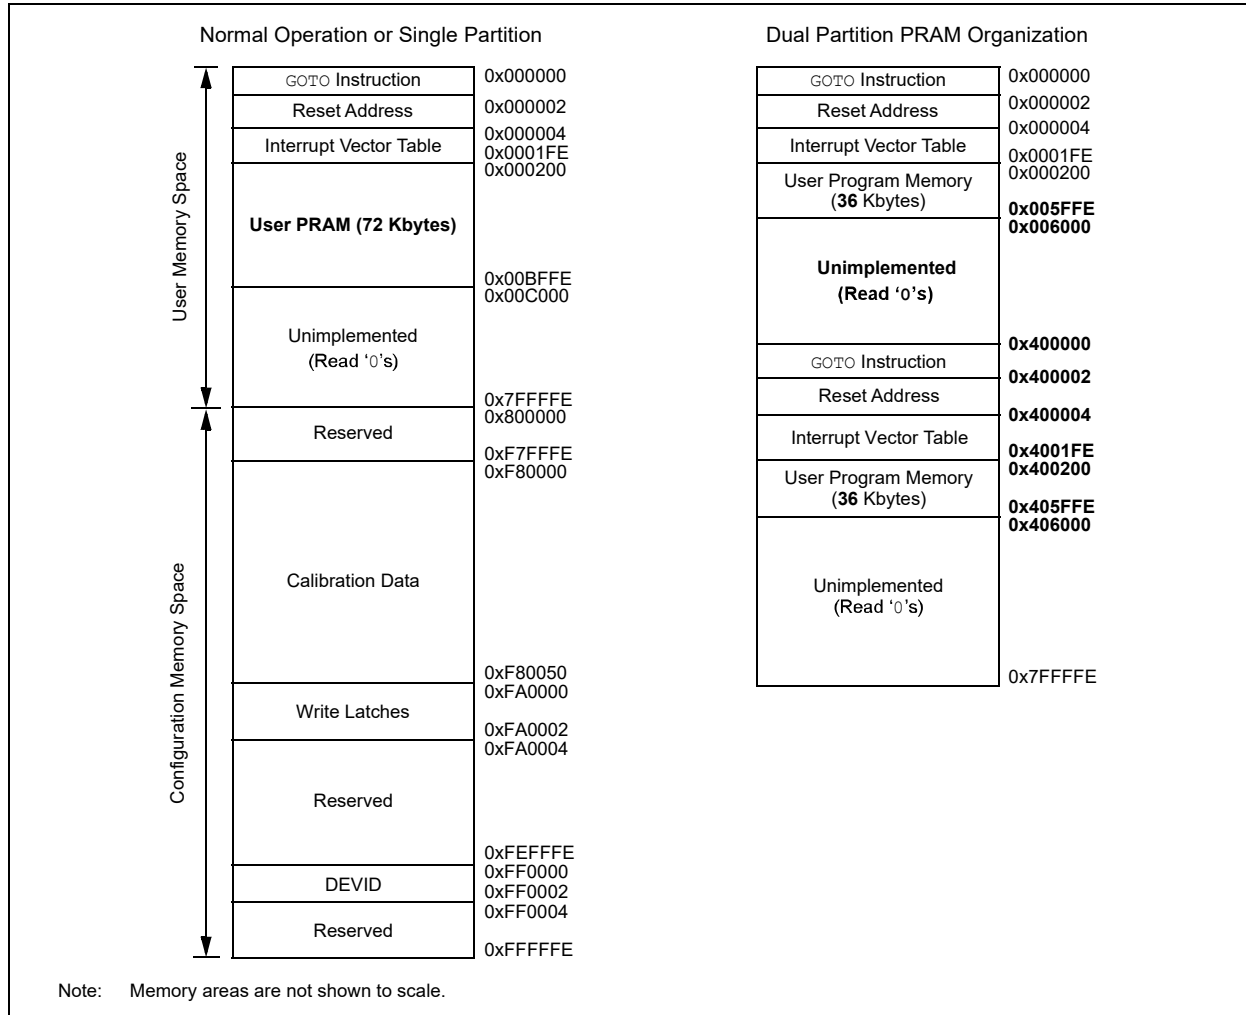
FIGURE 4-3: PRAM (PROGRAM MEMORY) FOR SECONDARY CORE dsPIC33CH512MP508S1 DEVICES

Figure 4-3 has been updated as shown in **bold** below.
