Product Change Notification / SYST-26SSCP212

ERRATA - PIC18(L)F24/25K42 Silicon Errata and Data Sheet Clarification Document Revision

PIC18(L)F24/25K42 Silicon Errata and Data Sheet Clarification

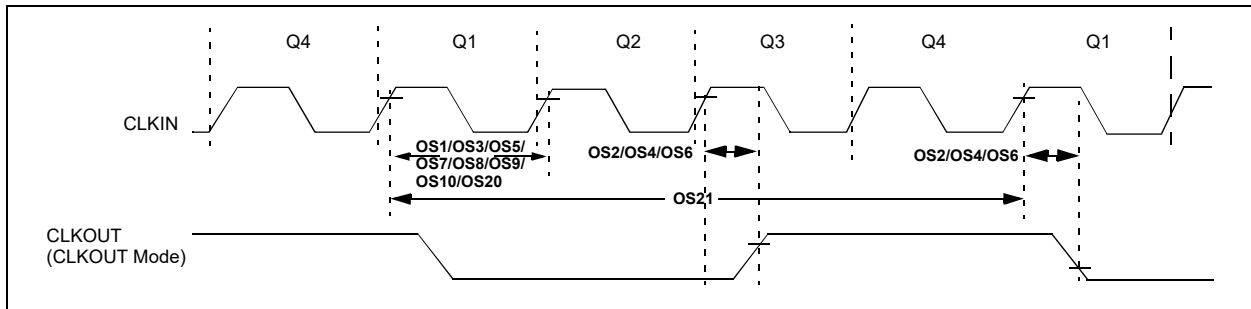
Figure 44-5 Clock Timing

Figure 44-5 incorrectly shows the location of parameters OS1, OS2, OS3, OS4, OS5, OS6, OS7, OS8, OS9, OS10, OS20 and OS21. The correct location for the above-mentioned parameters is depicted in the following figure.
