## Product Change Notification / SYST-25LGPN222

ERRATA - PIC16(L)F15324/44 Family Silicon Errata and Data Sheet Clarification Errata Document Revision

## PIC16(L)F15325/45 Family Silicon Errata and Data Sheet Clarification

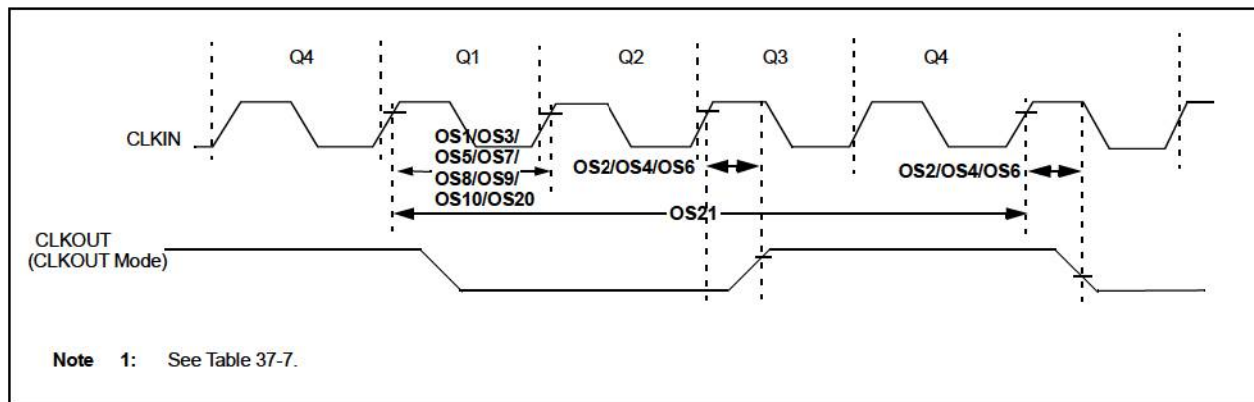
#### 2.1 Figure 37-5: Clock Timing

Figure 37-5 incorrectly shows the location of parameters OS1, OS2, OS3, OS4, OS5, OS6, OS7, OS8, OS9, OS10, OS20 and OS21. The correct location for the above-mentioned parameters is depicted in the following figure.

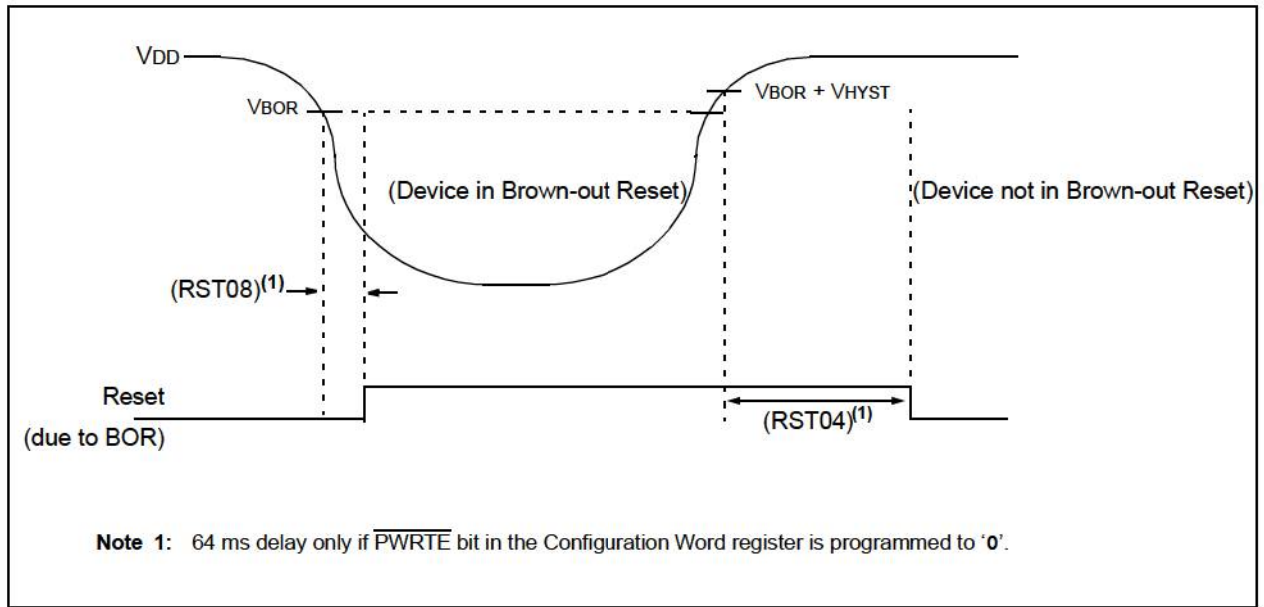
#### 2.2 Figure 37-9: Brown-Out Reset Timing and Characteristics

Note 1 in Figure 37-9 is incorrect. The correct note along with the figure is depicted below.
