Product Change Notification / SYST-21NWMU176

ERRATA - dsPIC33CH512MP508 Family Silicon Errata and Data Sheet Clarification

dsPIC33CH512MP508 Family Silicon Errata and Data Sheet Clarification

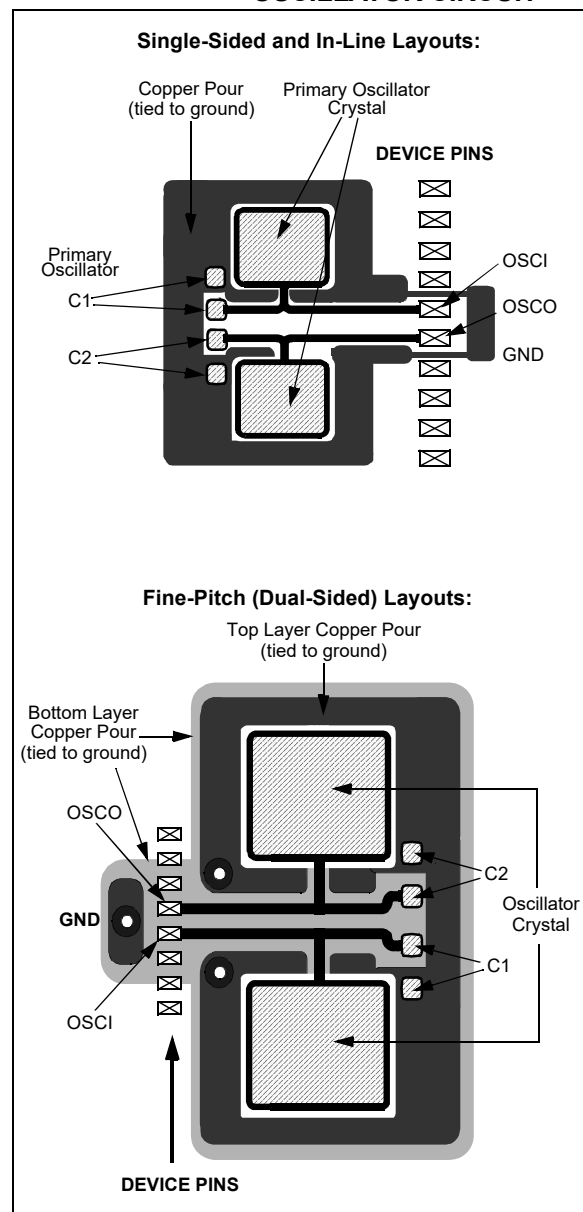
FIGURE 2-2: SUGGESTED PLACEMENT OF THE OSCILLATOR CIRCUIT

When the Primary Oscillator (POSC) circuit is used to connect a crystal oscillator, special care and consideration is needed to ensure proper operation. The POSC circuit should be tested across the environmental conditions that the end product is intended to be used. The load capacitors specified in the crystal oscillator data sheet can be used as a starting point, however, the parasitic capacitance from the PCB traces can affect the circuit and the values may need to be altered to ensure proper start-up and operation.

able solution is to tie the broken guard sections to a mirrored ground layer. In all cases, the guard trace(s) must be returned to ground.

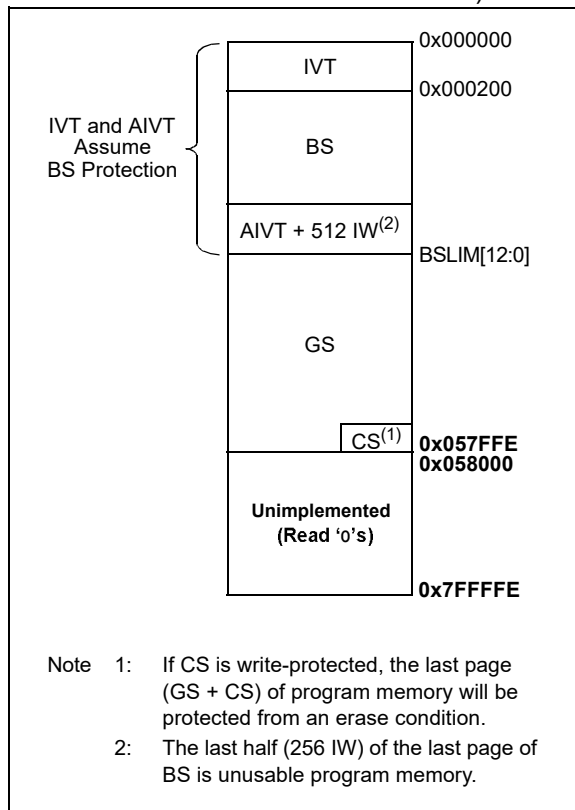
FIGURE 21-4: FLASH SECURITY SEGMENTS (SINGLE PARTITION MODE)

Figure 21-4 has been updated as shown in **bold** below.

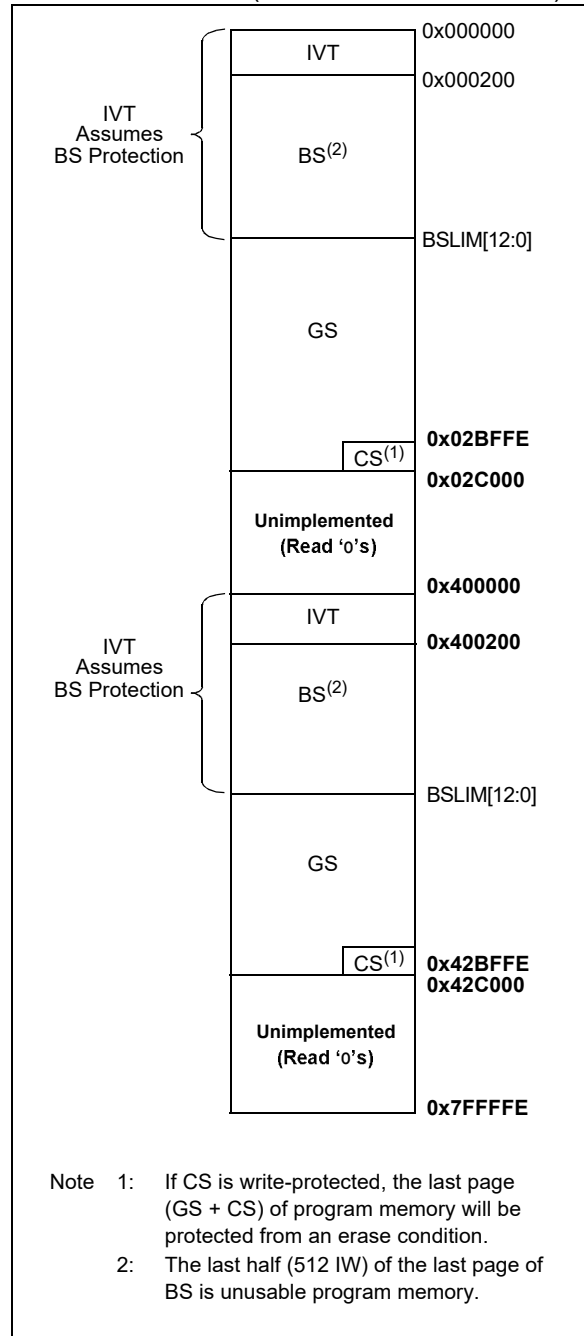
FIGURE 21-5: FLASH SECURITY SEGMENTS (DUAL PARTITION MODE)

Figure 21-5 has been updated as shown in **bold** below.

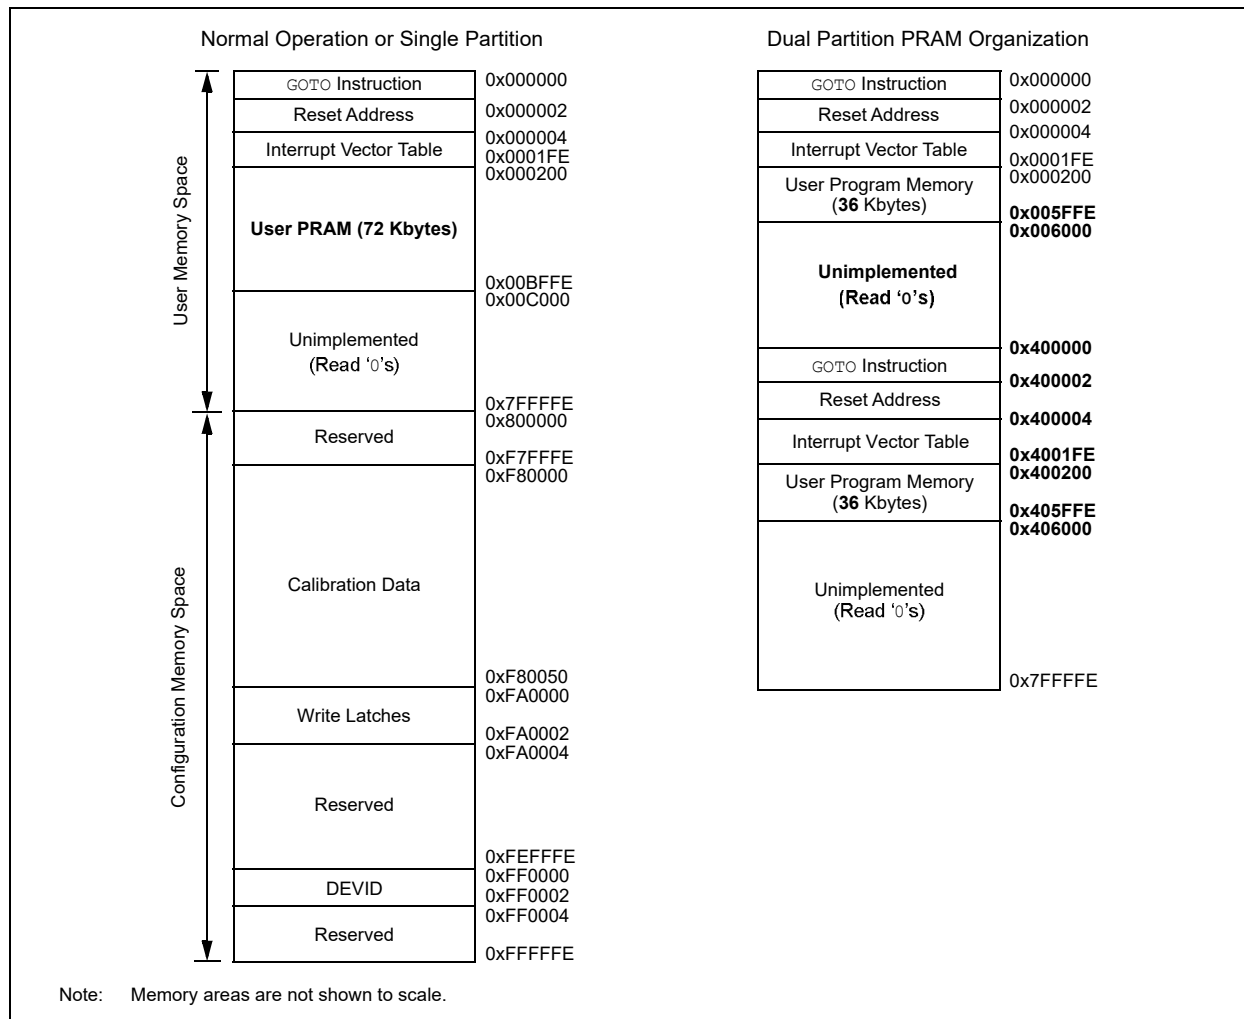
FIGURE 4-3: PRAM (PROGRAM MEMORY) FOR SECONDARY CORE dsPIC33CH512MP508S1 DEVICES

Figure 4-3 has been updated as shown in **bold** below.
