Information note

N° 10269AERRA

Errata sheet V1.9 affecting products TC39x_BC

Device TC39x
Marking/Step (E)ES-BC, BC
Package see Data Sheet

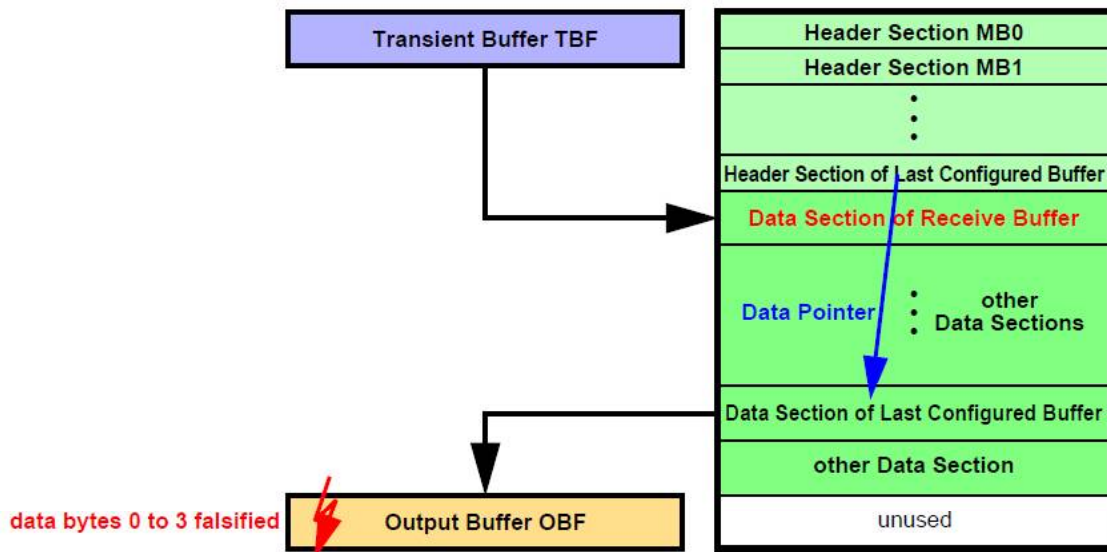
Figure 2 Message buffer transfer from Message RAM to OBF

When the message buffer has its payload configured to maximum length (**PLC** = 127), the OBF word on address 00h (payload data bytes 0 to 3) is overwritten with unexpected data at the end of the transfer.

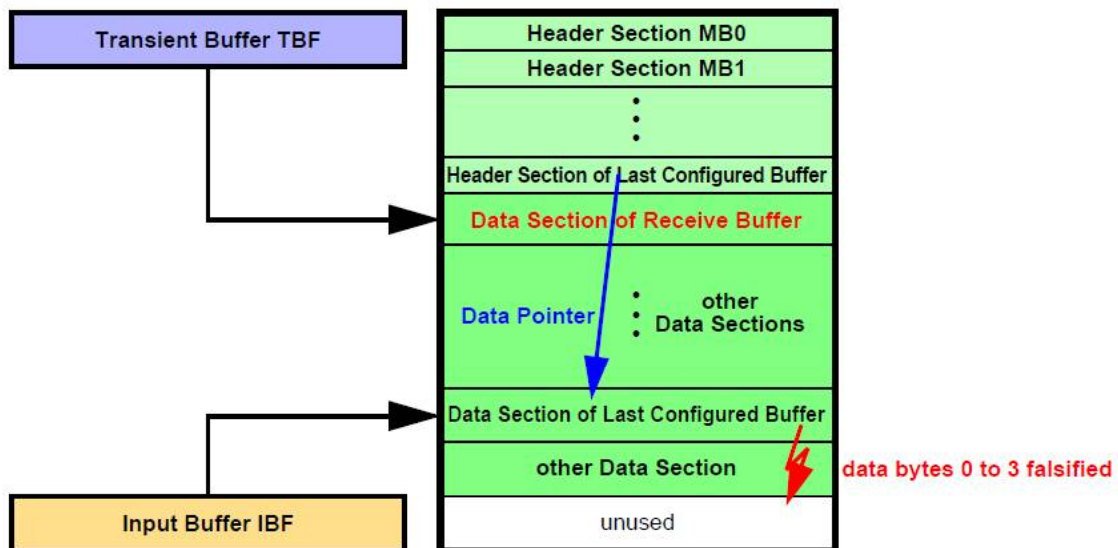
Figure 3 Message buffer transfer from IBF to Message RAM

After the Data Section of the selected message buffer in the Message RAM has been written, one additional write access overwrites the following word in the Message RAM which might be the first word of the next Data Section.

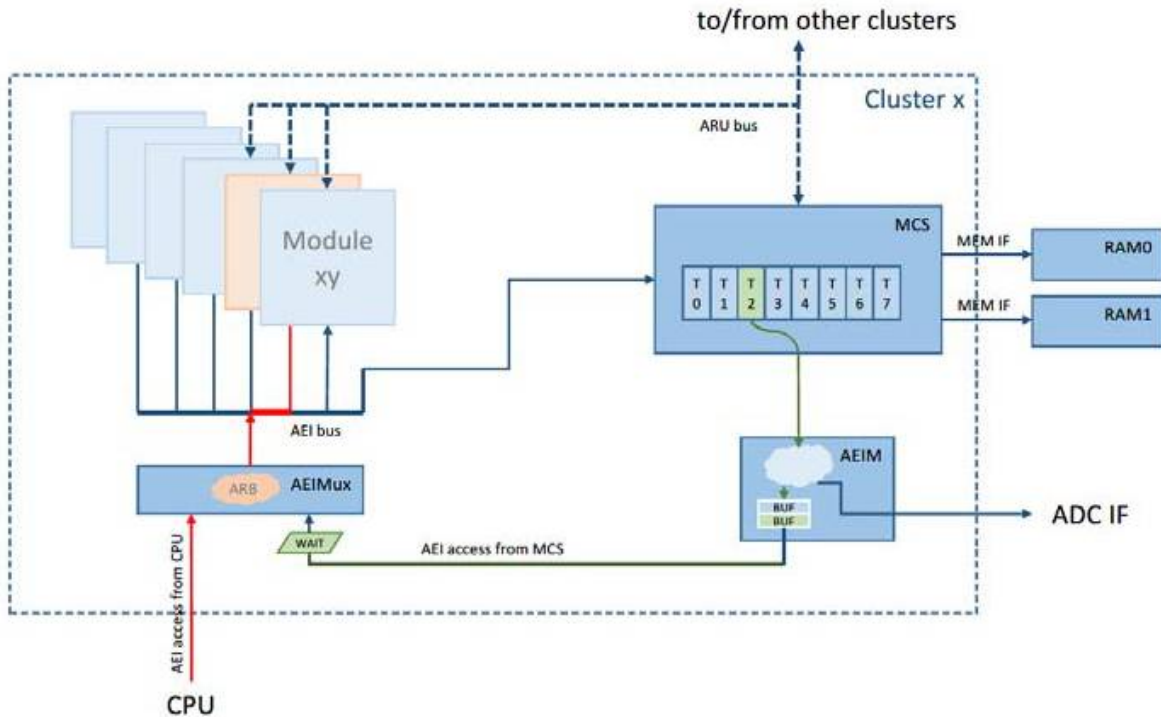
Figure 6 MCS AEI master access path

Figure 6 shows an uncritical traffic situation. Here an access of a MCS thread to the AEI bus (green access path) is temporary delayed due to an ongoing AEI bus access from the CPU (red access path). The MCS access to the AEI bus will be safely buffered at the AEIM (green buffer). As soon as the CPU access to the AEI bus completes, the buffered AEI bus access from MCS will be executed.

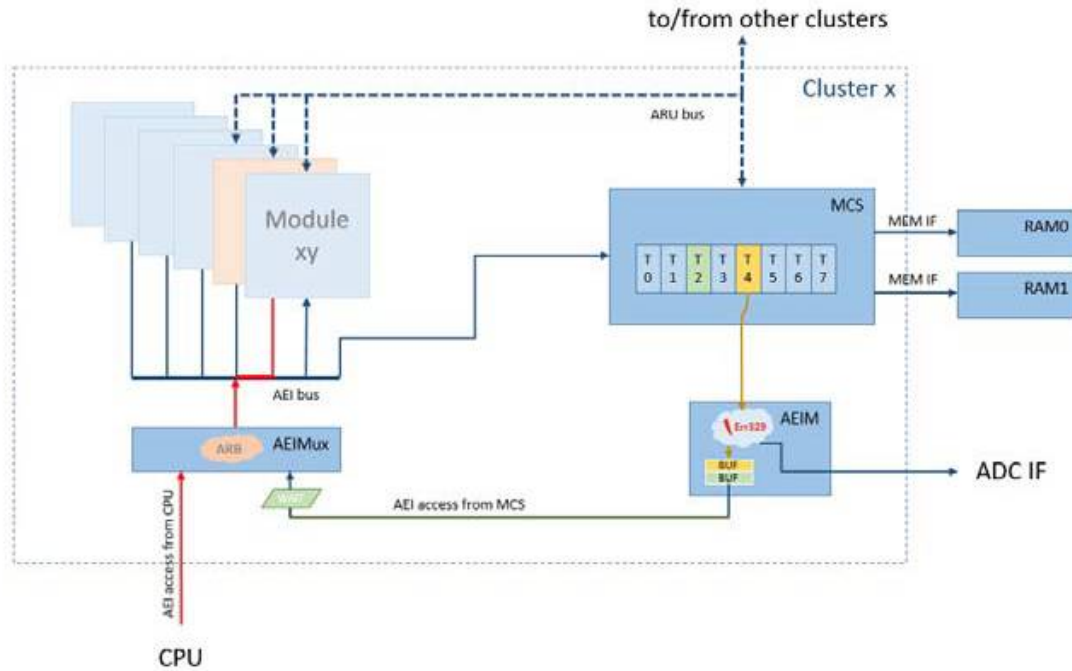
Figure 7 Critical MCS AEI master scenario

In [Figure 7](#), a potential risk for the occurrence of problem GTM_AI.329 is illustrated. Here the first buffer of the AEIM (green) is still waiting for the access to the AEI bus while a second AEI bus access from MCS arrives at the AEIM (yellow access path). Under certain, but for the user unpredictable timing conditions, this second AEI bus access arriving at the AEIM can trigger the misbehavior described in problem GTM_AI.329.

The workarounds described in the following section will ensure that not more than one AEIM buffer will be filled and therefore the occurrence of problem GTM_AI.329 is avoided. All workarounds have been tested and proven correct.

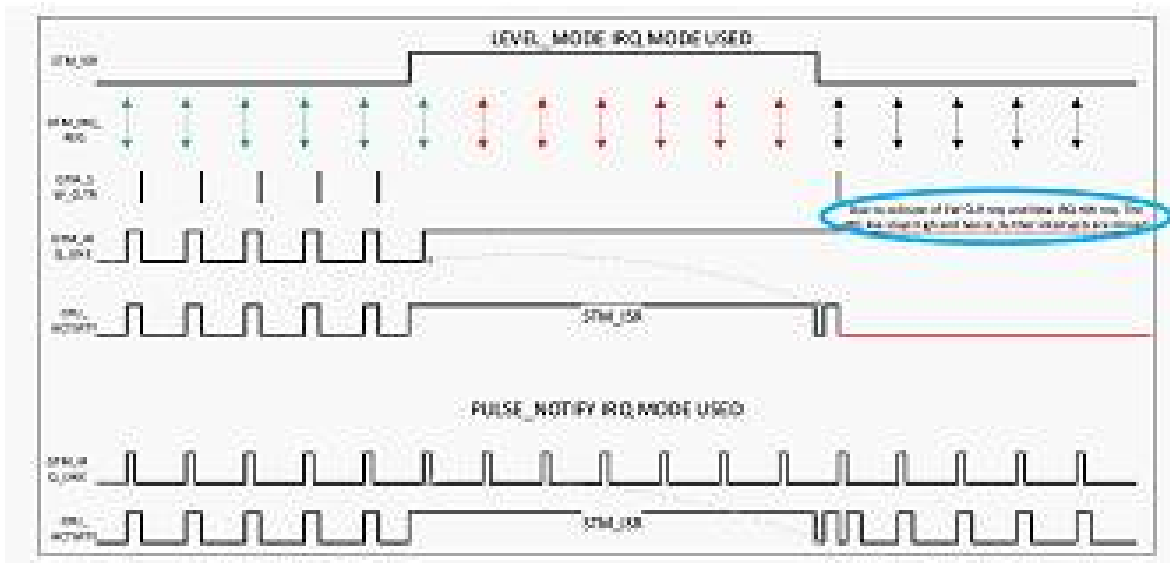
Figure 10 Interrupt Level vs. Pulse-Notify mode - Corner Case Example

Hence, in Level Mode, in some scenarios where another interrupt request is generated by GTM while the ISR handle also requests a SW clear, then, as the interrupt event is dominant over the clear event (for simultaneous interrupt and clear events), GTM_IRQ_XXX is not cleared and remains high. As a consequence, the IR observes no transition on GTM_IRQ_XX. Thus, any forthcoming interrupt events in this scenario are lost as there is no chance to release the CPU IRQ when a collision happens as shown in Figure below.

If Pulse-Notify mode is selected, every internal trigger will be forwarded to the IR, irrespective of the time of occurrence and the clear event, as the pulse-notify leads to set and reset of GTM_IRQ_XXX as compared to only setting of the GTM_IRQ_XXX line in Level mode.

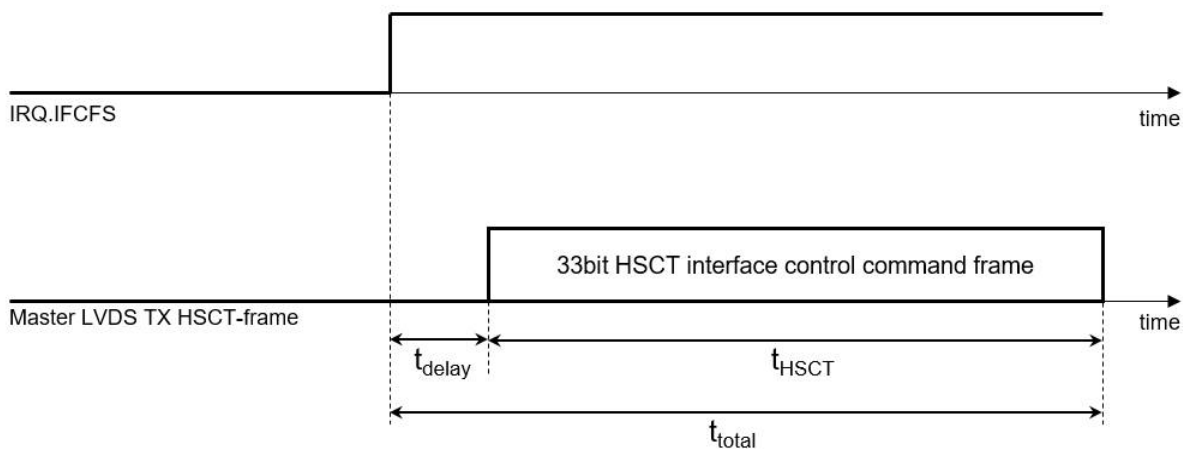
Figure 12 Timing of LVDS TX interface command sending in relation to IRQ.IFCFS

the user might falsely assume that also the actual sending on the LVDS TX port has already occurred once the IRQ.IFCFS flag is set, which is not true.

Instead the timing shown in **Figure 12** applies.

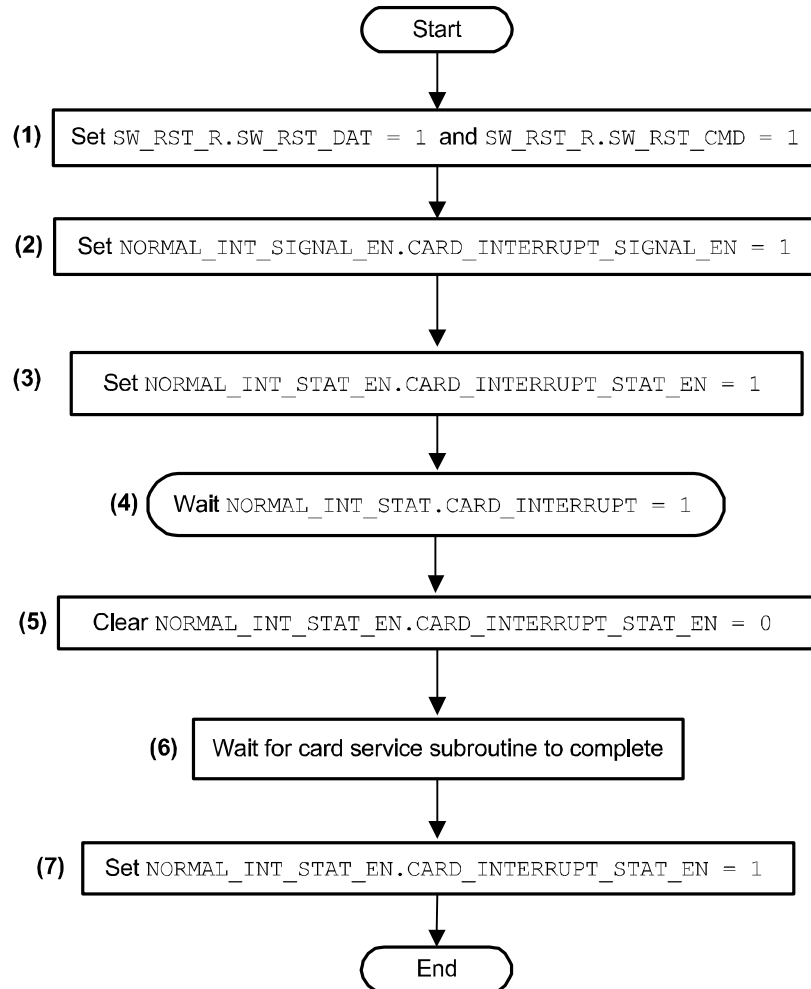
Figure 14 SDIO Card Interrupt Sequence

Figure “SDIO Card Interrupt Sequence” in the SDMMC chapter of the current version of the TC3xx User’s Manual is wrong. The correct sequence is shown in the following **Figure 14**.
