Product Change Notification / SYST-31HPWF472

ERRATA - dsPIC33CH128MP508 Family Silicon Errata and Datasheet Clarification

dsPIC33CH128MP508 Family Silicon Errata and Data Sheet Clarification

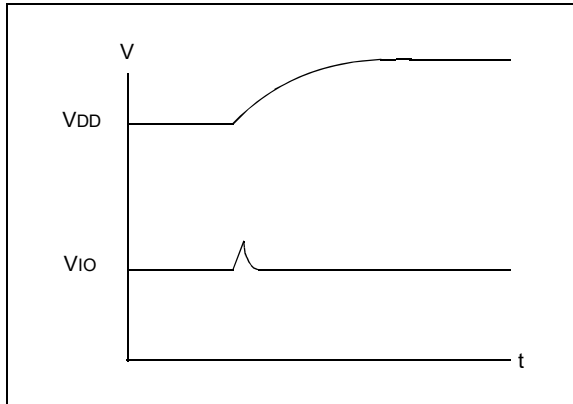
FIGURE 1: I/O RAMP

During a fast device power-up, when the VDD ramp is less than 4 mS, the I/O pins may drive up to 100 μ A current for a duration of up to 10 μ S (Figure 1).

Example applications affected may include complementary power switches, where a transient current shoot-through might occur.

1. Slow down the VDD ramp time (greater than 4 mS for VDD to ramp 0V to 3.3V).
2. Ensure the circuitry that is connected to the pins can endure this pulse.

High-voltage applications with complementary switches should power the high-voltage 200 μ Sec later than powering the dsPIC[®] device to avoid the current shoot-through. This behavior is specific to each device and not affected by aging.

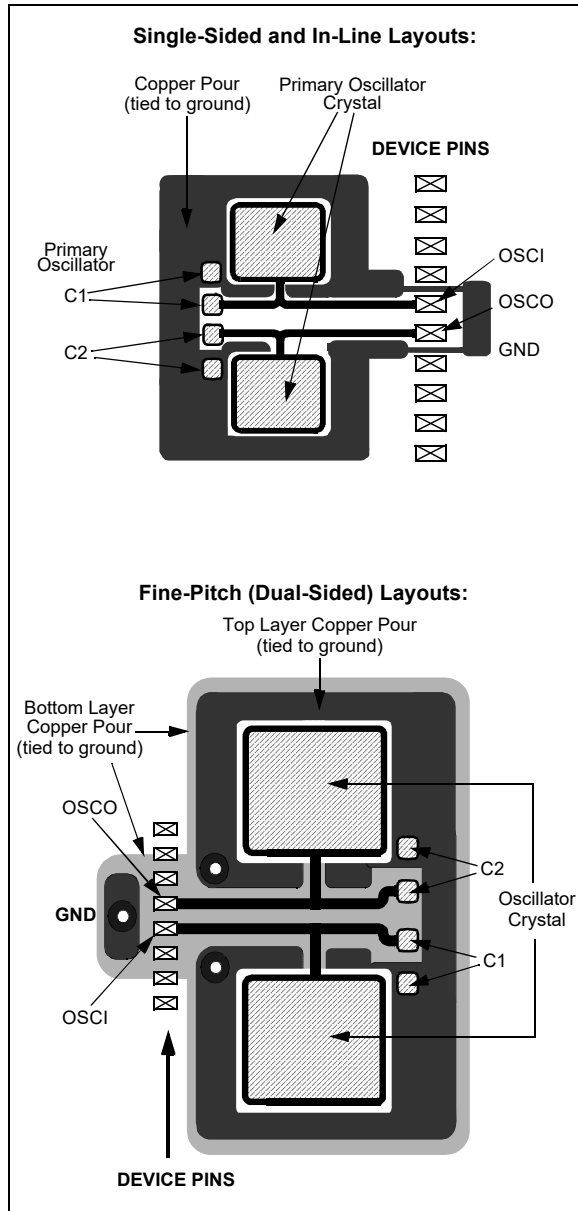
FIGURE 2-2: SUGGESTED PLACEMENT OF THE OSCILLATOR CIRCUIT

When the Primary Oscillator (POSC) circuit is used to connect a crystal oscillator, special care and consideration is needed to ensure proper operation. The POSC circuit should be tested across the environmental conditions that the end product is intended to be used. The load capacitors specified in the crystal oscillator data sheet can be used as a starting point, however, the parasitic capacitance from the PCB traces can affect the circuit and the values may need to be altered to ensure proper start-up and operation.

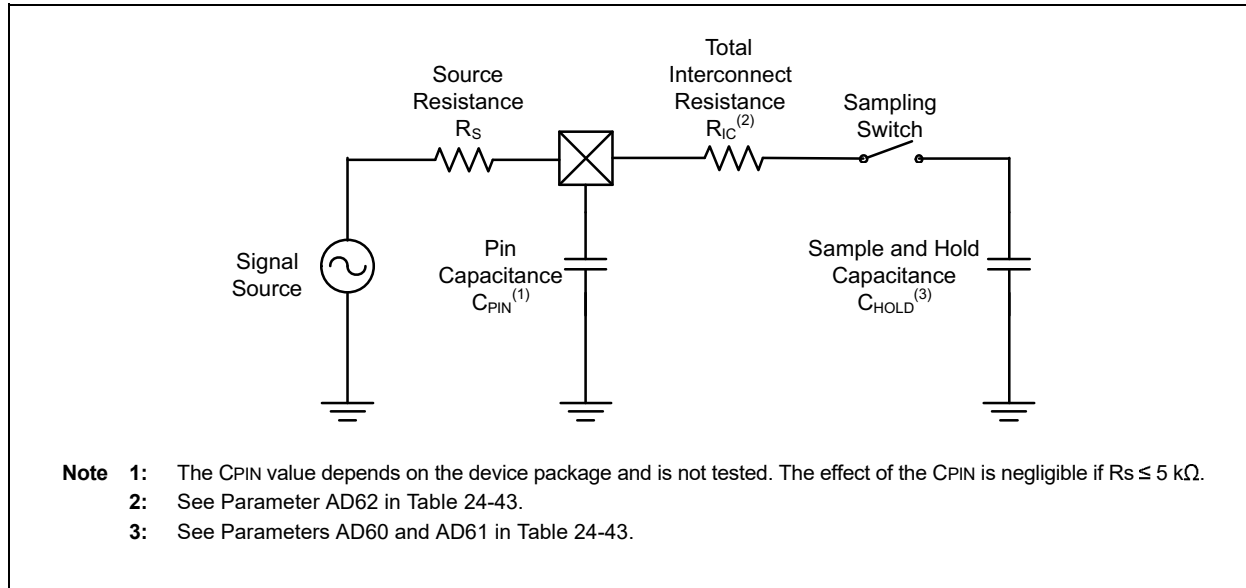
FIGURE: ADC ANALOG INPUT MODEL

The analog input model of the ADC is shown in the figure below.

The total acquisition time for the Analog-to-Digital conversion is a function of the Holding Capacitor (C_{HOLD}) charge time. For the ADC module to meet its specified accuracy, the Holding Capacitor (C_{HOLD}) must be allowed to fully charge to the voltage level on the analog input pin. The Signal Source Impedance (R_S)

and the Interconnect Impedance (R_{IC}) combine to affect the time required to charge the C_{HOLD} . The total resistance ($R_S + R_{IC}$) must therefore, be small enough to fully charge the Holding Capacitor within the selected sample time.
