## Product Change Notification / SYST-03GWYJ923

ERRATA - dsPIC33EVXXXGM00X/10X Family Silicon Errata and Data Sheet Clarification Errata Document Revision

## dsPIC33EVXXXGM00X/10X Family Silicon Errata and Data Sheet Clarification

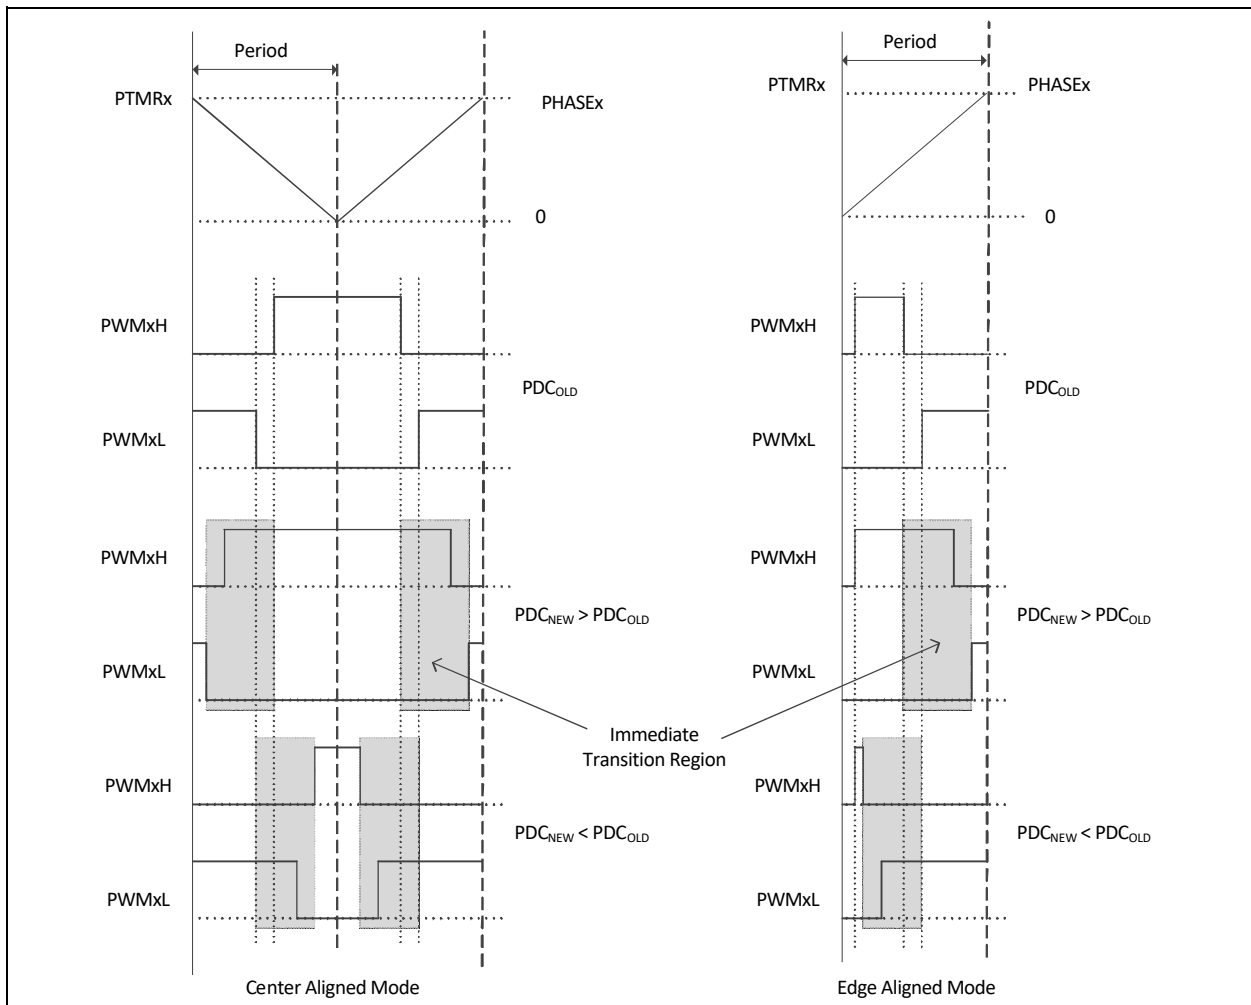
**FIGURE 2: TIMING DIAGRAMS FOR CENTER-ALIGNED AND EDGE-ALIGNED MODES**

The PWM generator may not assert dead time on the edges of transitions. This has been observed when all of the following conditions are present:

In [Figure 2](#), if the duty cycle write occurred in the shaded box, then PWMxH and PWMxL will make an immediate transition without dead time.

However, in most applications, the duty cycle update timing can be controlled using the TRIGx trigger or Special Event Trigger, such that the above mentioned conditions are avoided altogether.

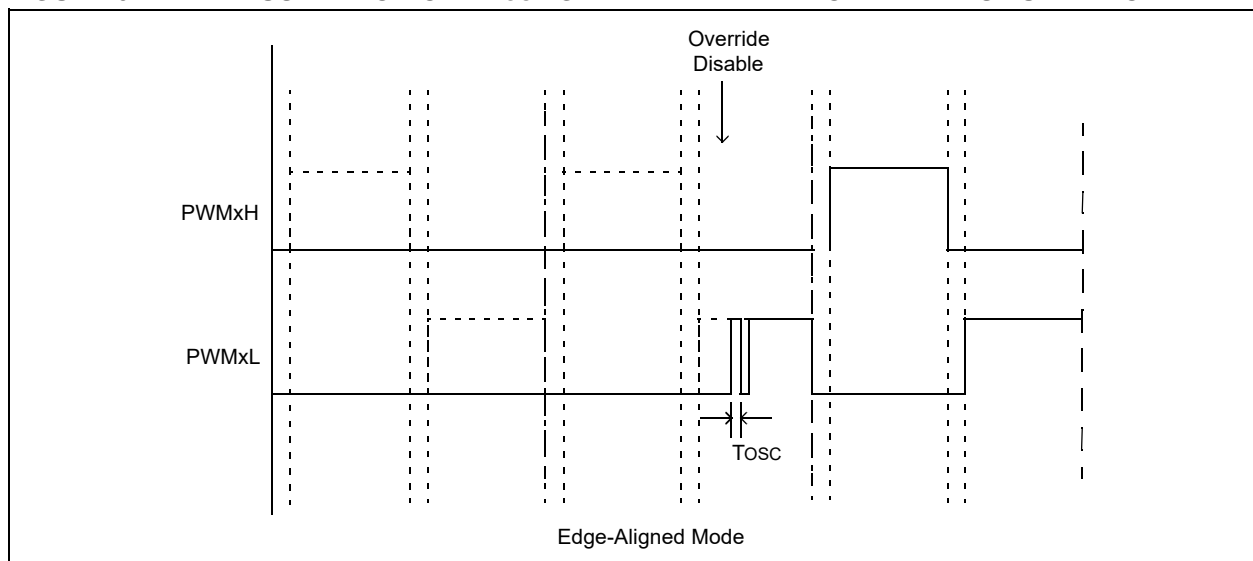
**FIGURE 3: ILLUSTRATION OF 1 TOSC GLITCH WHEN PWM OVERRIDE IS TURNED OFF**

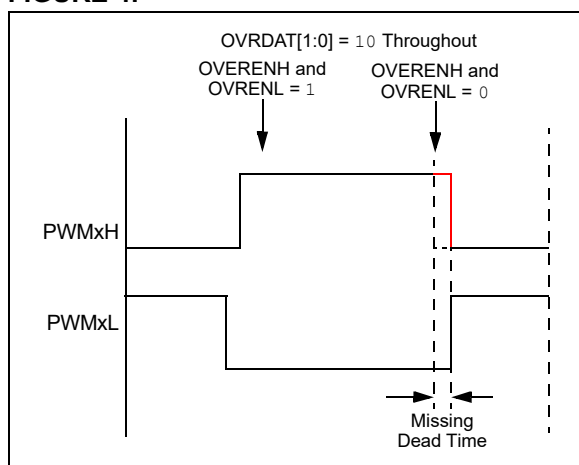
FIGURE 4:

- Output override synchronization is configured to occur on the CPU clock boundary (IOCONx[0] = 0);
- Both PWMxH and PWMxL overrides are enabled prior to the event (OVRENH and OVRENL are both '1'), and
- Both overrides are disabled (OVRENH and OVRENL are both '0') at the instant the dead time should be asserted (Figure 4). This has been observed in both Center-Aligned and Edge-Aligned modes.

None.

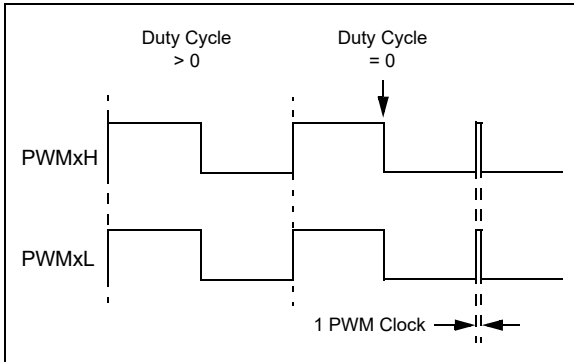
FIGURE 5:

In the Redundant Output mode (IOCONx[11:10] = 10) and Push-Pull Output mode (IOCONx[11:10] = 01) with Immediate Update disabled (PWMCONx[0] = 0), when the Duty Cycle register is updated from a non-zero value to zero, a glitch pulse of a width equal to one PWM clock will appear at the next PWM period boundary, as shown in Figure 5, for the Redundant Output mode. Here, the Duty Cycle register refers to the PDCx register if PWMCONx[8] = 0 or the MDC register if PWMCONx[8] = 1.

If the application requires a zero duty cycle output, there are two possible work around methods:

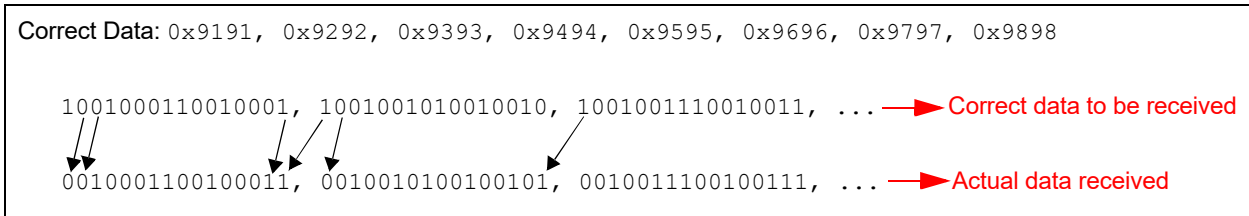
**FIGURE 6:**

Received data of the SPI are sampled one clock cycle late for the following conditions:

For example, the correct data that should be received are 0x9191, 0x9292, 0x9393, 0x9494, 0x9595, 0x9696, 0x9797, 0x9898, but the actual data received are 0x2323, 0x2525, 0x2727, 0x2929, 0x2B2B, 0x2D2D, 0x2F2F, 0x3130 (Figure 6).

None.

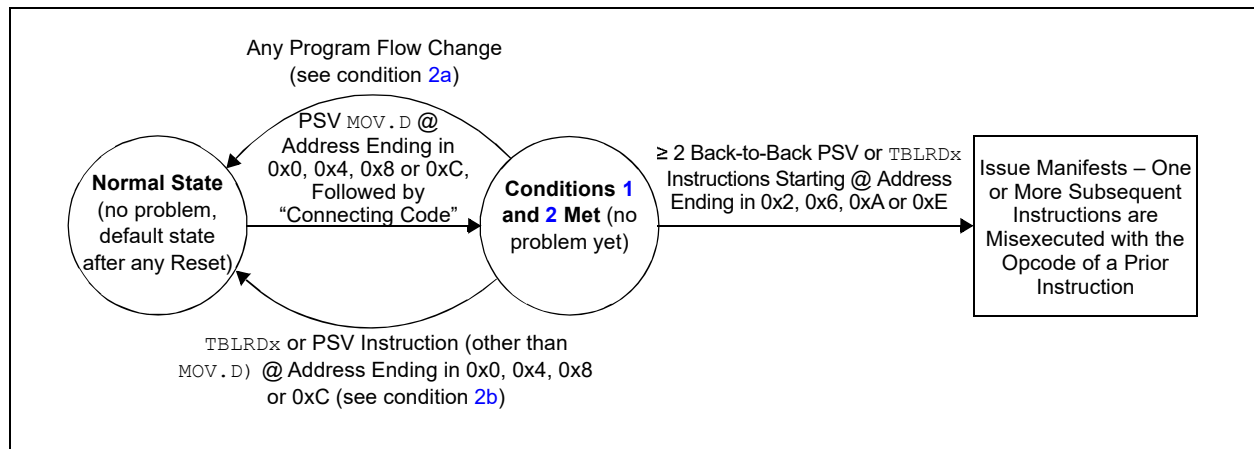
When two or more data Flash read instructions (via Program Space Visibility (PSV) read or table read) are executed back-to-back, one or more subsequent instructions can be misexecuted when all of the conditions in [Table 6](#) occur.

[Figure 7](#) provides an example of the effective behavior.

**FIGURE 7: SIMPLIFIED BEHAVIOR**

1. All instances of PSV `MOV.D` can be replaced with two PSV `MOV` instructions instead. Non-PSV `MOV.D` instructions acting on RAM/SFRs do not need to be modified; or
2. If not already present, a program flow change instruction (such as `BRA $+2`) can be inserted above back-to-back data Flash read sequences; or
3. Back-to-back data Flash read instruction sequences can be broken up by inserting a non-Flash read instruction (such as a `NOP`), in between the Flash read instructions; or
4. The alignment of the code can be shifted to avoid the required opcode location addresses.
