## Product Change Notification / SYST-09WTKU988

ERRATA - PIC32MM0256GPM064 Family Silicon Errata and Data Sheet Clarification

## PIC32MM0256GPM064 Family Silicon Errata and Data Sheet Clarification

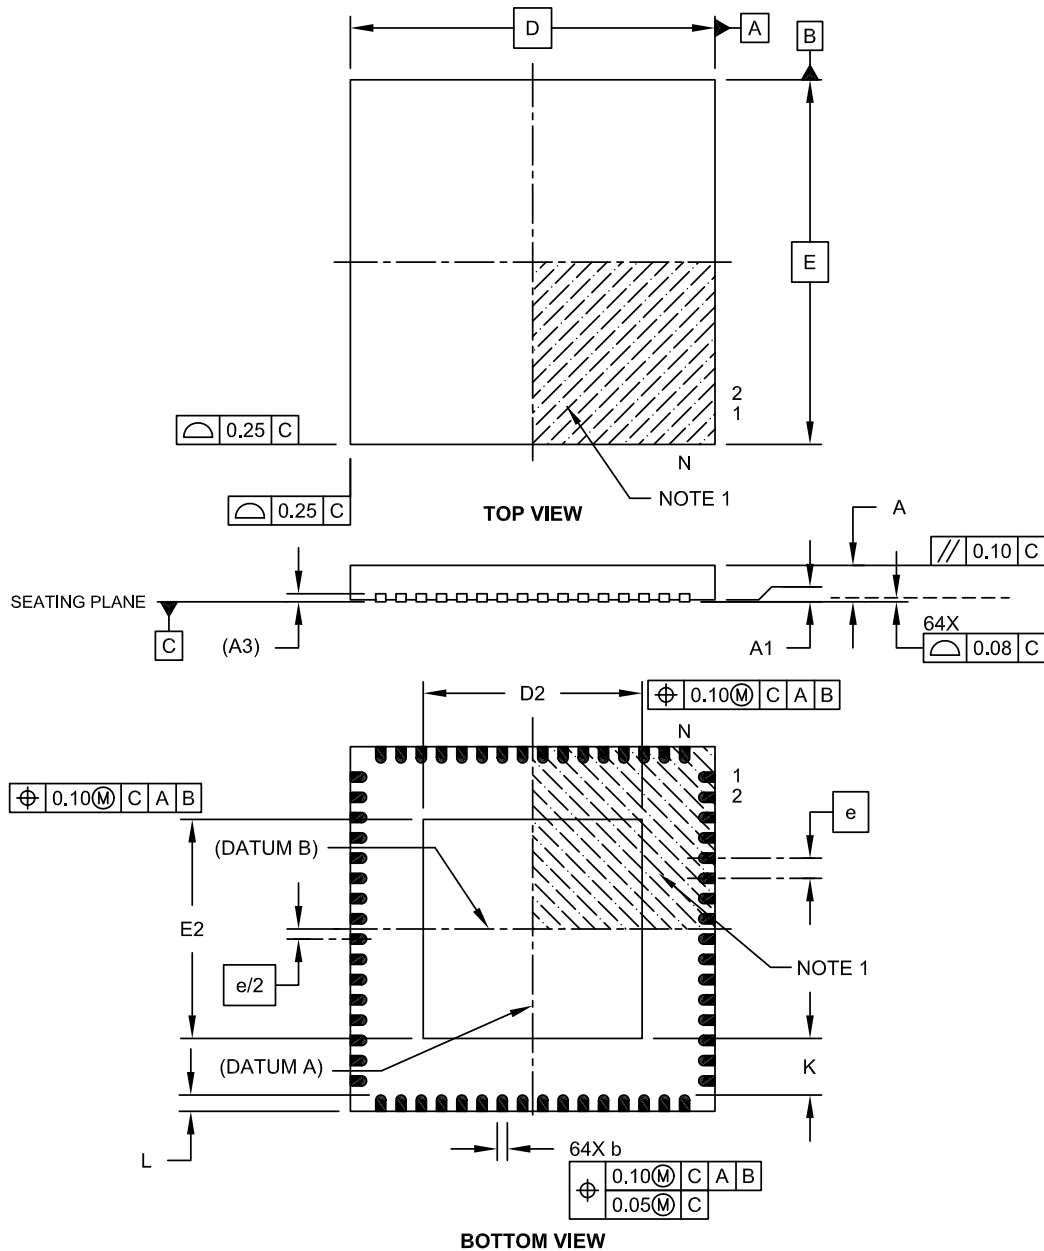
Microchip Technology Drawing C04-154A Sheet 1 of 2

The following figure shows the updated package drawing for the 64-Pin QFN device.
