Information note

N° 10292AERRA

Errata sheet V1.10 affecting products TC39x_BC

Subject Errata sheet V1.10 affecting products TC39x_BC

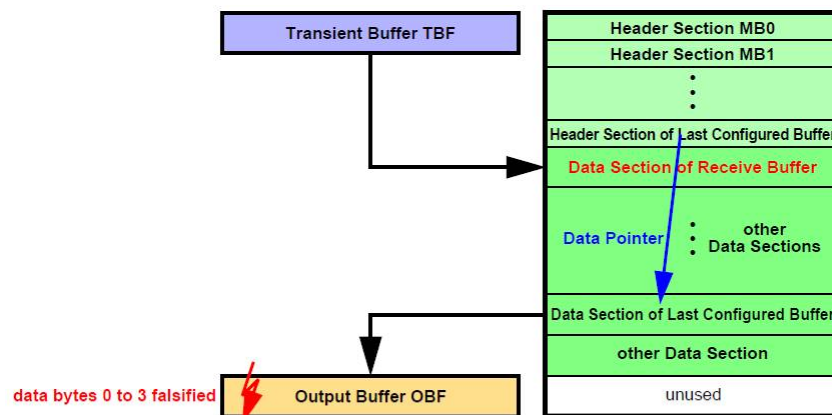
Figure 2 Message buffer transfer from Message RAM to OBF

When the message buffer has its payload configured to maximum length (**PLC** = 127), the OBF word on address 00h (payload data bytes 0 to 3) is overwritten with unexpected data at the end of the transfer.

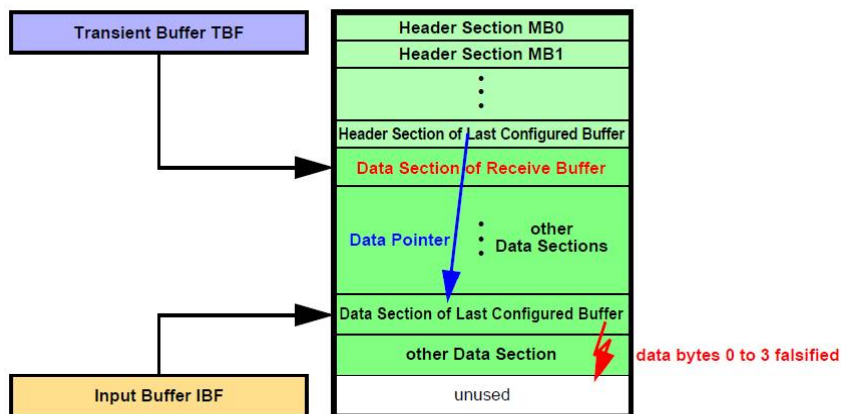
Figure 3 Message buffer transfer from IBF to Message RAM

After the Data Section of the selected message buffer in the Message RAM has been written, one additional write access overwrites the following word in the Message RAM which might be the first word of the next Data Section.

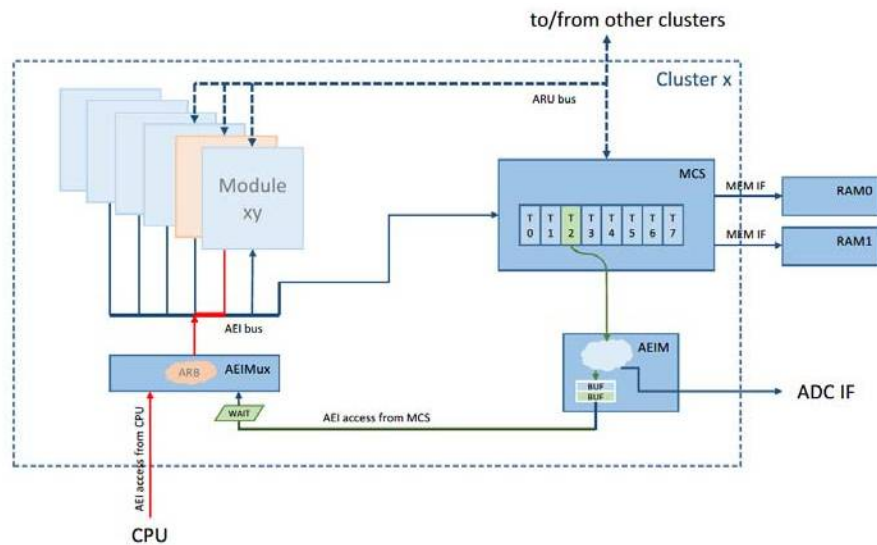
Figure 6 MCS AEI master access path

Figure 6 shows an uncritical traffic situation. Here an access of a MCS thread to the AEI bus (green access path) is temporary delayed due to an ongoing AEI bus access from the CPU (red access path). The MCS access to the AEI bus will be safely buffered at the AEIM (green buffer). As soon as the CPU access to the AEI bus completes, the buffered AEI bus access from MCS will be executed.

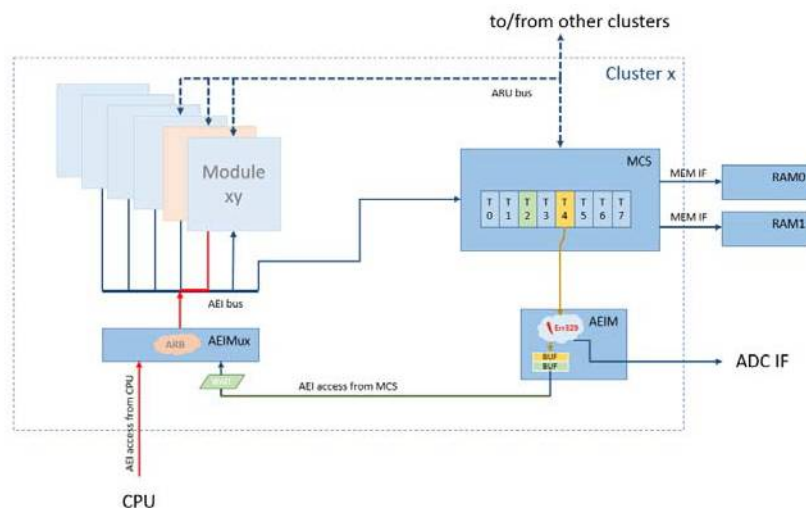
Figure 7 Critical MCS AEI master scenario

In [Figure 7](#), a potential risk for the occurrence of problem GTM_AI.329 is illustrated. Here the first buffer of the AEIM (green) is still waiting for the access to the AEI bus while a second AEI bus access from MCS arrives at the AEIM (yellow access path). Under certain, but for the user unpredictable timing conditions, this second AEI bus access arriving at the AEIM can trigger the misbehavior described in problem GTM_AI.329.

The workarounds described in the following section will ensure that not more than one AEIM buffer will be filled and therefore the occurrence of problem GTM_AI.329 is avoided. All workarounds have been tested and proven correct.

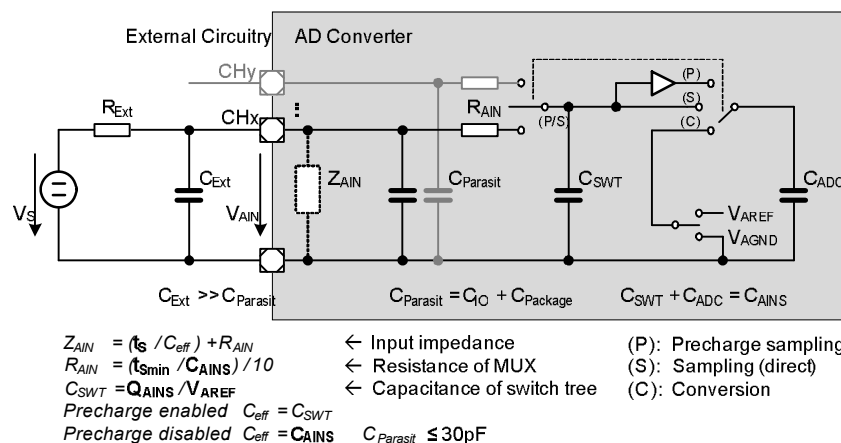
Figure 9 Equivalent Circuitry for Analog Inputs

Figure "Equivalent Circuitry for Analog Inputs" will be modified in future revisions of the Data Sheet, including the term $C_{\text{Parasit}} \leq 30 \text{ pF}$, as shown in the following figure:

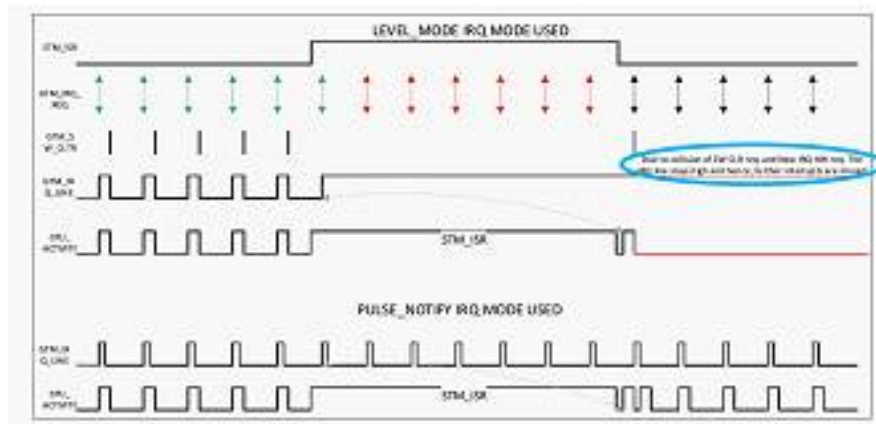
Figure 10 Interrupt Level vs. Pulse-Notify mode - Corner Case Example

As described in the text below this figure, while using Level mode, if more internal “interrupt” events are generated (i.e. two TOM channels generating a CCU0 interrupt), just one interrupt signal is sent to the IR, and no more interrupts are triggered until the SW clears the GTM_IRQ_XXX line towards the IR.

Hence, in Level Mode, in some scenarios where another interrupt request is generated by GTM while the ISR handle also requests a SW clear, then, as the interrupt event is dominant over the clear event (for simultaneous interrupt and clear events), GTM_IRQ_XXX is not cleared and remains high. As a consequence, the IR observes no transition on GTM_IRQ_XX. Thus, any forthcoming interrupt events in this scenario are lost as there is no chance to release the CPU IRQ when a collision happens as shown in Figure below.

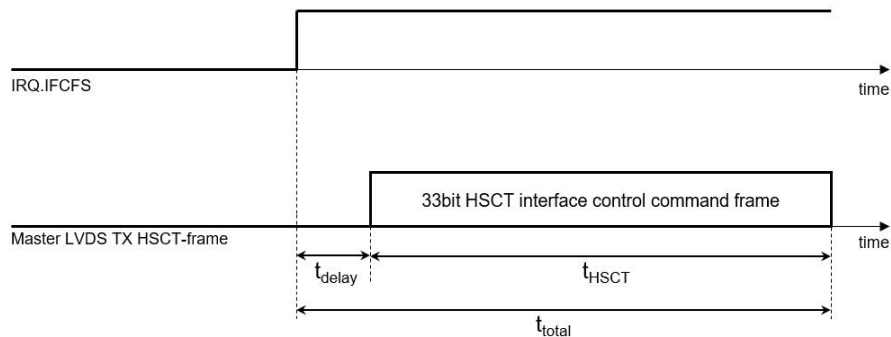
Figure 12 Timing of LVDS TX interface command sending in relation to IRQ.IFCFS

the user might falsely assume that also the actual sending on the LVDS TX port has already occurred once the IRQ.IFCFS flag is set, which is not true.

Instead the timing shown in **Figure 12** applies.

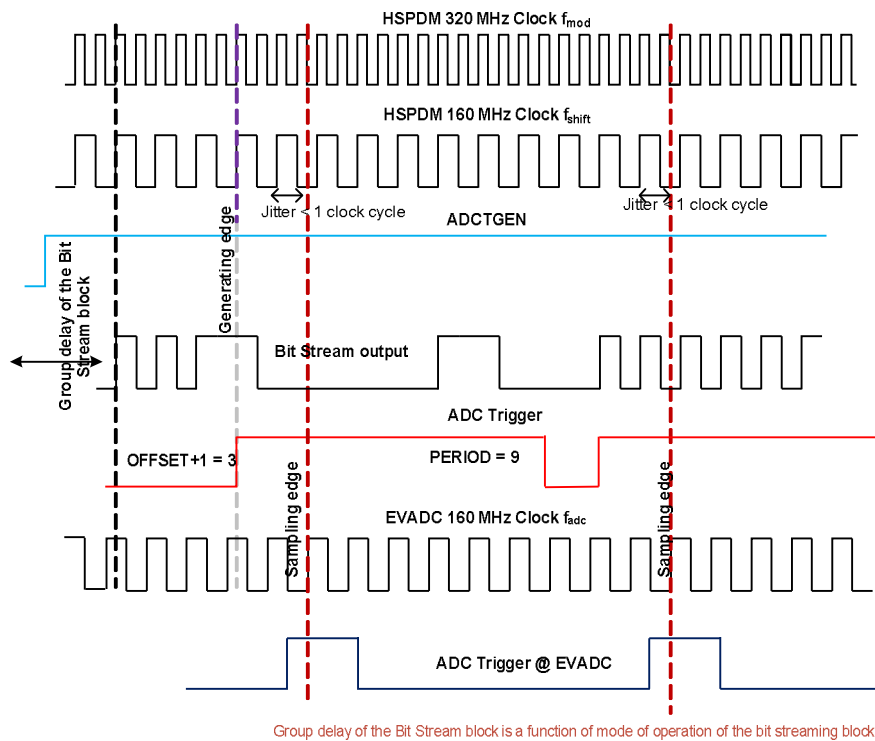
Figure 13 ADC Trigger Concept

Figure “ADC Trigger Concept” in the current version of the HSPDM chapter of the TC3xx User’s Manual shall be replaced with the following updated figure:

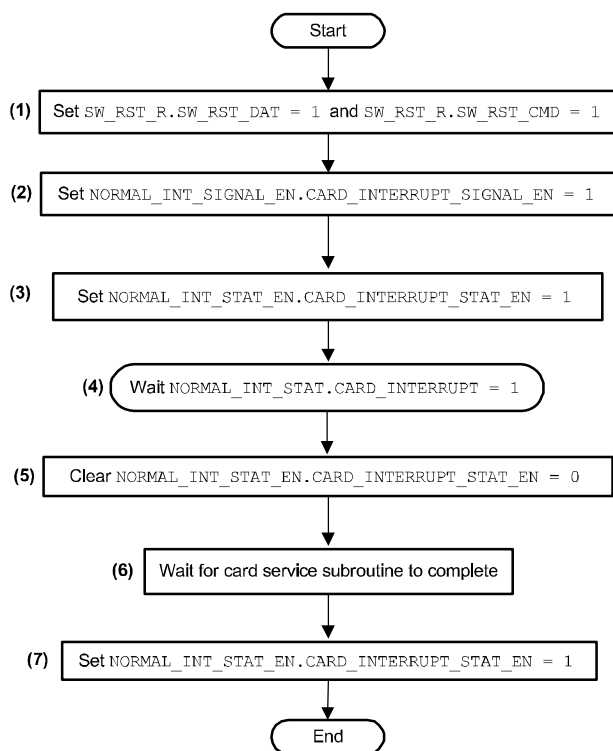
Figure 14 SDIO Card Interrupt Sequence

Figure "SDIO Card Interrupt Sequence" in the SDMMC chapter of the current version of the TC3xx User's Manual is wrong. The correct sequence is shown in the following [Figure 14](#).
