## **Information note**

**N° 10296AERRA**

**Errata sheet V1.8 affecting products TC37x\_AA**

**Subject** Errata sheet V1.8 affecting products TC37x\_AA

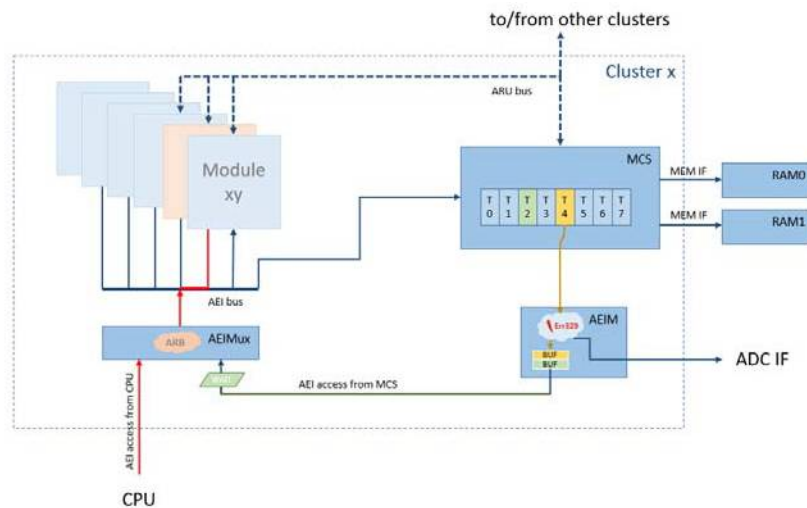
**Figure 7 Critical MCS AEI master scenario**

Problem GTM\_AI.329 is related to a potential incorrect handling of MCS access requests to the AEI bus at the AEIM entry stage in case that one AEIM buffer is already filled. If in such a case a new access request from MCS enters the AEIM logic during a very specific time window (related to progress on the AEI bus), the AEIM logic might signalize incorrect parameters back to MCS that could result in incorrect data, the loss of data or a repetitive execution of MCS accesses to AEI.

In [Figure 7](#), a potential risk for the occurrence of problem GTM\_AI.329 is illustrated. Here the first buffer of the AEIM (green) is still waiting for the access to the AEI bus while a second AEI bus access from MCS arrives at the AEIM (yellow access path). Under certain, but for the user unpredictable timing conditions, this second AEI bus access arriving at the AEIM can trigger the misbehavior described in problem GTM\_AI.329.

To avoid the potential occurrence of problem GTM\_AI.329 it has to be ensured that not more than 1 AEIM buffer gets filled due to backpressure in the AEI bus system.

The workarounds described in the following section will ensure that not more than one AEIM buffer will be filled and therefore the occurrence of problem GTM\_AI.329 is avoided. All workarounds have been tested and proven correct.

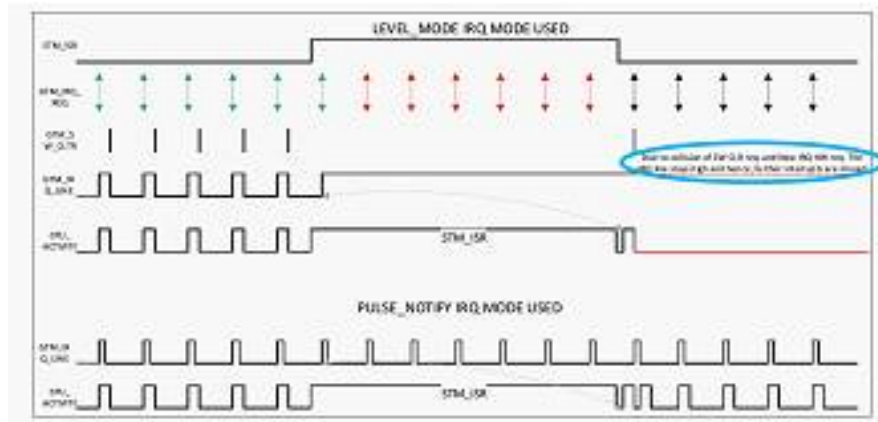
AEI read access to registers via legacy address space which are not in any cluster will respond always with read value 0 if cluster 0 is disabled.

Hence, in Level Mode, in some scenarios where another interrupt request is generated by GTM while the ISR handle also requests a SW clear, then, as the interrupt event is dominant over the clear event (for simultaneous interrupt and clear events), GTM\_IRQ\_XXX is not cleared and remains high. As a consequence, the IR observes no transition on GTM\_IRQ\_XX. Thus, any forthcoming interrupt events in this scenario are lost as there is no chance to release the CPU IRQ when a collision happens as shown in Figure below.

If Pulse-Notify mode is selected, every internal trigger will be forwarded to the IR, irrespective of the time of occurrence and the clear event, as the pulse-notify leads to set and reset of GTM\_IRQ\_XXX as compared to only setting of the GTM\_IRQ\_XXX line in Level mode.

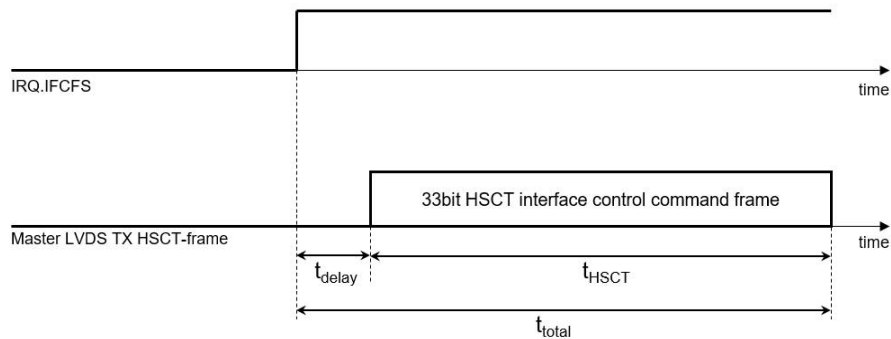
**Figure 12 Timing of LVDS TX interface command sending in relation to IRQ.IFCFS**

the user might falsely assume that also the actual sending on the LVDS TX port has already occurred once the IRQ.IFCFS flag is set, which is not true.

Instead the timing shown in [Figure 12](#) applies.

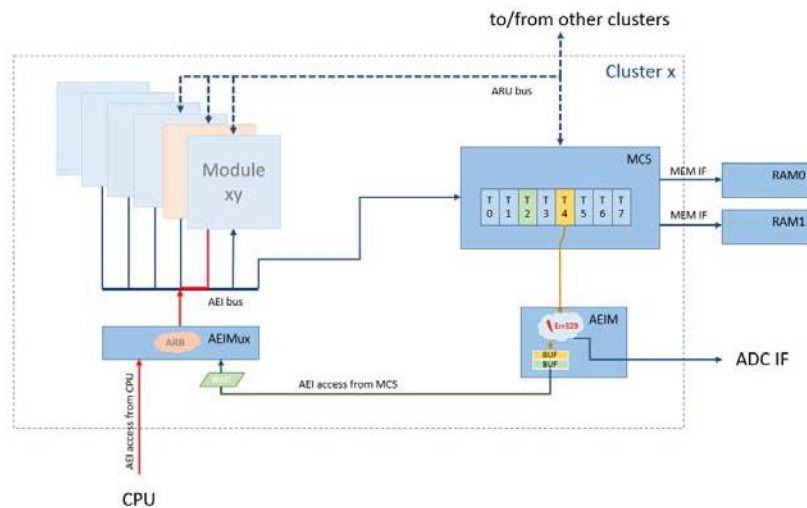
**Figure 7 Critical MCS AEI master scenario**

Problem GTM\_AI.329 is related to a potential incorrect handling of MCS access requests to the AEI bus at the AEIM entry stage in case that one AEIM buffer is already filled. If in such a case a new access request from MCS enters the AEIM logic during a very specific time window (related to progress on the AEI bus), the AEIM logic might signalize incorrect parameters back to MCS that could result in incorrect data, the loss of data or a repetitive execution of MCS accesses to AEI.

In [Figure 7](#), a potential risk for the occurrence of problem GTM\_AI.329 is illustrated. Here the first buffer of the AEIM (green) is still waiting for the access to the AEI bus while a second AEI bus access from MCS arrives at the AEIM (yellow access path). Under certain, but for the user unpredictable timing conditions, this second AEI bus access arriving at the AEIM can trigger the misbehavior described in problem GTM\_AI.329.

To avoid the potential occurrence of problem GTM\_AI.329 it has to be ensured that not more than 1 AEIM buffer gets filled due to backpressure in the AEI bus system.

The workarounds described in the following section will ensure that not more than one AEIM buffer will be filled and therefore the occurrence of problem GTM\_AI.329 is avoided. All workarounds have been tested and proven correct.

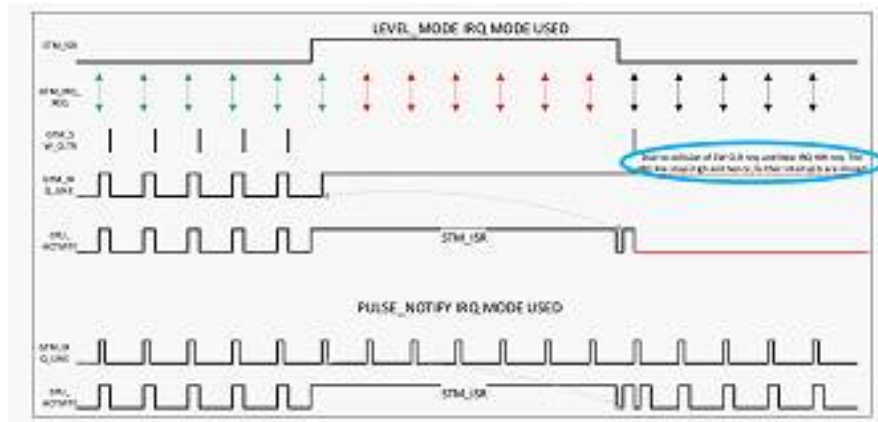
**Figure 10 Interrupt Level vs. Pulse-Notify mode - Corner Case Example**

Hence, in Level Mode, in some scenarios where another interrupt request is generated by GTM while the ISR handle also requests a SW clear, then, as the interrupt event is dominant over the clear event (for simultaneous interrupt and clear events), GTM\_IRQ\_XXX is not cleared and remains high. As a consequence, the IR observes no transition on GTM\_IRQ\_XX. Thus, any forthcoming interrupt events in this scenario are lost as there is no chance to release the CPU IRQ when a collision happens as shown in Figure below.

If Pulse-Notify mode is selected, every internal trigger will be forwarded to the IR, irrespective of the time of occurrence and the clear event, as the pulse-notify leads to set and reset of GTM\_IRQ\_XXX as compared to only setting of the GTM\_IRQ\_XXX line in Level mode.

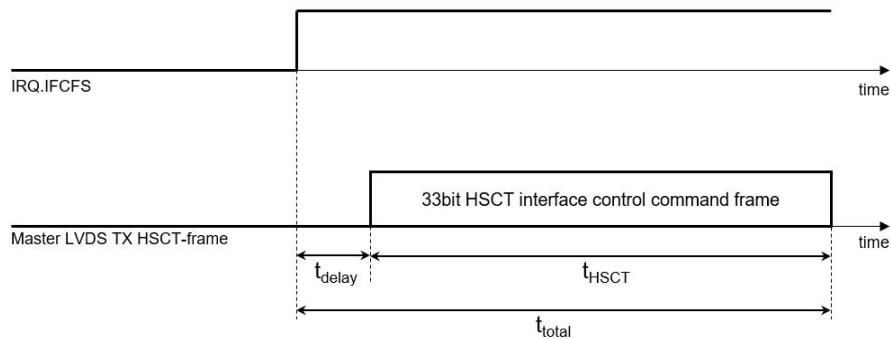
**Figure 12 Timing of LVDS TX interface command sending in relation to IRQ.IFCFS**

the user might falsely assume that also the actual sending on the LVDS TX port has already occurred once the IRQ.IFCFS flag is set, which is not true.

Instead the timing shown in [Figure 12](#) applies.
