## Product Change Notification / SYST-21DFRY755

ERRATA - PIC18(L)F24/25K42 Silicon Errata and Data Sheet Clarification Errata Document Revision

## PIC18(L)F24/25K42 Silicon Errata and Data Sheet Clarification

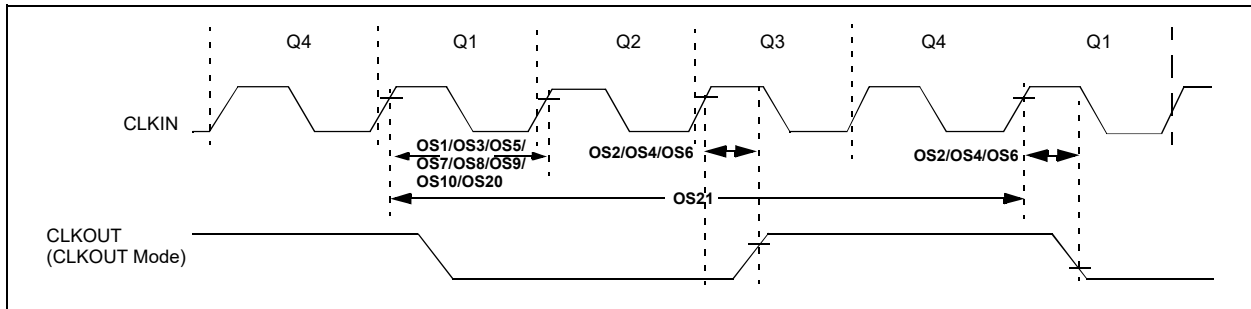
Figure 44-5 Clock Timing

Figure 44-5 incorrectly shows the location of parameters OS1, OS2, OS3, OS4, OS5, OS6, OS7, OS8, OS9, OS10, OS20 and OS21. The correct location for the above-mentioned parameters is depicted in the following figure.
