Product Change Notification / SYST-08OAYW733

ERRATA - PIC24FJ256GB110 Family Silicon/Data Sheet Errata Document Revision

PIC24FJ256GB110 Family Silicon Errata and Data Sheet Clarification

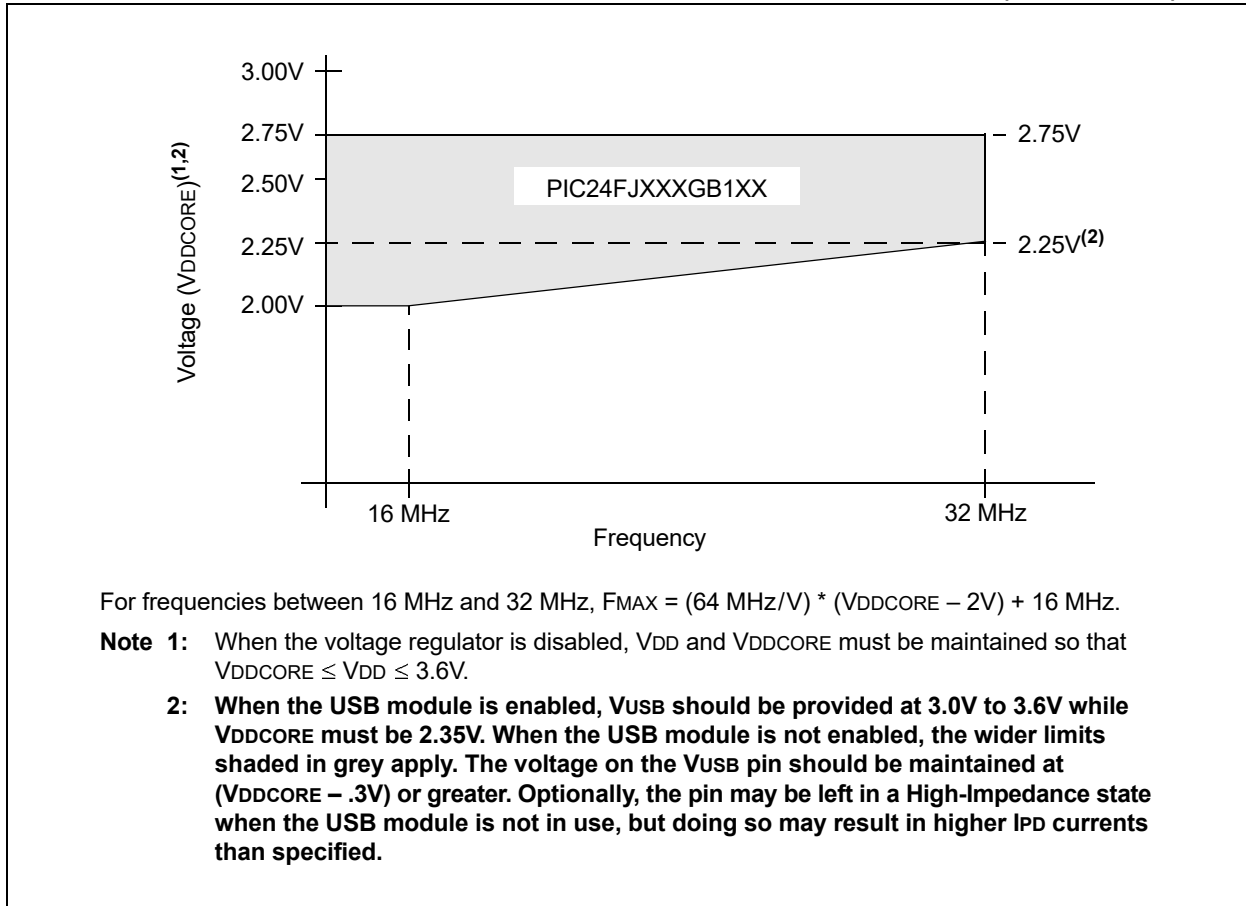
FIGURE 29-1: PIC24FJ256GB110 FAMILY VOLTAGE-FREQUENCY GRAPH (INDUSTRIAL)

Figure 29-1 (“PIC24FJ256GB110 Family Voltage-Frequency Graph”) is amended by adding an additional footnote. The updated figure is shown below (changes in **bold**; bold in original removed for clarity).
