## Product Change Notification / SYST-28KSUP099

ERRATA - USB72x6/USB7252 Silicon Errata and Data Sheet Clarification Document Revision

## USB72x6/USB7252 Silicon Errata and Data Sheet Clarification

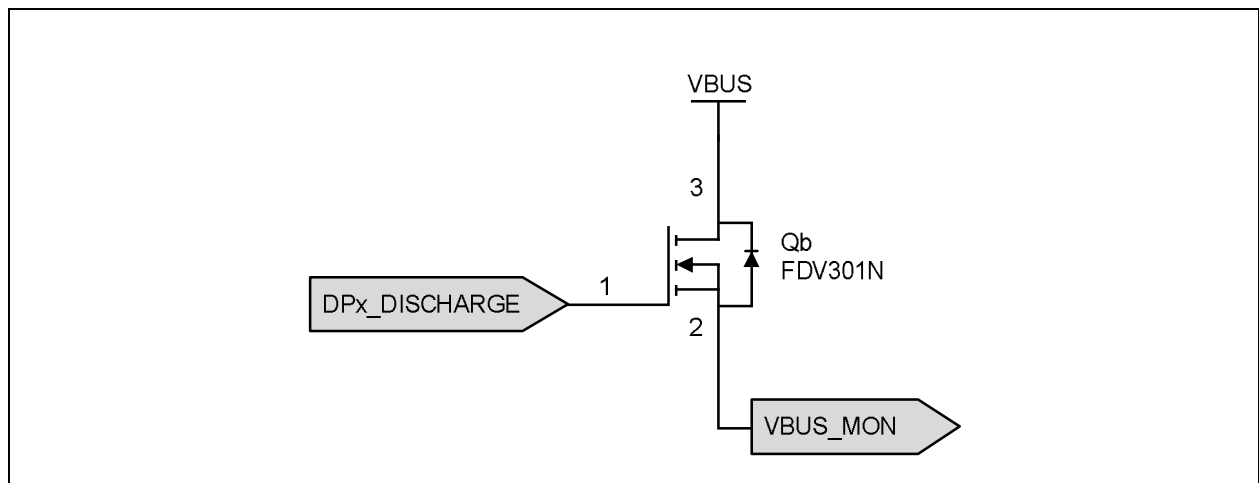
**FIGURE 2: TYPE-C DISCHARGE WORKAROUND FOR MODULE 3**

One requirement for USB-IF compliance certification of a system with an exposed Type-C port is the *Port Power On/Off* test. This test is part of the HUBCV suite of *Command Verification* tests for USB 2 devices. As part of this test, the hub must discharge VBUS, and then energize VBUS in response to CLEAR\_FEATURE and SET\_FEATURE commands from the test host.

Frequently, these ports will be implemented with electrolytic VBUS load capacitors, which retain a small residual charge that is released slowly compared to the timing of the discharge. In such cases, as energy is released from the capacitor the voltage can drift upward slightly after the discharge, which can cross the VBUS\_DET threshold for detecting VBUS high. In the sequence of the Port Power On/Off test, this can inhibit subsequent turning on of VBUS in response to commands from the test host and the test fails.

Type C ports that have a large electrolytic capacitor may require this workaround to pass the HUBCV Port Power On/Off test.

In reference designs for USB7216 and USB7252 devices, an N-channel MOSFET with a  $V_{GS}$  less than 1.0V is connected between VBUS and VBUS\_MON, with gate control from the DISCHARGE signal. This additional component creates an additional current path as the discharge is monitored by VBUS\_MON, which biases VBUS\_MON higher. This results in discharge to a lower voltage than what is otherwise achieved, and compensates for any residual energy that the capacitor releases after the discharge. At times other than the discharge, the MOSFET is turned off and does not influence VBUS.

No components of the reference design need to be removed; only the MOSFET is added.
