Product Change Notification / SYST-02WMHA586

ERRATA - dsPIC33CK256MP508 Family Silicon Errata and Data Sheet Clarification

dsPIC33CK256MP508 Family Silicon Errata and Data Sheet Clarification

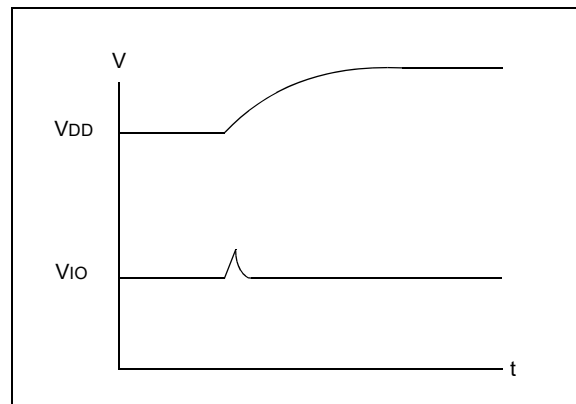
FIGURE 1-1: I/O RAMP

During a fast device power-up when the V_{DD} ramp is less than 4 mS, the I/O pins may drive up to 100 μ A current for a duration of up to 10 μ S (Figure 1-1).

Example applications affected may include complementary power switches, where a transient current shoot-through might occur. High-voltage applications with complementary switches should power the high-voltage 200 μ Sec later than powering the dsPIC[®] device to avoid the current shoot-through. This behavior is specific to each device and not affected by aging.

1. Slow down the V_{DD} ramp time (greater than 4 mS for V_{DD} to ramp 0V to 3.3V).
2. Ensure the circuitry that is connected to the pins can endure this pulse.
