Product Change Notification / SYST-23EQNR513

ERRATA - PIC18F27/47/57Q43 Family Silicon Errata and Data Sheet Clarifications Revision

PIC18F27/47/57Q43 Silicon Errata and Data Sheet Clarifications

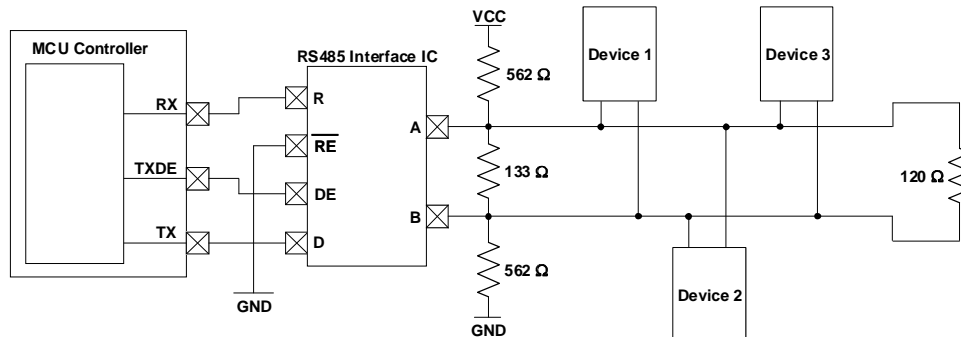
1.7.1 UART TXDE Signal May go Low Before The STOP Bit Has Been Entirely Transmitted.

The UART Transmit Drive Enable (TXDE) signal could potentially transition into a low state before the UART STOP bit has been entirely transmitted due to the effects of parasitic capacitance on the TX line. In some applications, this could result in communication being prematurely terminated due to the TXDE bit going low before the STOP bit has had enough time to settle.

In order to ensure that the STOP bit settles into its final logic state before the TXDE signal transitions low, a biasing circuit can be implemented. A biasing circuit allows the TX line to either be driven high or low, rather than being left in a floating tri-state mode where prolonged rise or fall times could lead to communication being disrupted. This bias circuit should only be implemented on one end of the serial bus, and a termination resistor should be used on the other end. The figure below show an example of a bias circuit that can be used to achieve this. Please note that the resistor values used in this circuit are recommendations, and that the actual resistor values required may vary based on the application.
