Product Change Notification / SYST-27XBYV713

ERRATA - dsPIC33EPXXXGM3XX/6XX/7XX Errata Document Revision

dsPIC33EPXXXGM3XX/6XX/7XX Family Silicon Errata and Data Sheet Clarification

The dsPIC33EPXXXGM3XX/6XX/7XX family devices that you have received conform functionally to the current Device Data Sheet (DS70000689D), except for the anomalies described in this document.

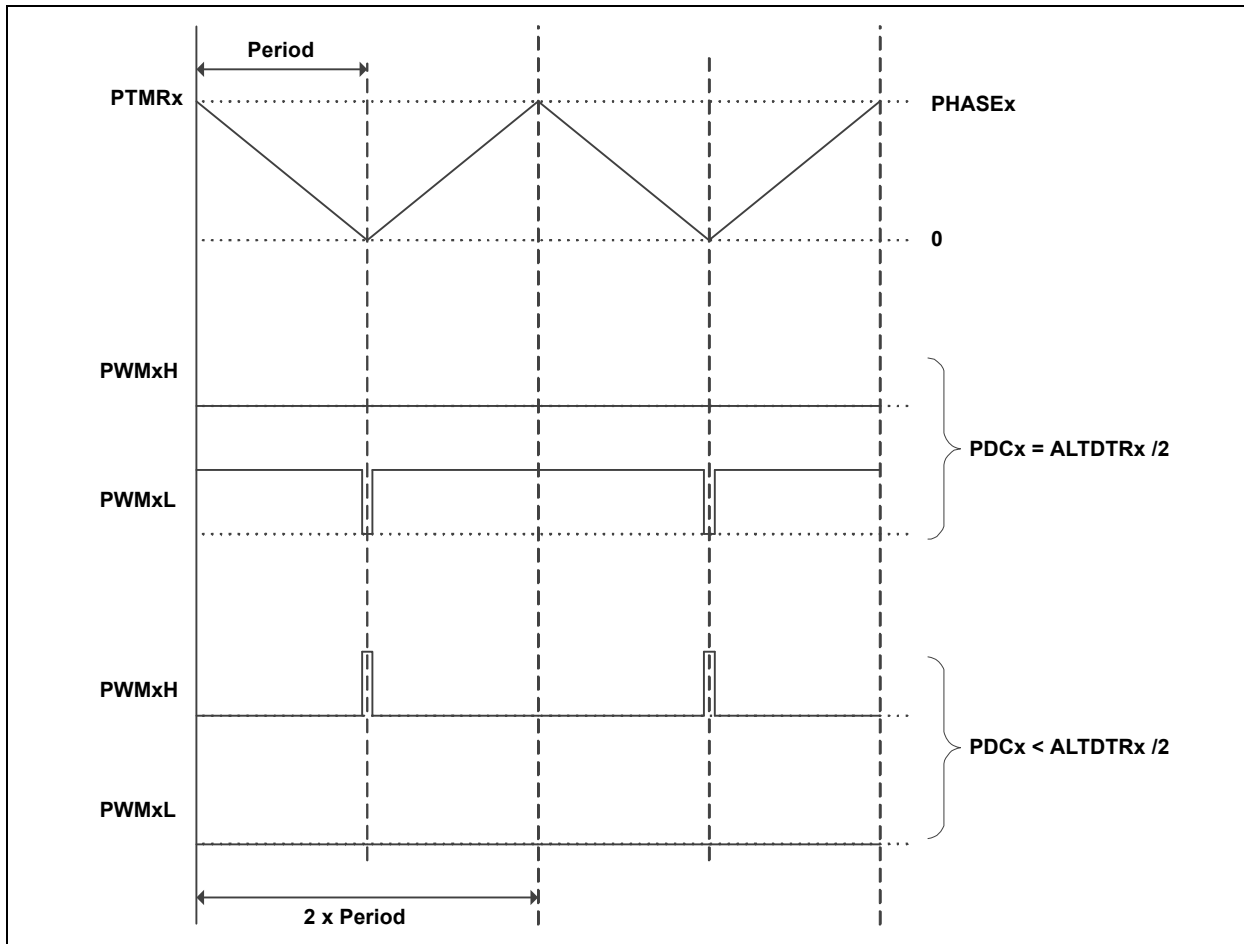
FIGURE 2: PWM GENERATOR TIMING DIAGRAM

In Center-Aligned Complementary mode with Independent Time Base, if the value in the PDCx register is less than one-half the value in the ALTDTRx register, the PWM generator will force the PWMxL to low, and on the PWMxH, generates pulses of a width less than twice the dead time, as shown in Figure 2.

Include a software routine to ensure that the duty cycle value written to the PDCx register is at least one-half of the value in ALTDTRx. Example 1 shows one method, with PDCtemp representing the variable which has the value to be written to the PDCx register. Alternatively, for duty cycle values less than half the desired dead-time value, zero out the ALTDTRx register or dynamically reduce the value in the ALTDTRx register, such that ALTDTRx is always equal to $2 * PDCx$, as shown in Example 2.

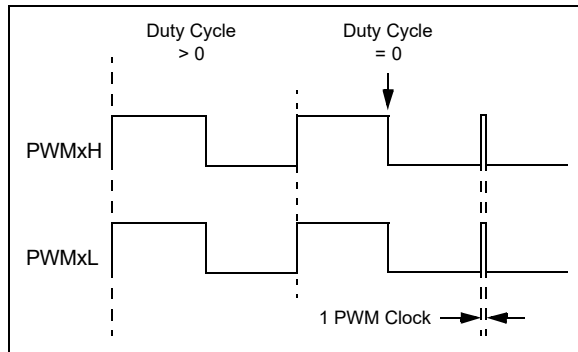
FIGURE 3:

In certain output modes, the PWMx module produces a pulse glitch of one PWM clock in width (Figure 3). This has been observed only when all of the following are true:

The pulse glitch has been observed to occur at the beginning of the following PWM boundary period.

If the application requires a duty cycle of zero, two possible work arounds are available.

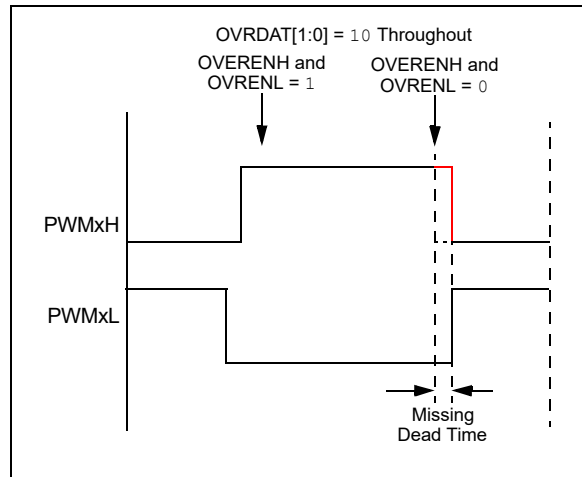
FIGURE 4:

This has been observed in both Center-Aligned and Edge-Aligned modes.

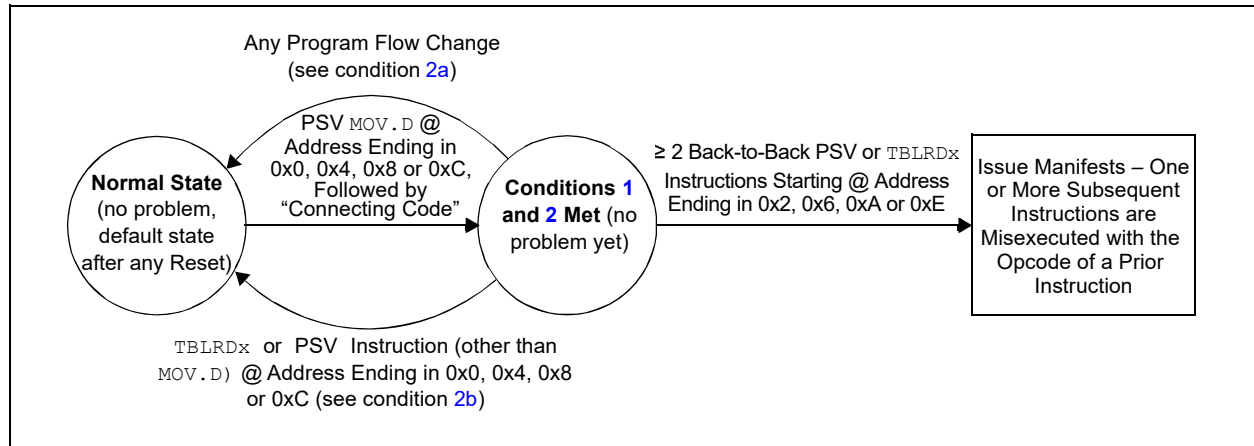
FIGURE 7: SIMPLIFIED BEHAVIOR

When two or more data Flash read instructions (via Program Space Visibility (PSV) read or table read) are executed back-to-back, one or more subsequent instructions can be misexecuted when all of the conditions in [Table 6](#) occur.

[Figure 7](#) provides an example of the effective behavior.

1. All instances of PSV MOV.D can be replaced with two PSV MOV instructions instead. Non-PSV MOV.D instructions acting on RAM/SFRs do not need to be modified; or
2. If not already present, a program flow change instruction (such as BRA \$+2) can be inserted above back-to-back data Flash read sequences; or
3. Back-to-back data Flash read instruction sequences can be broken up by inserting a non-Flash read instruction (such as a NOP), in between the Flash read instructions; or
4. The alignment of the code can be shifted to avoid the required opcode location addresses.
