Product Change Notification / SYST-27OHRV327

ERRATA - PIC18(L)F24/25K42 Silicon Errata and Data Sheet Clarification

PIC18(L)F24/25K42 Silicon Errata and Data Sheet Clarification

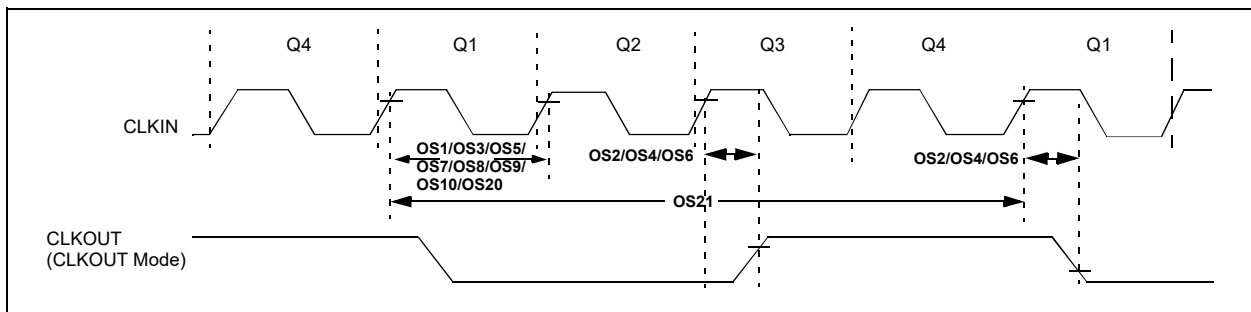
Figure 44-5 Clock Timing

Figure 44-5 incorrectly shows the location of parameters OS1, OS2, OS3, OS4, OS5, OS6, OS7, OS8, OS9, OS10, OS20 and OS21. The correct location for the above-mentioned parameters is depicted in the following figure.
