Product Change Notification / SYST-20FAKY890

ERRATA - PIC18(L)F26/45/46K40 Family Silicon Errata and Data Sheet Clarification Revision

PIC18(L)F26/45/46K40 Family Silicon Errata and Data Sheet Clarification

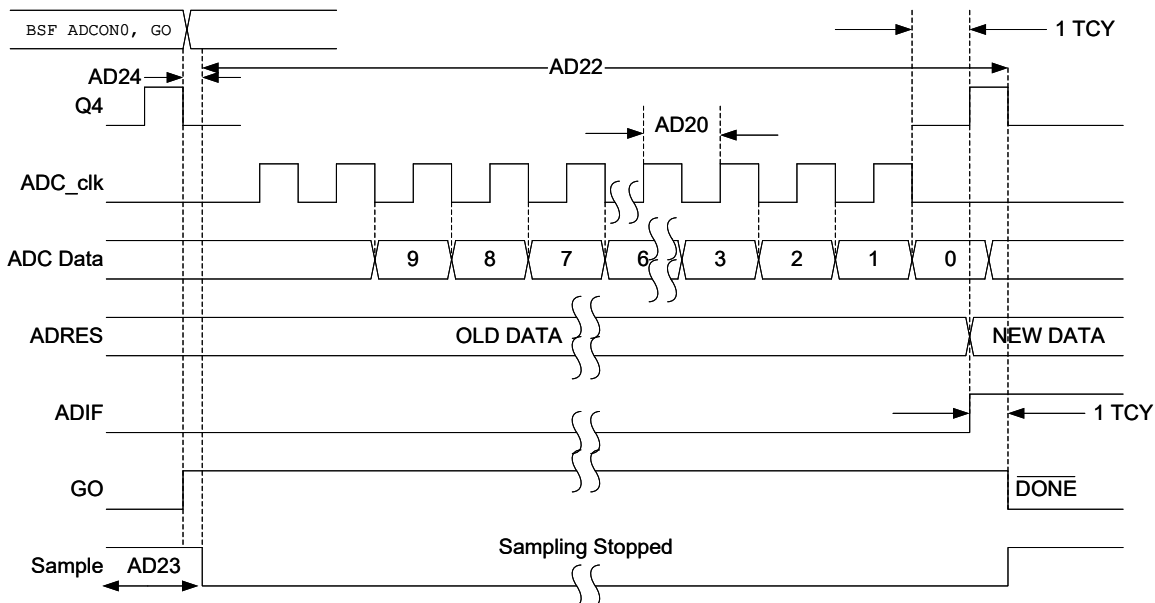
Figure 38-10: ADC Conversion Timing (ADC Clock F_{OSC} -Based)

Refer to the images below for corrections of Figure 38-10 and Figure 38-11. Previously, the parameter numbers were incorrect.
