## Product Change Notification / SYST-20UWAM093

ERRATA - dsPIC33CK256MP508 Family Silicon Errata and Data Sheet Clarification Errata Document Revision

## dsPIC33CK256MP508 Family Silicon Errata and Data Sheet Clarification

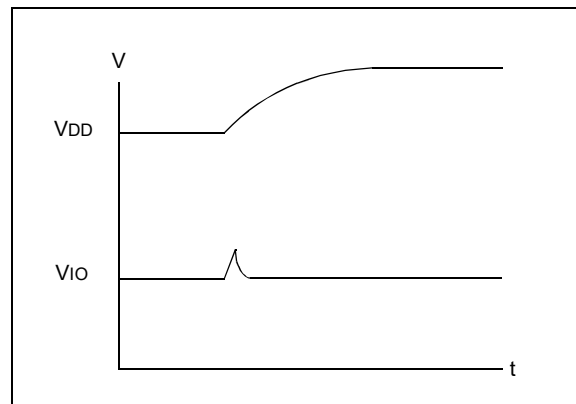
FIGURE 1-1: I/O RAMP

## 24. Module: I/O

During a fast device power-up when the  $V_{DD}$  ramp is less than 4 mS, the I/O pins may drive up to 100  $\mu$ A current for a duration of up to 10  $\mu$ S (Figure 1-1).

Example applications affected may include complementary power switches, where a transient current shoot-through might occur. High-voltage applications with complementary switches should power the high-voltage 200  $\mu$ Sec later than powering the dsPIC<sup>®</sup> device to avoid the current shoot-through. This behavior is specific to each device and not affected by aging.

1. Slow down the  $V_{DD}$  ramp time (greater than 4 mS for  $V_{DD}$  to ramp 0V to 3.3V).
2. Ensure the circuitry that is connected to the pins can endure this pulse.
