Product Change Notification / SYST-07KIRV017

ERRATA - PIC32MK General Purpose and Motor Control (GP/MC) Family Silicon Errata and Data Sheet Clarification Errata Document Revision

PIC32MK General Purpose and Motor Control (GP/MC) Silicon Errata and Data Sheet Clarification

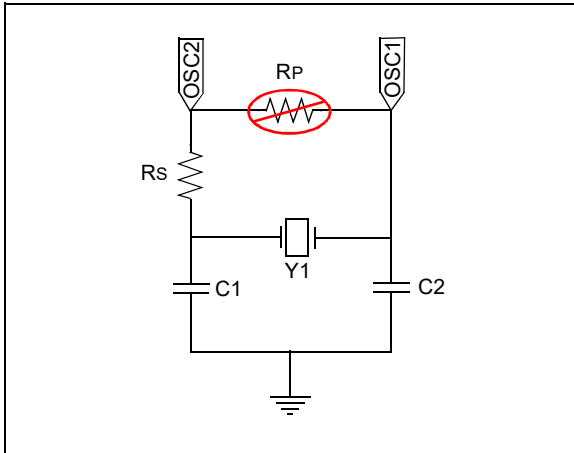
FIGURE 1: POSC CRYSTAL CIRCUIT

The POSC supports only specific crystal operation, as provided in [Table 1](#).

The Primary Oscillator (POSC) has been characterized to operate at 8 MHz and 12 MHz when the circuit shown in [Figure 1](#) is implemented and the operating conditions provided in [Table 1](#) are met.

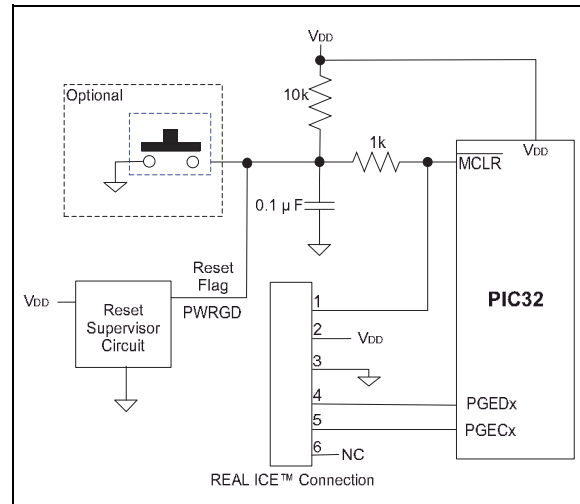
FIGURE 2: RESET SUPERVISOR CIRCUIT

On a BOR event, $V_{POR} < V_{DD} < V_{BOR}$, a Reset is not generated when the BOR threshold is reached. System clocks will stop with all I/O pins functions frozen in their present state until either V_{DD} falls to V_{POR} or V_{DD} returns to above V_{BOR} . The user must assess if this V_{DD} brown-out condition and the resulting frozen I/O pin state has an adverse effect on their application (UART, PWM, I/O, OC, etc.).

If the application can sustain frozen I/O states for ~2.1 ms (UART, CAN, I/O, etc.), the application must enable the Deep Sleep Watchdog Timer and Clock Fail Monitor, based on the details provided in Table 3 and Table 4. If implemented correctly, after ~2.1 ms, a valid internal reset state is entered and the I/O pins are set to the device default Reset state.
