Product Change Notification / SYST-21QLVX434

ERRATA - dsPIC33EPXXXGM3XX/6XX/7XX Family Silicon Errata and Data Sheet Clarification Document Revision

dsPIC33EPXXXGM3XX/6XX/7XX Family Silicon Errata and Data Sheet Clarification

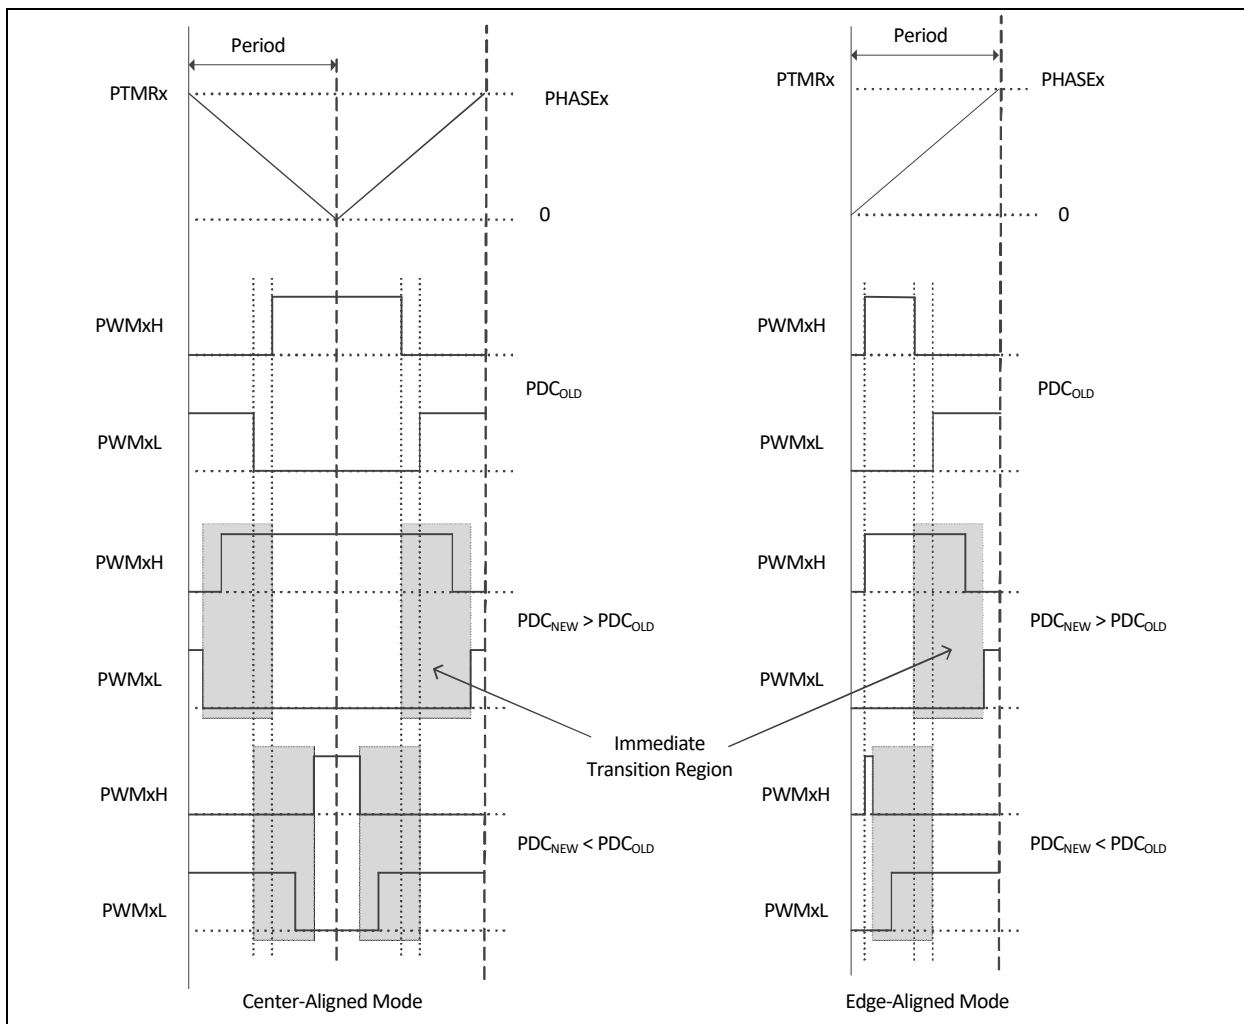
FIGURE 1: TIMING DIAGRAMS FOR CENTER-ALIGNED AND EDGE-ALIGNED MODES

The PWM generator may not assert dead time on the edges of transitions. This has been observed when all of the following conditions are present:

In Figure 1, if the duty cycle write occurred in the shaded box, then PWMxH and PWMxL will make an immediate transition without dead time.

None.

In most applications, the duty cycle update timing can be controlled using the TRIGx trigger, or Special Event Trigger, such that the above mentioned conditions are avoided altogether.

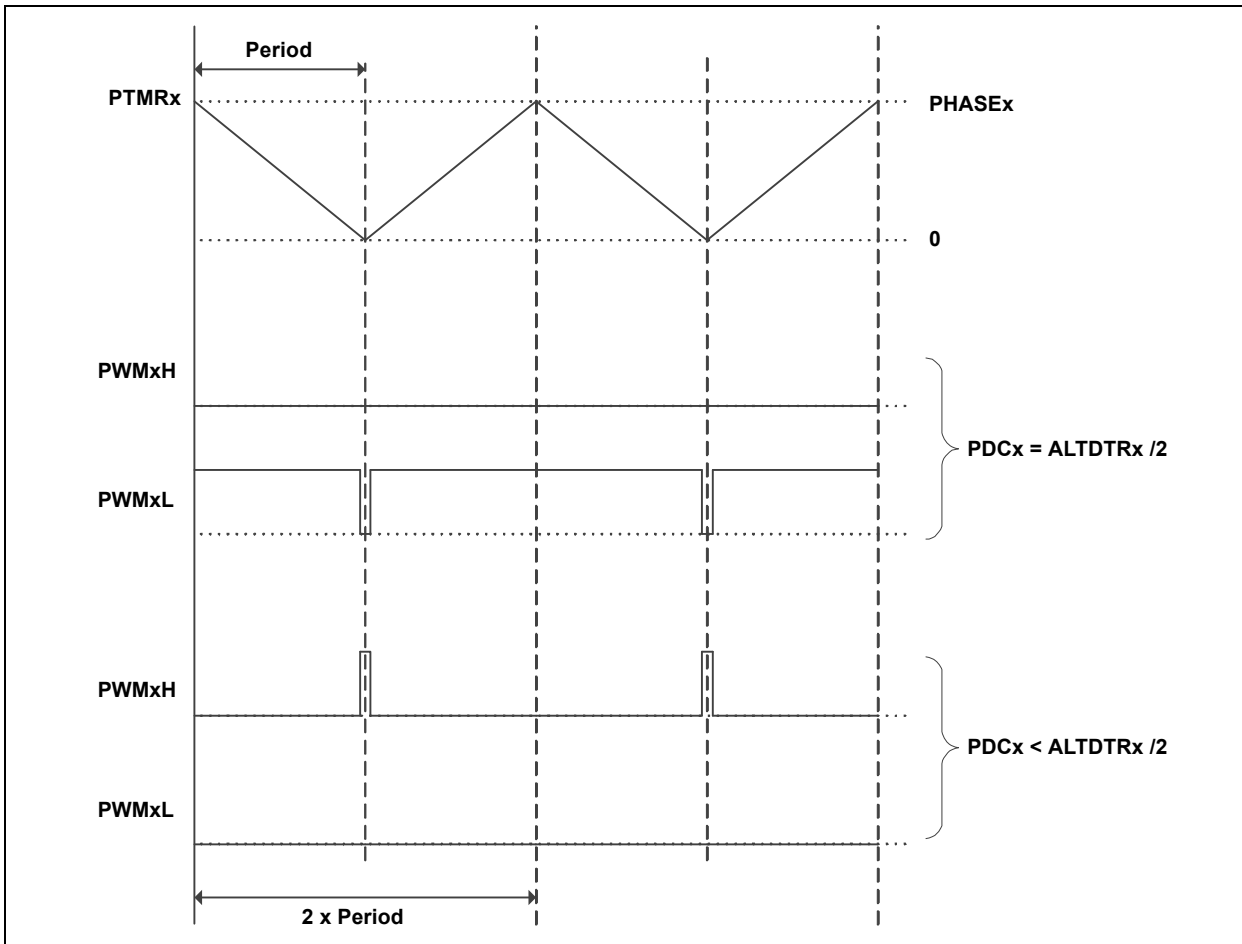
FIGURE 2: PWM GENERATOR TIMING DIAGRAM

In Center-Aligned Complementary mode with Independent Time Base, if the value in the PDCx register is less than one-half the value in the ALTDTRx register, the PWM generator will force the PWMxL to low, and on the PWMxH, generates pulses of a width less than twice the dead time, as shown in Figure 2.

Include a software routine to ensure that the duty cycle value written to the PDCx register is at least one-half of the value in ALTDTRx. Example 1 shows one method, with PDCtemp representing the variable which has the value to be written to the PDCx register. Alternatively, for duty cycle values less than half the desired dead-time value, zero out the ALTDTRx register or dynamically reduce the value in the ALTDTRx register, such that ALTDTRx is always equal to $2 * PDCx$, as shown in Example 2.

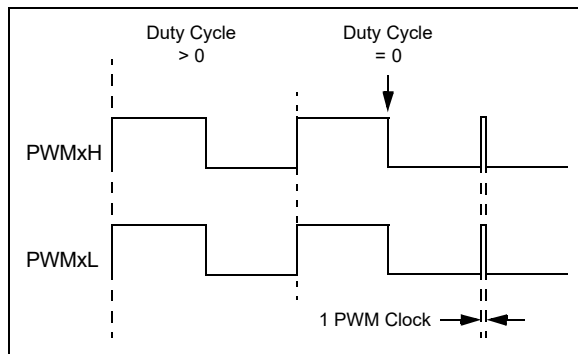
FIGURE 3:

In certain output modes, the PWMx module produces a pulse glitch of one PWM clock in width (Figure 3). This has been observed only when all of the following are true:

The pulse glitch has been observed to occur at the beginning of the following PWM boundary period.

If the application requires a duty cycle of zero, two possible work arounds are available.

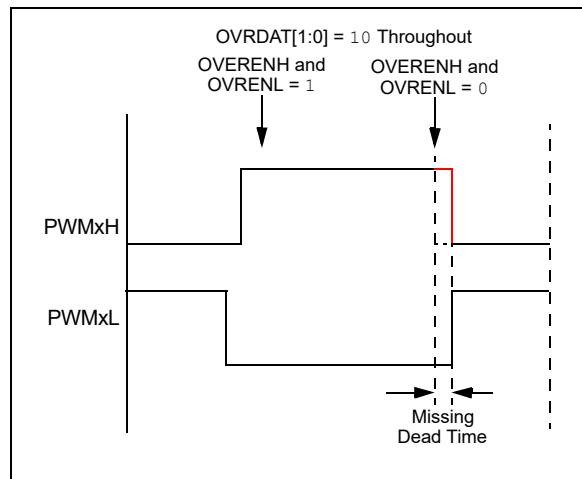
FIGURE 4:

This has been observed in both Center-Aligned and Edge-Aligned modes.

None.

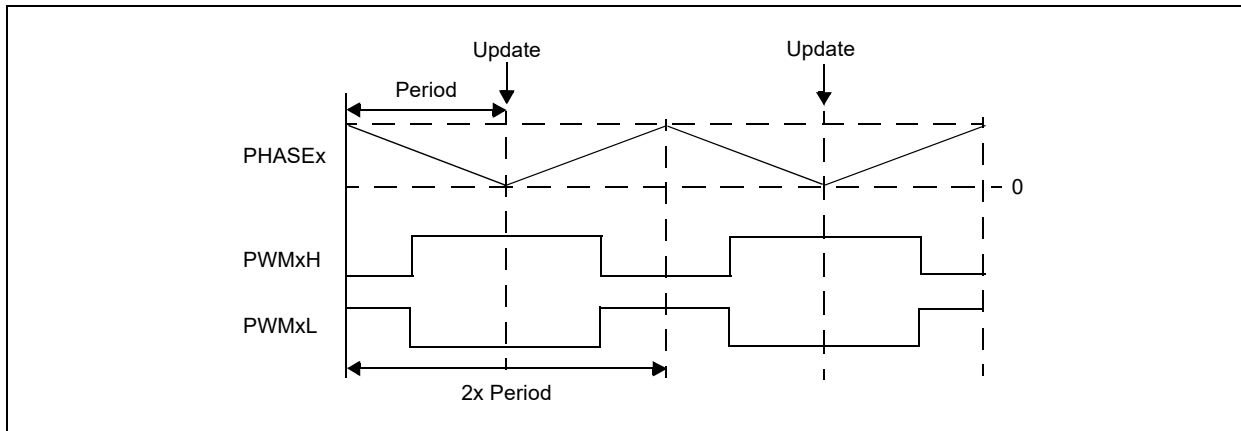
FIGURE 5:

In Center-Aligned Complementary mode with Independent Time Base, updates to the PHASEx register take effect in the middle of a Center-Aligned PWM cycle, as shown in Figure 5. This occurs only when the Immediate Update feature is disabled (IUE = 0). If Immediate Update is enabled (IUE = 1), the PHASEx register updates will take effect immediately.

None.

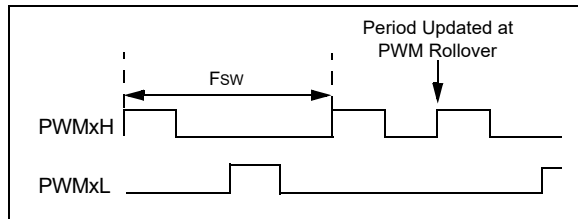
FIGURE 6:

When the PWM module is configured for Push-Pull mode (IOCONx[11:10] = 10) with the Enable Immediate Period Update bit enabled (PTCON[10] = 1), a write to the Period register that coincides with the period rollover event may cause the push-pull output logic to produce back-to-back pulses on the PWMx pins (Figure 6).

Ensure that the update to the PWM Period register occurs away from the PWM rollover event by setting the EIPU bit (PTCON[10] = 1). Use either the PWM Special Event Trigger (SEVTCMP) or the PWM Primary Trigger (TRIGx) to generate a PWM Interrupt Service Routine (ISR) near the start of the PWM cycle. This ISR will ensure that period writes do not occur near the PWM period rollover event.

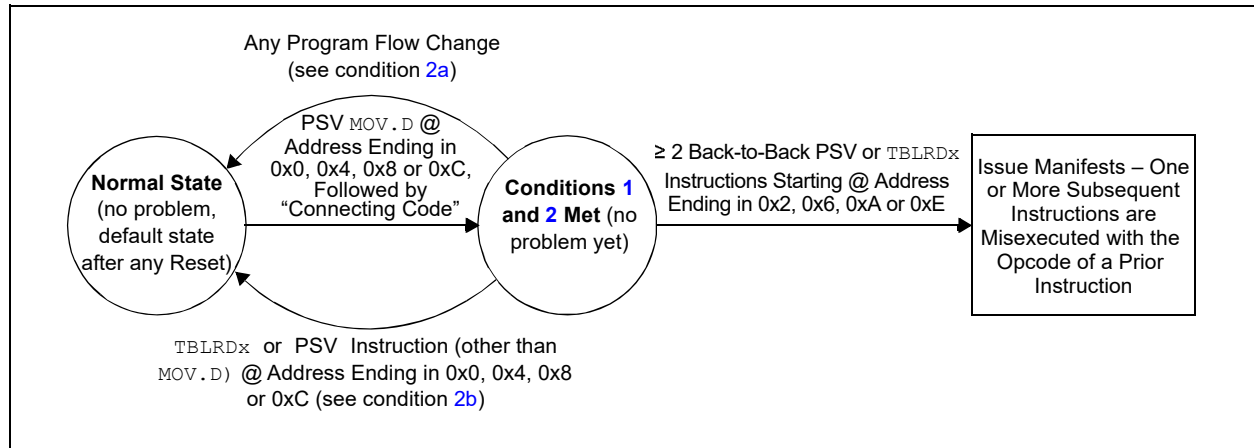
FIGURE 7: SIMPLIFIED BEHAVIOR

When two or more data Flash read instructions (via Program Space Visibility (PSV) read or table read) are executed back-to-back, one or more subsequent instructions can be misexecuted when all of the conditions in [Table 6](#) occur.

[Figure 7](#) provides an example of the effective behavior.

1. All instances of PSV MOV.D can be replaced with two PSV MOV instructions instead. Non-PSV MOV.D instructions acting on RAM/SFRs do not need to be modified; or
2. If not already present, a program flow change instruction (such as BRA \$+2) can be inserted above back-to-back data Flash read sequences; or
3. Back-to-back data Flash read instruction sequences can be broken up by inserting a non-Flash read instruction (such as a NOP), in between the Flash read instructions; or
4. The alignment of the code can be shifted to avoid the required opcode location addresses.
