Product Change Notification / SYST-28CLNB029

ERRATA - PIC18(L)F27/47K40 Family Silicon Errata and Data Sheet Clarifications Revision

PIC18(L)F27/47K40 Family Silicon Errata and Data Sheet Clarifications

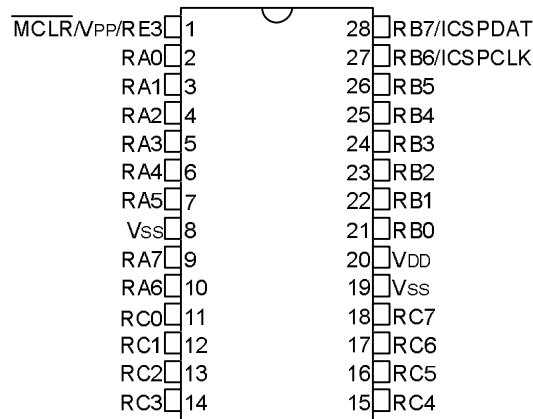
Figure 1. 28-pin SPDIP, SSOP, SOIC

The correct marking for pin 26 on the 28-pin SPDIP/SSOP/SOIC package is **RB5**.

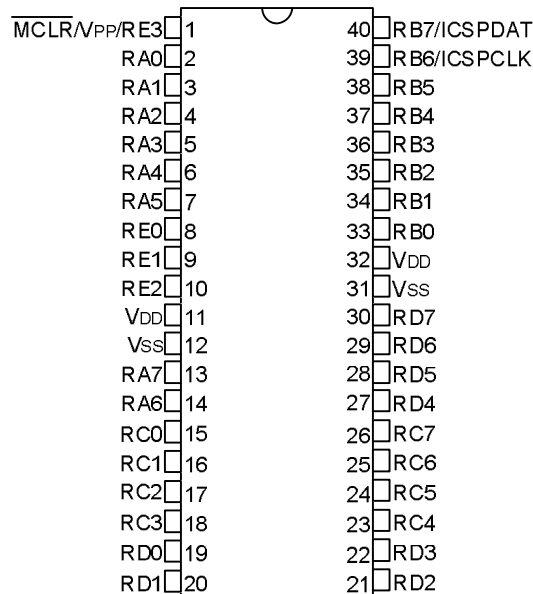
Figure 3. 40-pin PDIP

The correct marking for pin 38 on the 40-pin SPDIP package is **RB5**.

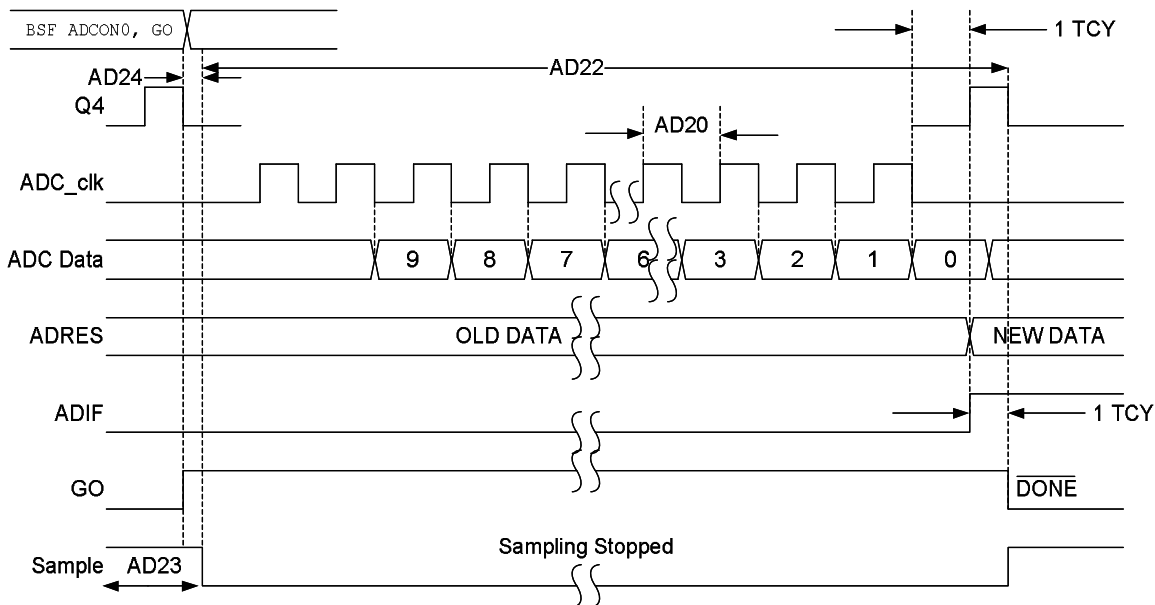
Figure 38-10: ADC Conversion Timing (ADC Clock F_{OSC} -Based)

Refer to the images below for corrections of Figure 38-10 and Figure 38-11. Previously, the parameter numbers were incorrect.
