Product Change Notification / SYST-28ZNPW394

ERRATA - PIC18(L)F24/25K40 Family Silicon Errata and Data Sheet Clarification Revision

PIC18(L)F24/25K40 Family Silicon Errata and Data Sheet Clarification

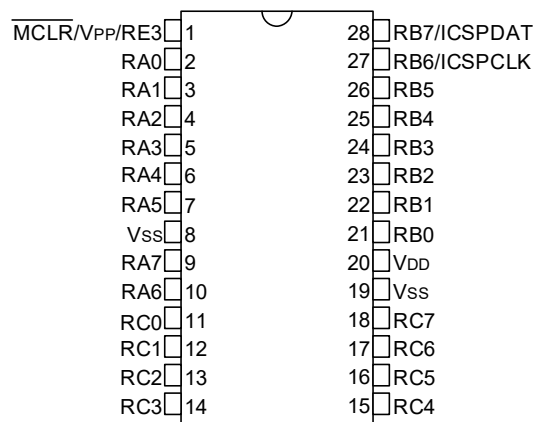
Figure 1. 28-pin SPDIP, SSOP, SOIC

The correct marking for pin 26 on the 28-pin SPDIP/SSOP/SOIC package is **RB5**.

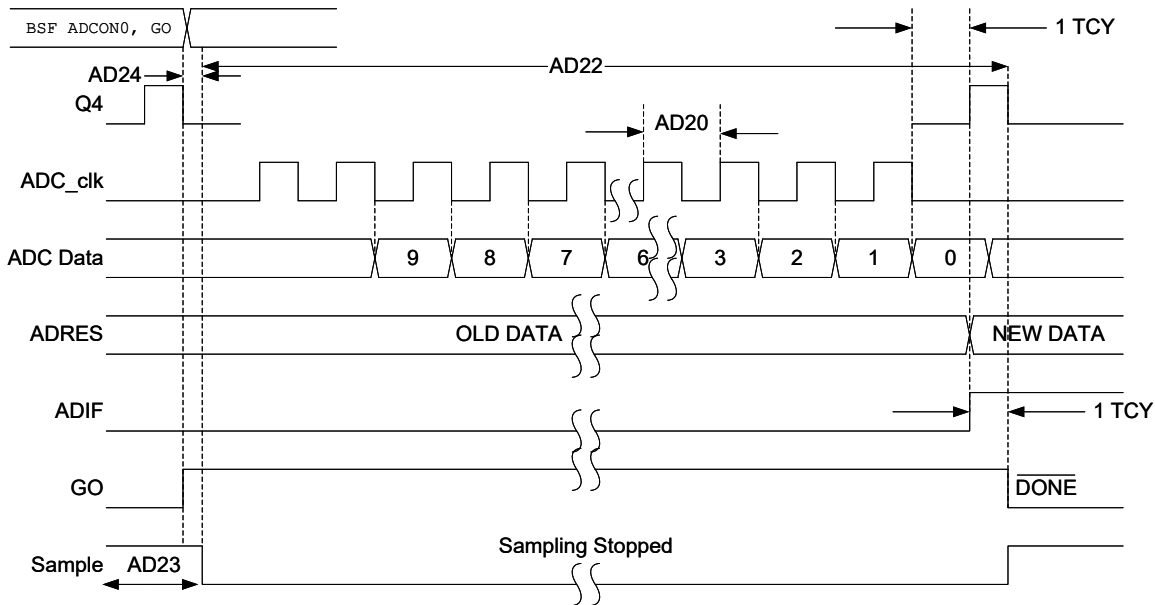
Figure 38-10: ADC Conversion Timing (ADC Clock F_{OSC}-Based)

Refer to the images below for corrections of Figure 38-10 and Figure 38-11. Previously, the parameter numbers were incorrect.
