## Product Change Notification / SYST-05XJMF681

ERRATA - PIC18(L)F26/45/46K40 Family Silicon Errata and Data Sheet Clarification

## PIC18(L)F26/45/46K40 Family Silicon Errata and Data Sheet Clarification

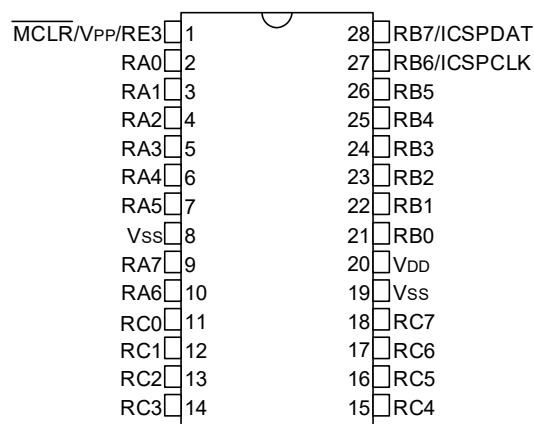
**Figure 1. 28-pin SPDIP, SSOP, SOIC**

The correct marking for pin 26 on the 28-pin SPDIP/SSOP/SOIC package is **RB5**.

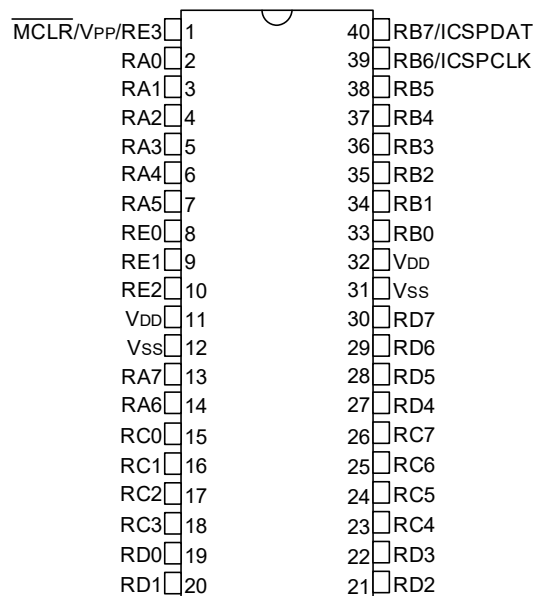
**Figure 3. 40-pin PDIP**

The correct marking for pin 38 on the 40-pin SPDIP package is **RB5**.

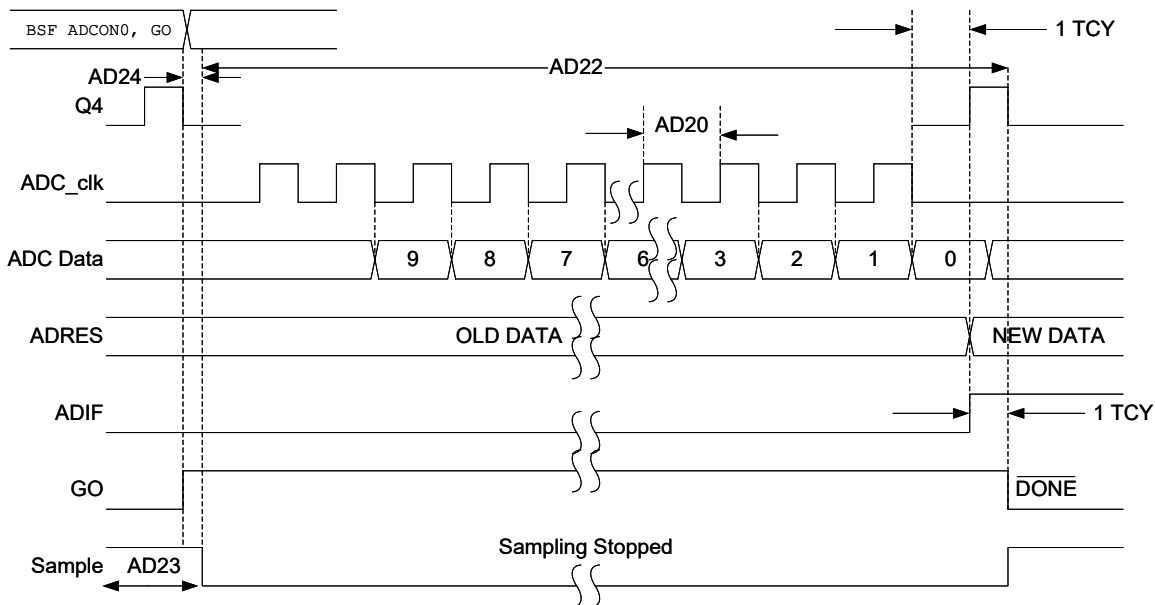
**Figure 38-10: ADC Conversion Timing (ADC Clock  $F_{OSC}$ -Based)**

Refer to the images below for corrections of Figure 38-10 and Figure 38-11. Previously, the parameter numbers were incorrect.
