## Product Change Notification / SYST-11ARMC394

ERRATA - KSZ9897R Silicon Errata and Data Sheet Clarification

## KSZ9897R Silicon Errata and Data Sheet Clarification

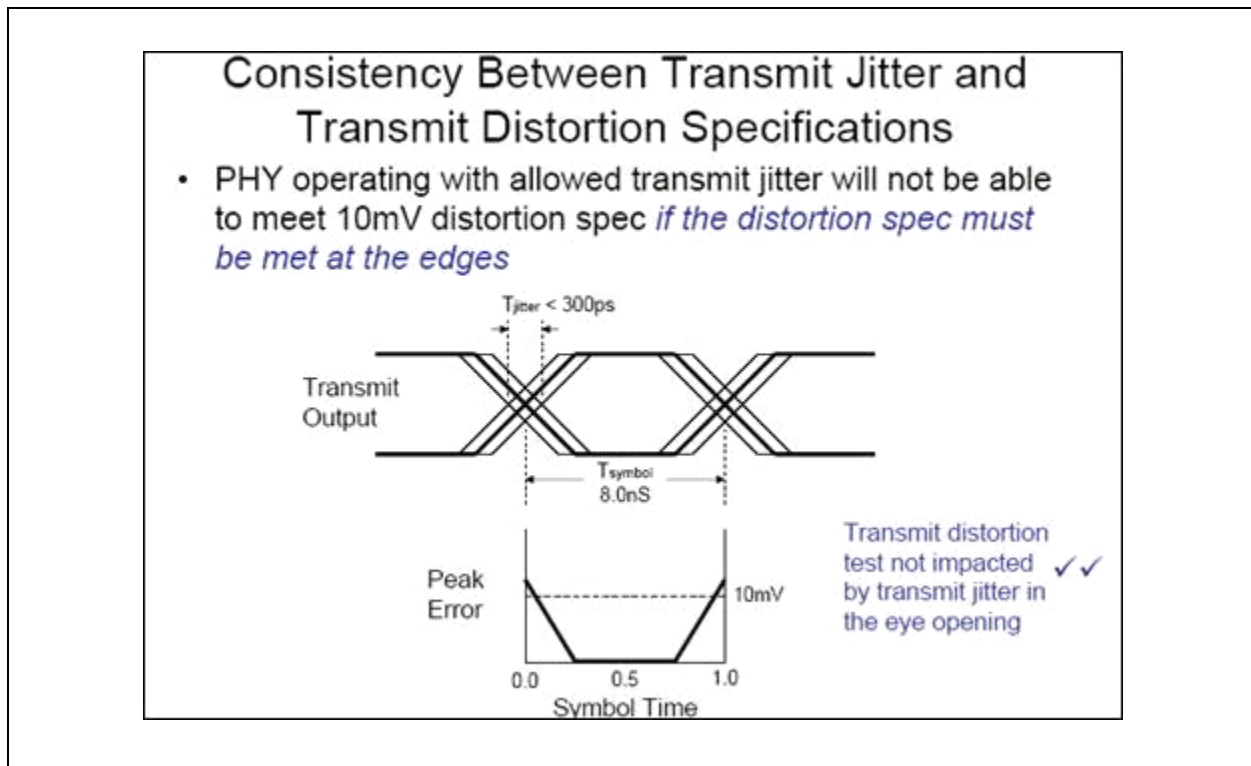
**FIGURE 1: IEEE DOCUMENT PAGE 6**

The device's 1000BASE-T Transmitter Distortion is approximately 40mV, versus the <10mV indicated in the IEEE specification.

IEEE testing calls for <10mV peak transmitter distortion for at least 60% of the UI within the eye opening. However, this measurement might not be valid, as the transmit distortion test is sensitive to transmit jitter. Refer to the explanation below, taken from the aforementioned IEEE document.

- On page 6, a contradiction between Transmit Jitter and Transmit Distortion requirements:

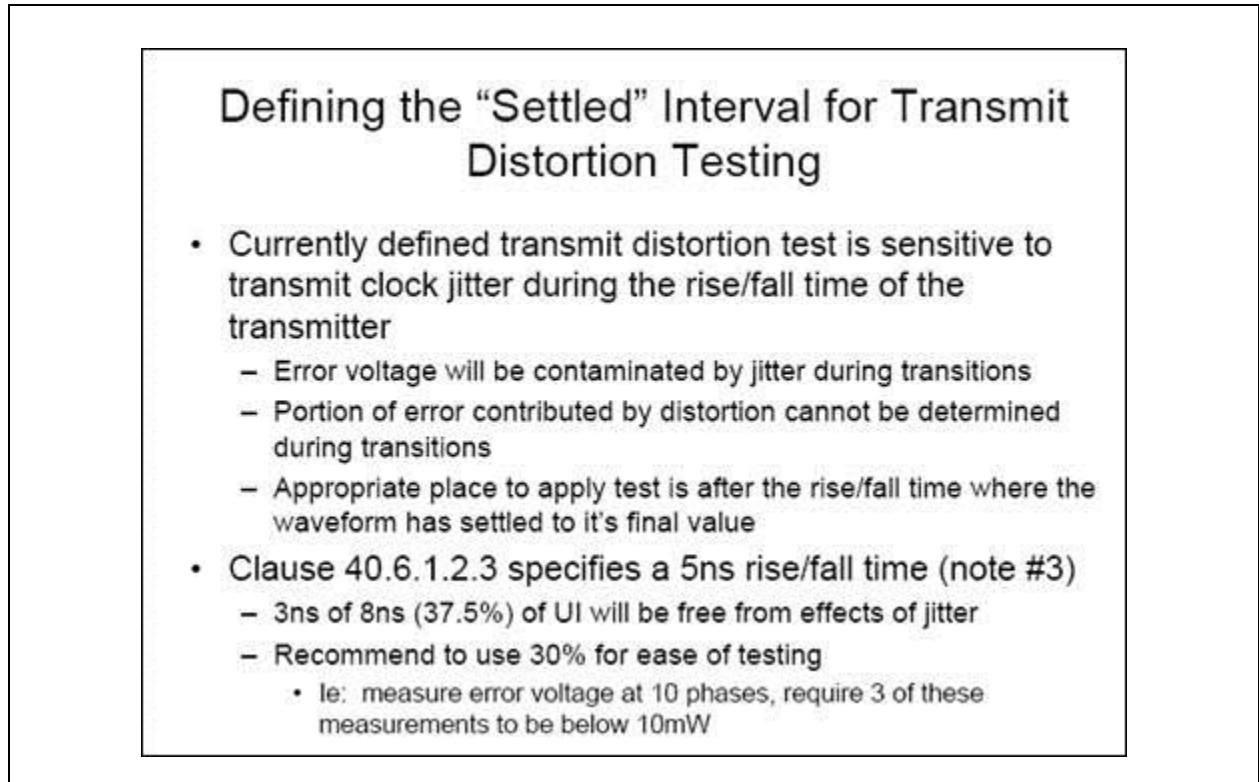
**FIGURE 2: IEEE DOCUMENT PAGE 7**

- On page 7:
  - The transmit distortion test is sensitive to transmit clock jitter during the rise/fall time.
  - It is recommended to change the requirement to use at least 30%, instead of at least 60%, of the UI within the eye opening for the <10mV peak transmitter distortion.
