Product Change Notification / SYST-11QMDW332

ERRATA - KSZ9477S Silicon Errata and Data Sheet Clarification

KSZ9477S Silicon Errata and Data Sheet Clarification

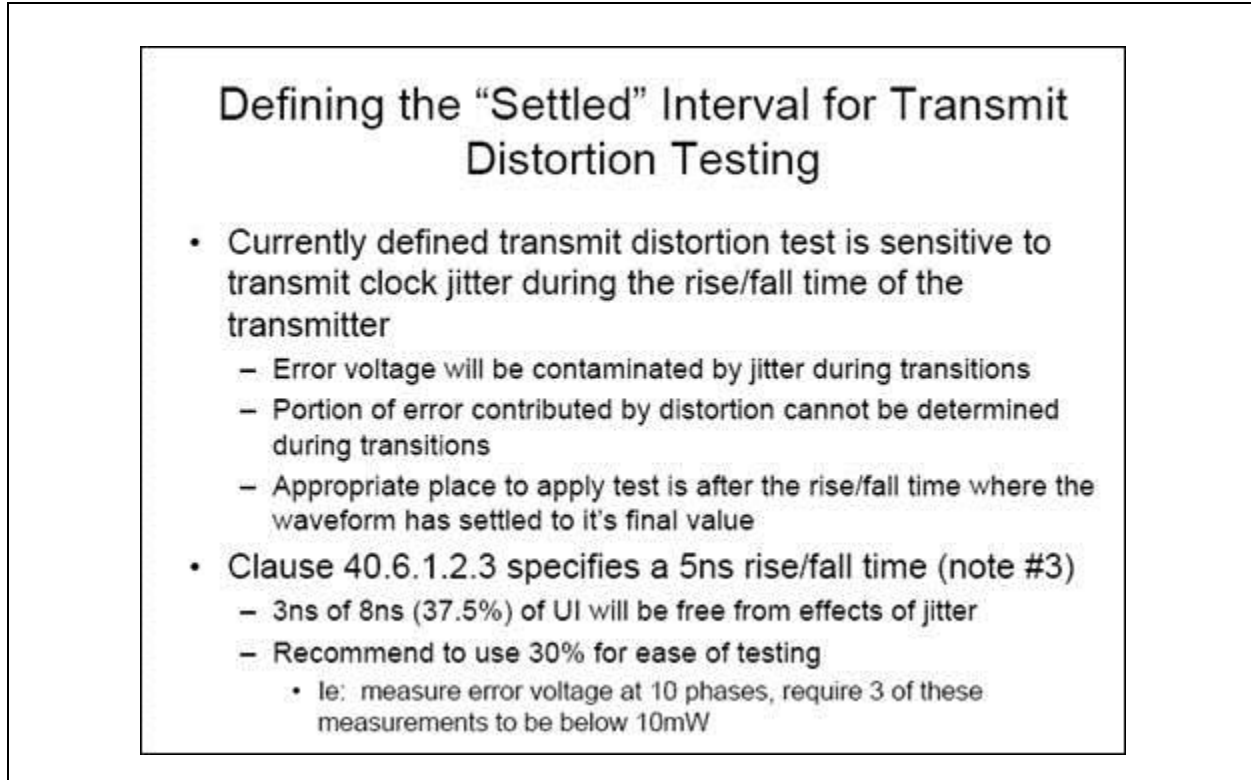
FIGURE 2: IEEE DOCUMENT PAGE 7

- On page 7:
 - The transmit distortion test is sensitive to transmit clock jitter during the rise/fall time.
 - It is recommended to change the requirement to use at least 30%, instead of at least 60%, of the UI within the eye opening for the <10mV peak transmitter distortion.
