Information note

N° 10375AERRA

Errata sheet V1.11 affecting products TC37x_AA

Subject Errata sheet V1.11 affecting products TC37x_AA

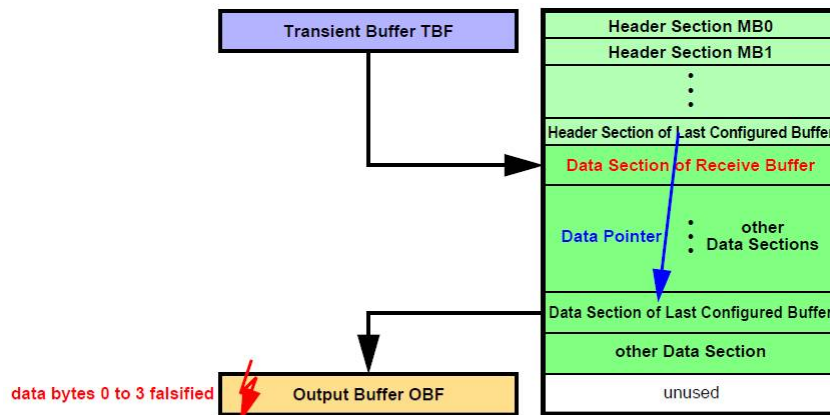
Figure 1 Message buffer transfer from Message RAM to OBF

When the message buffer has its payload configured to maximum length (**PLC = 127**), the OBF word on address 00h (payload data bytes 0 to 3) is overwritten with unexpected data at the end of the transfer.

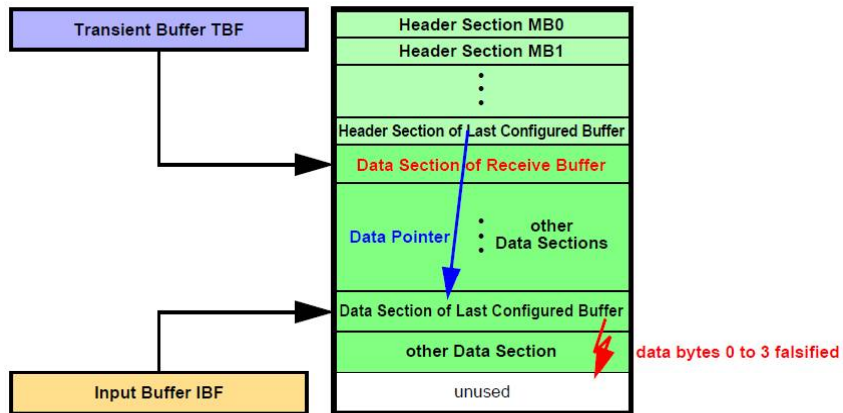
Figure 2 Message buffer transfer from IBF to Message RAM

After the Data Section of the selected message buffer in the Message RAM has been written, one additional write access overwrites the following word in the Message RAM which might be the first word of the next Data Section.

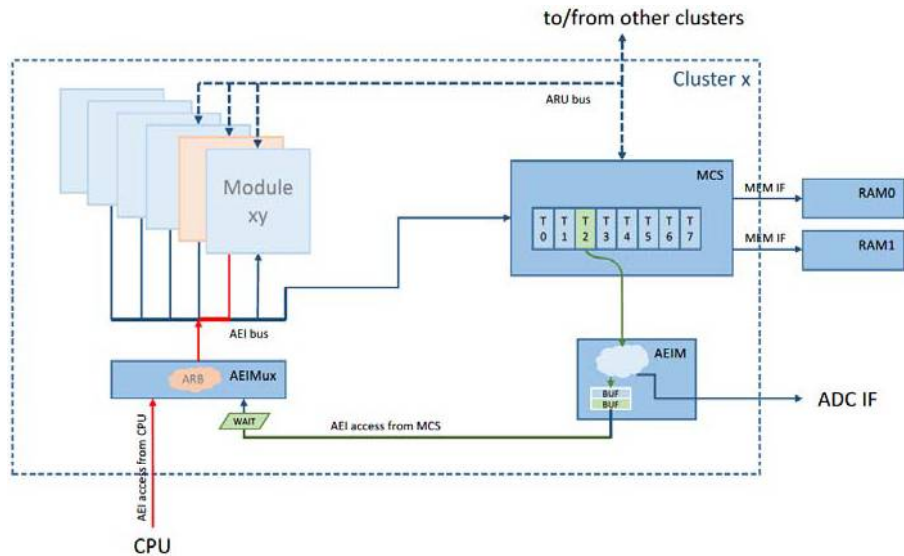
Figure 5 MCS AEI master access path

Figure 5 shows an uncritical traffic situation. Here an access of a MCS thread to the AEI bus (green access path) is temporary delayed due to an ongoing AEI bus access from the CPU (red access path). The MCS access to the AEI bus will be safely buffered at the AEIM (green buffer). As soon as the CPU access to the AEI bus completes, the buffered AEI bus access from MCS will be executed.

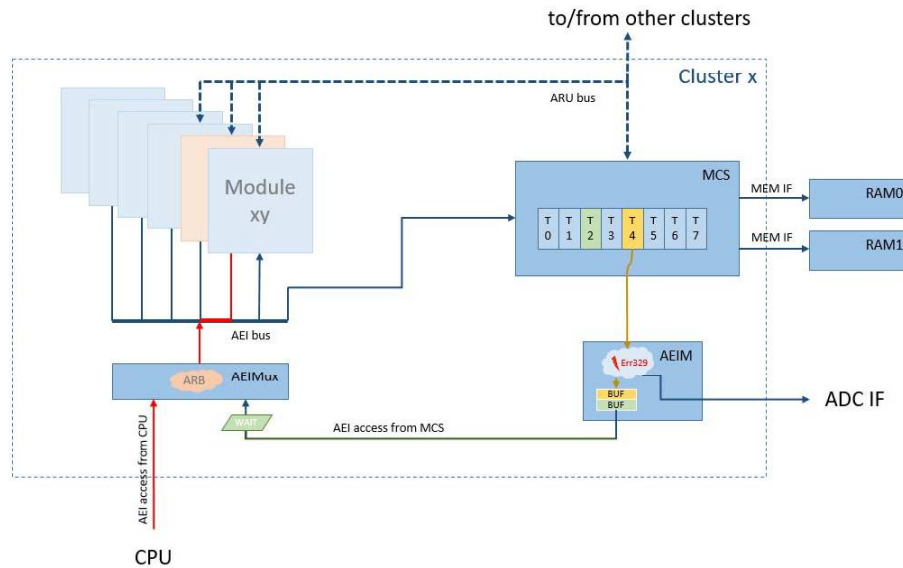
Figure 6 Critical MCS AEI master scenario

In [Figure 6](#), a potential risk for the occurrence of problem GTM_AI.329 is illustrated. Here the first buffer of the AEIM (green) is still waiting for the access to the AEI bus while a second AEI bus access from MCS arrives at the AEIM (yellow access path). Under certain, but for the user unpredictable timing conditions, this second AEI bus access arriving at the AEIM can trigger the misbehavior described in problem GTM_AI.329.

The workarounds described in the following section will ensure that not more than one AEIM buffer will be filled and therefore the occurrence of problem GTM_AI.329 is avoided. All workarounds have been tested and proven correct.

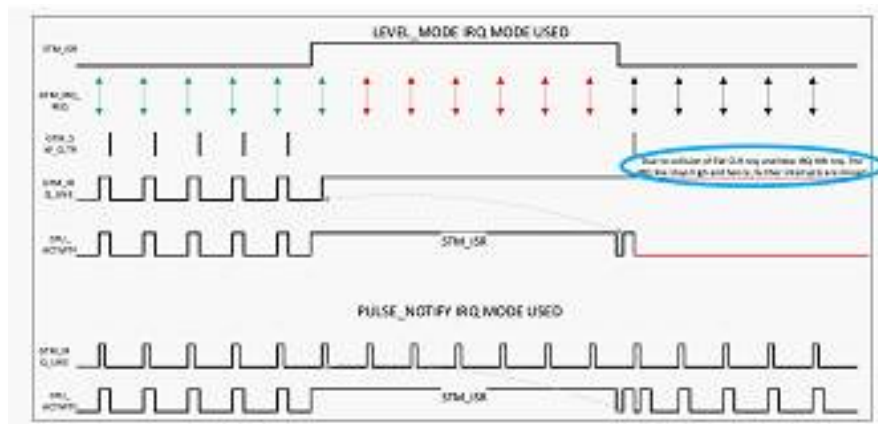
Figure 8 Interrupt Level vs. Pulse-Notify mode - Corner Case Example

Hence, in Level Mode, in some scenarios where another interrupt request is generated by GTM while the ISR handle also requests a SW clear, then, as the interrupt event is dominant over the clear event (for simultaneous interrupt and clear events), GTM_IRQ_XXX is not cleared and remains high. As a consequence, the IR observes no transition on GTM_IRQ_XX. Thus, any forthcoming interrupt events in this scenario are lost as there is no chance to release the CPU IRQ when a collision happens as shown in Figure below.

If Pulse-Notify mode is selected, every internal trigger will be forwarded to the IR, irrespective of the time of occurrence and the clear event, as the pulse-notify leads to set and reset of GTM_IRQ_XXX as compared to only setting of the GTM_IRQ_XXX line in Level mode.

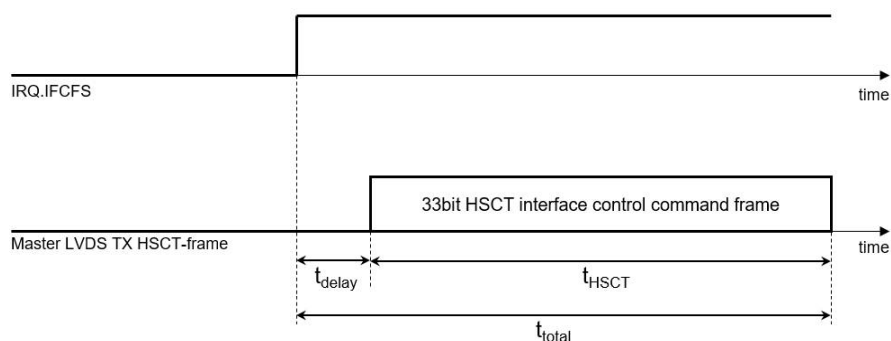
Figure 9 Timing of LVDS TX interface command sending in relation to IRQ.IFCFS

the user might falsely assume that also the actual sending on the LVDS TX port has already occurred once the IRQ.IFCFS flag is set, which is not true.

Instead the timing shown in [Figure 9](#) applies.

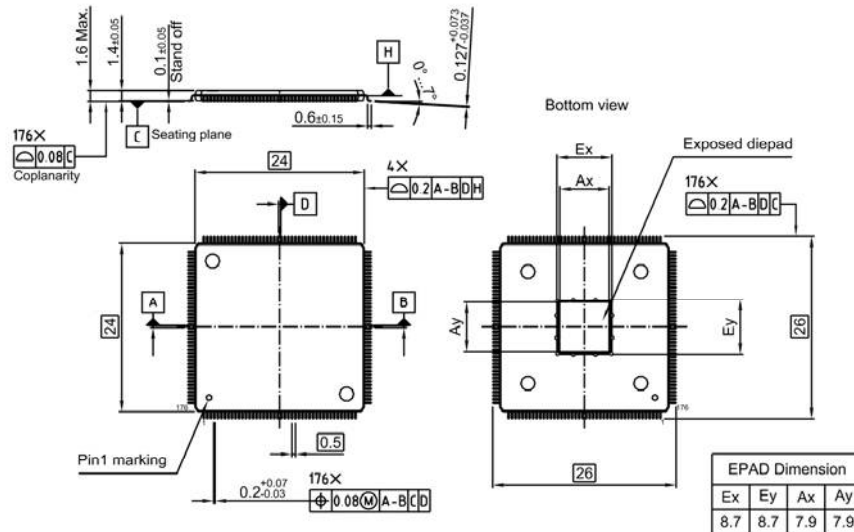
Figure 10 Package Outlines LQFP-176 for TC37x

Note: For the exposed diepad of the LQFP-176 package of the TC37x, structural corner protrusions have to be considered for purposes of system design and integration with a maximum boundary of 9.4 mm.

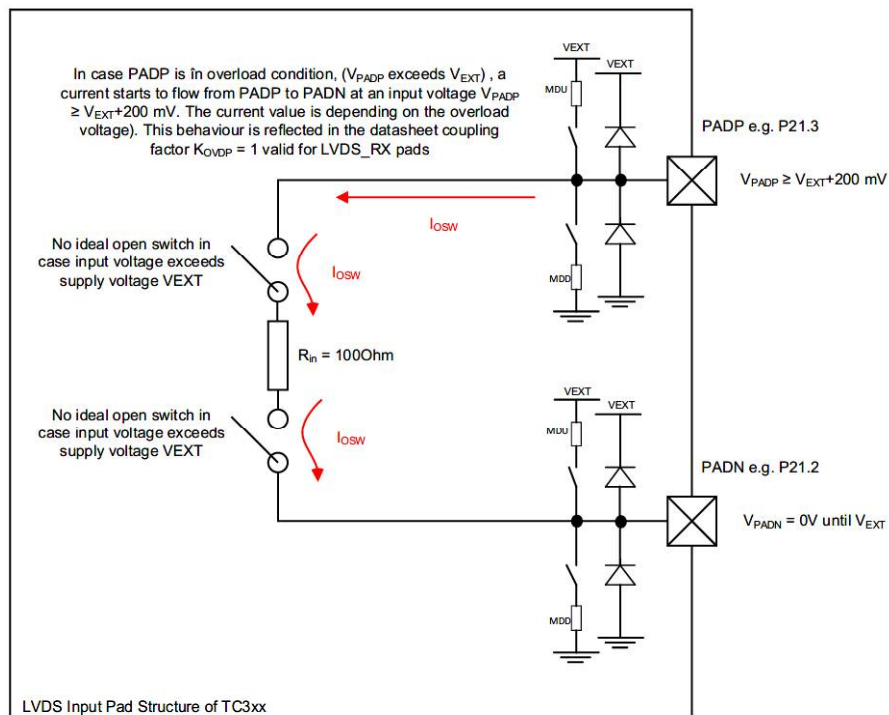
Figure 11 Positive overload on P-pad of a LVDS RX pin pair (both used as inputs)

The following figure illustrates the effect for a positive overload condition ($V_{PADP} > V_{EXT}$) on the P-pad (PADP) of a pin pair where both the P-pad and the corresponding N-pad (NPAD, with $0V \leq V_{NPAD} \leq V_{EXT}$) are used as digital CMOS inputs.

The overload current I_{OSW} through the non-ideal open switch significantly increases when $V_{PADP} \geq V_{EXT} + 200\text{ mV}$.

Note: In general, the effect will also occur if the N-pad is used as output, or for a negative overload condition on either the P-pad or the N-pad.
