Product Change Notification / SYST-28DSPA532

ERRATA - PIC18F27/47/57Q43 Silicon Errata and Data Sheet Clarifications

PIC18F27/47/57Q43 Silicon Errata and Data Sheet Clarifications

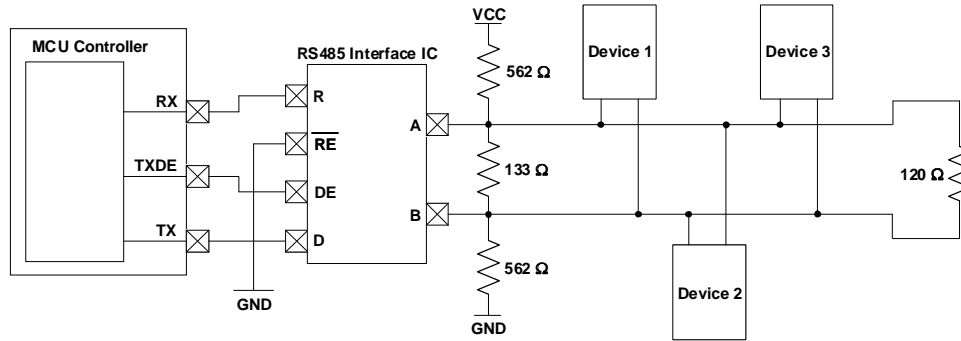
The UART Transmit Drive Enable (TXDE) signal could potentially transition into a low state before the UART STOP bit has been entirely transmitted due to the effects of parasitic capacitance on the TX line. In some applications, this could result in communication being prematurely terminated due to the TXDE bit going low before the STOP bit has had enough time to settle.

In order to ensure that the STOP bit settles into its final logic state before the TXDE signal transitions low, a biasing circuit can be implemented. A biasing circuit allows the TX line to either be driven high or low, rather than being left in a floating tri-state mode where prolonged rise or fall times could lead to communication being disrupted. This bias circuit should only be implemented on one end of the serial bus, and a termination resistor should be used on the other end. The figure below shows an example of a bias circuit that can be used to achieve this.

Please note that the resistor values used in this circuit are recommendations, and that the actual resistor values required may vary based on the application.
