Information note

N° 10403AERRA

Errata sheet V2.00 affecting products TC37x_AA

Subject Errata sheet V2.0 affecting products TC37x_AA

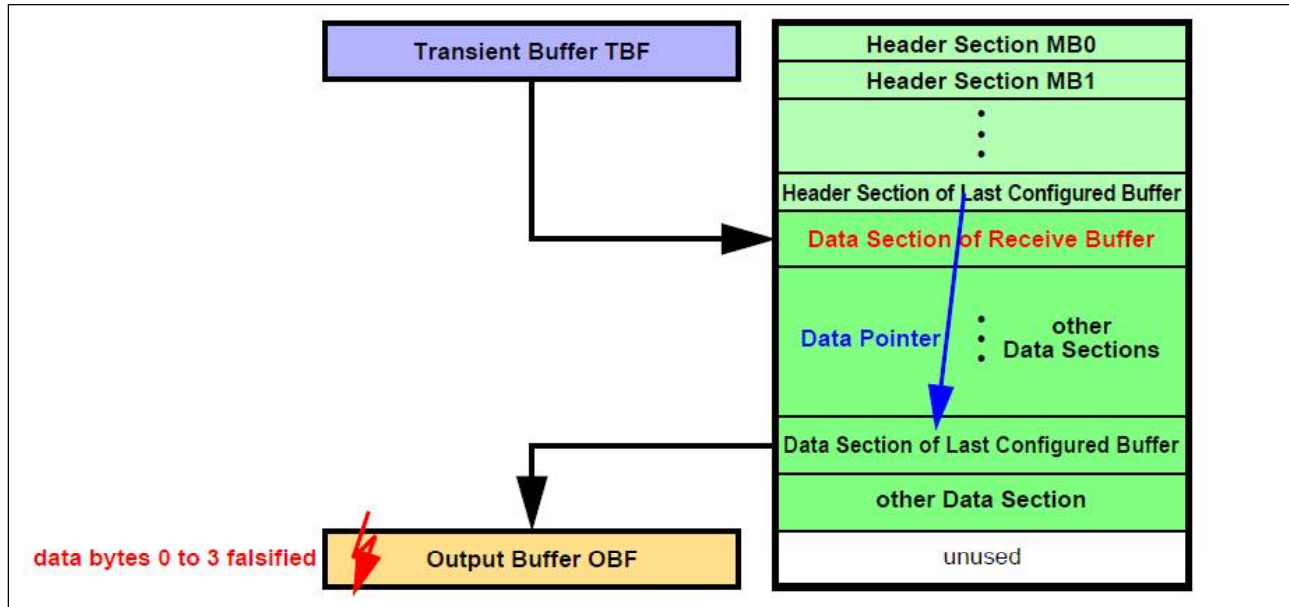
Figure 1 Message buffer transfer from Message RAM to OBF

When the message buffer has its payload configured to maximum length (`PLC = 127`), the OBF word on address `00h` (payload data bytes 0 to 3) is overwritten with unexpected data at the end of the transfer.

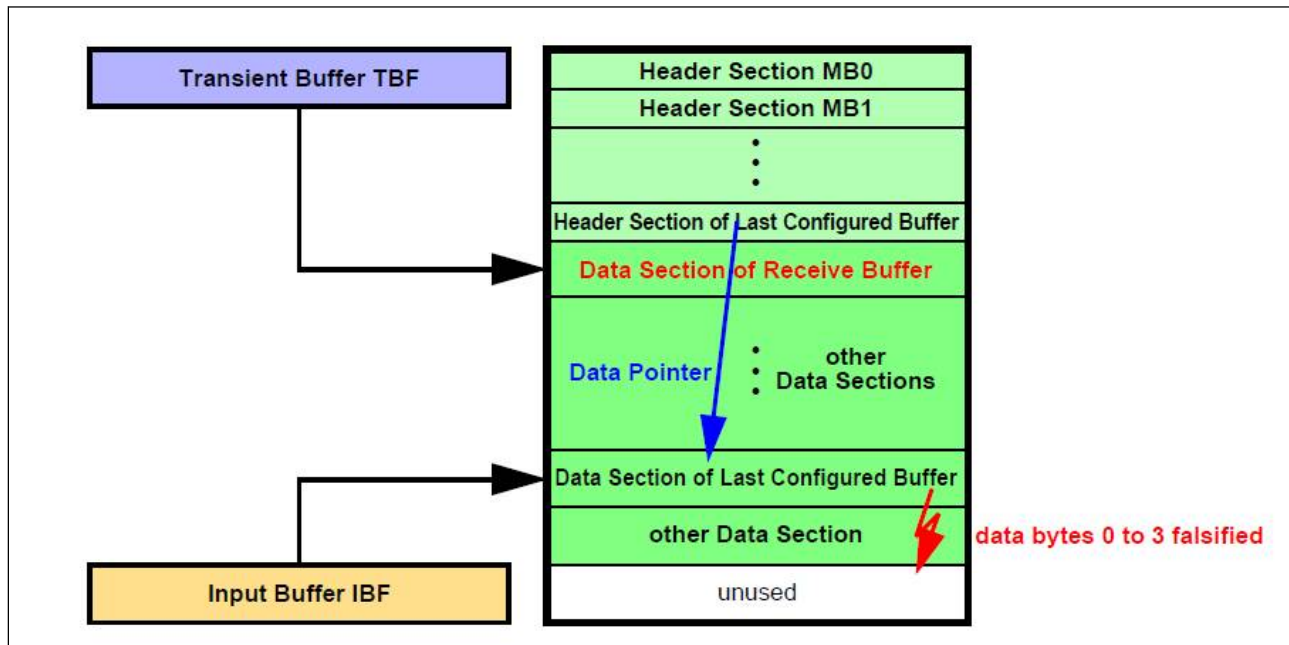
Figure 2 Message buffer transfer from IBF to Message RAM

After the Data Section of the selected message buffer in the Message RAM has been written, one additional write access overwrites the following word in the Message RAM which might be the first word of the next Data Section.

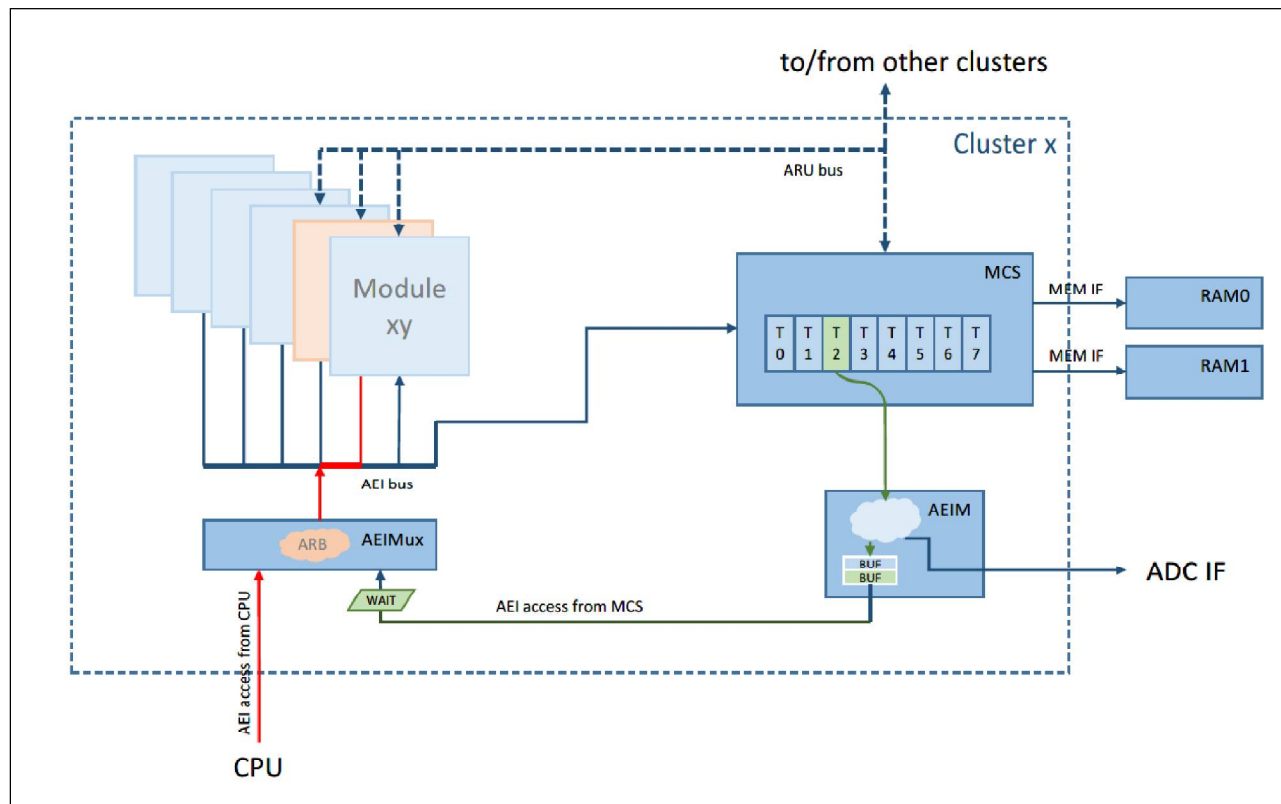
Figure 5 MCS AEI master access path

Figure 5 shows an uncritical traffic situation. Here an access of a MCS thread to the AEI bus (green access path) is temporarily delayed due to an ongoing AEI bus access from the CPU (red access path). The MCS access to the AEI bus will be safely buffered at the AEIM (green buffer). As soon as the CPU access to the AEI bus completes, the buffered AEI bus access from MCS will be executed.

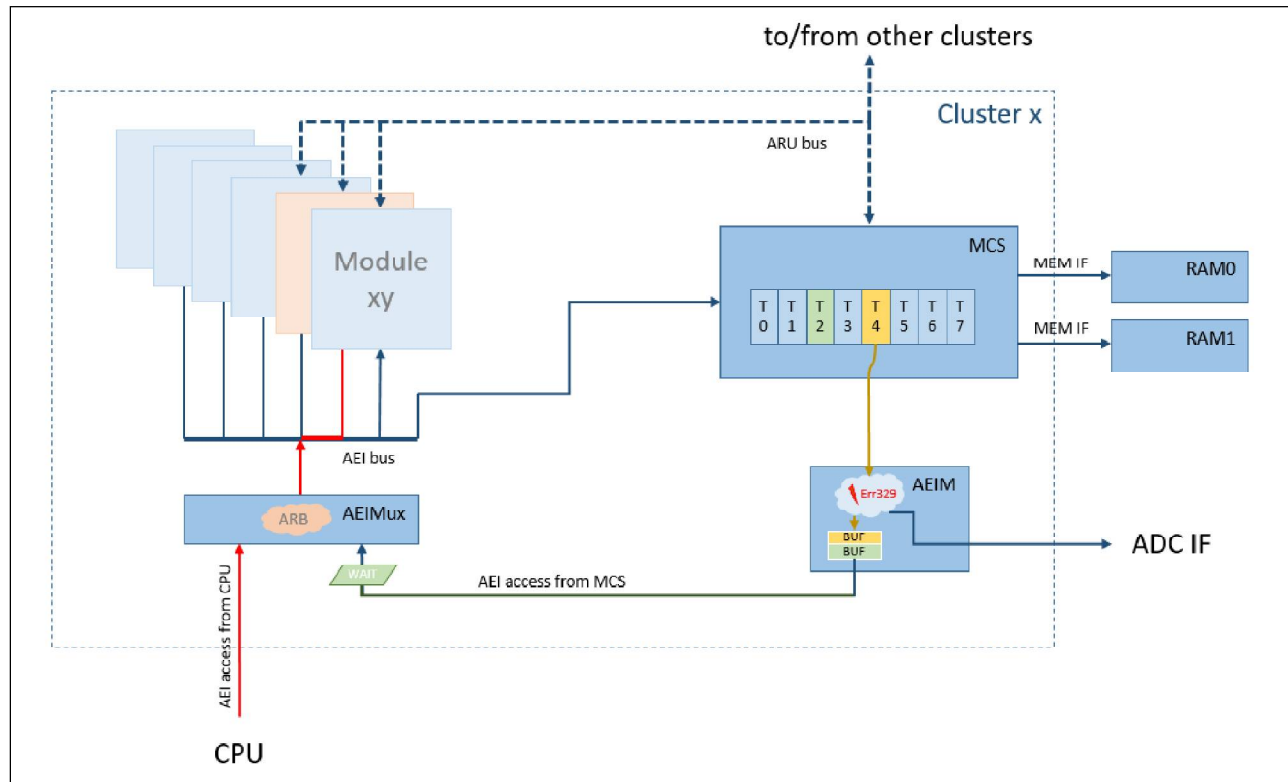
Figure 6 Critical MCS AEI master scenario

In [Figure 6](#), a potential risk for the occurrence of problem GTM_AI.329 is illustrated. Here the first buffer of the AEIM (green) is still waiting for the access to the AEI bus while a second AEI bus access from MCS arrives at the AEIM (yellow access path). Under certain, but for the user unpredictable timing conditions, this second AEI bus access arriving at the AEIM can trigger the misbehavior described in problem GTM_AI.329.

The workarounds described in the 'Workaround' section will ensure that not more than one AEIM buffer will be filled and therefore the occurrence of problem GTM_AI.329 is avoided. All workarounds have been tested and proven correct.

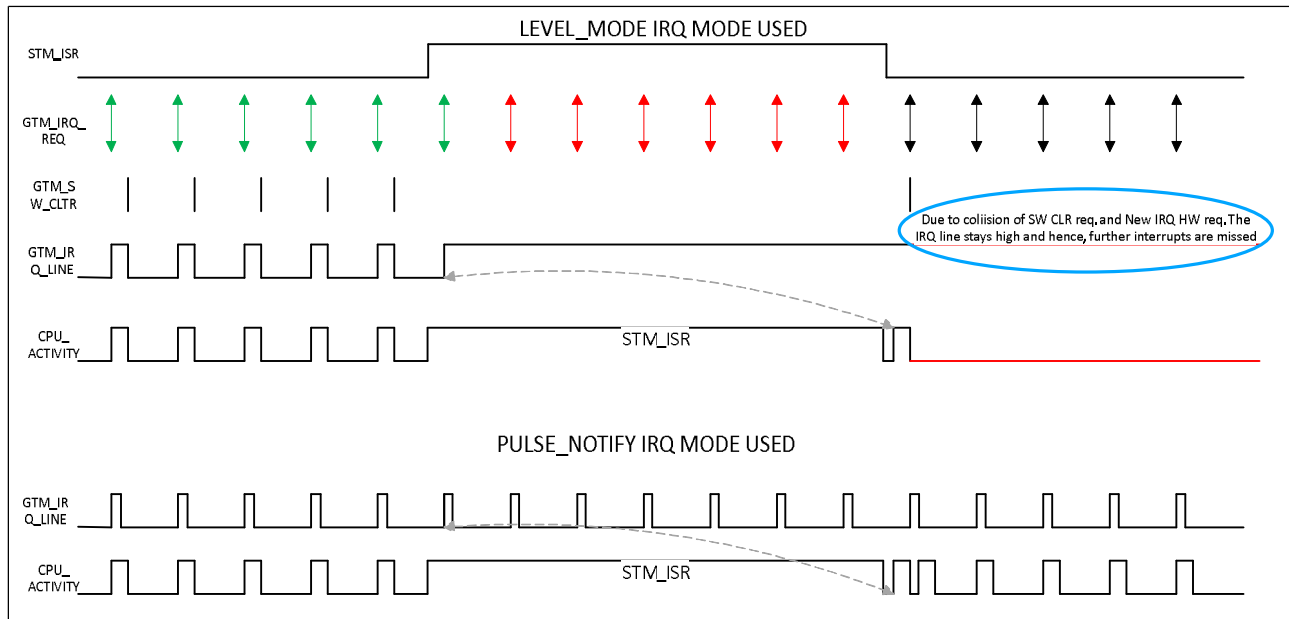
Figure 8 Interrupt Level vs. Pulse-Notify mode - Corner Case Example

As described in the text below this figure, while using Level mode, if more internal “interrupt” events are generated (i.e. two TOM channels generating a CCU0 interrupt), just one interrupt signal is sent to the IR, and no more interrupts are triggered until the SW clears the GTM_IRQ_XXX line towards the IR.

Hence, in Level Mode, in some scenarios where another interrupt request is generated by GTM while the ISR handle also requests a SW clear, then, as the interrupt event is dominant over the clear event (for simultaneous interrupt and clear events), GTM_IRQ_XXX is not cleared and remains high. As a consequence, the IR observes no transition on GTM_IRQ_XX. Thus, any forthcoming interrupt events in this scenario are lost as there is no chance to release the CPU IRQ when a collision happens as shown in Figure below.

If Pulse-Notify mode is selected, every internal trigger will be forwarded to the IR, irrespective of the time of occurrence and the clear event, as the pulse-notify leads to set and reset of GTM_IRQ_XXX as compared to only setting of the GTM_IRQ_XXX line in Level mode.

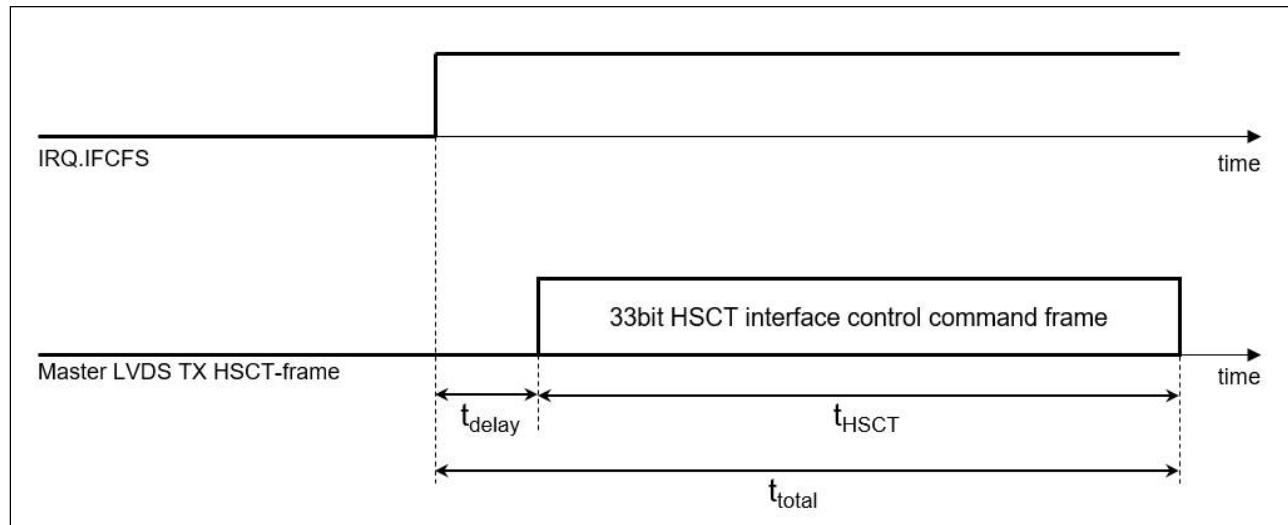
Figure 9 Timing of LVDS TX interface command sending in relation to IRQ.IFCFS

Instead the timing shown in the following figure applies.

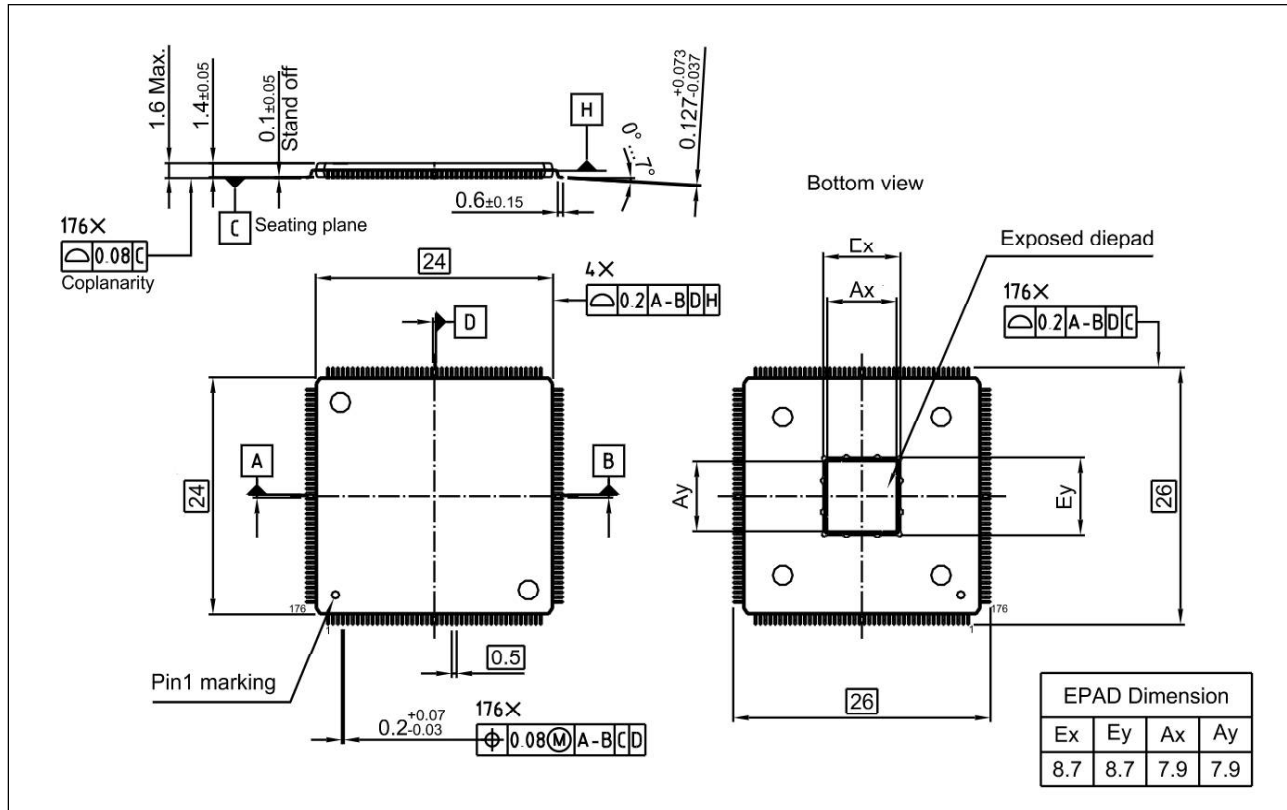
Figure 10 Package Outlines LQFP-176 for TC37x

Note: For the exposed diepad of the LQFP-176 package of the TC37x, structural corner protrusions have to be considered for purposes of system design and integration with a maximum boundary of 9.4 mm.

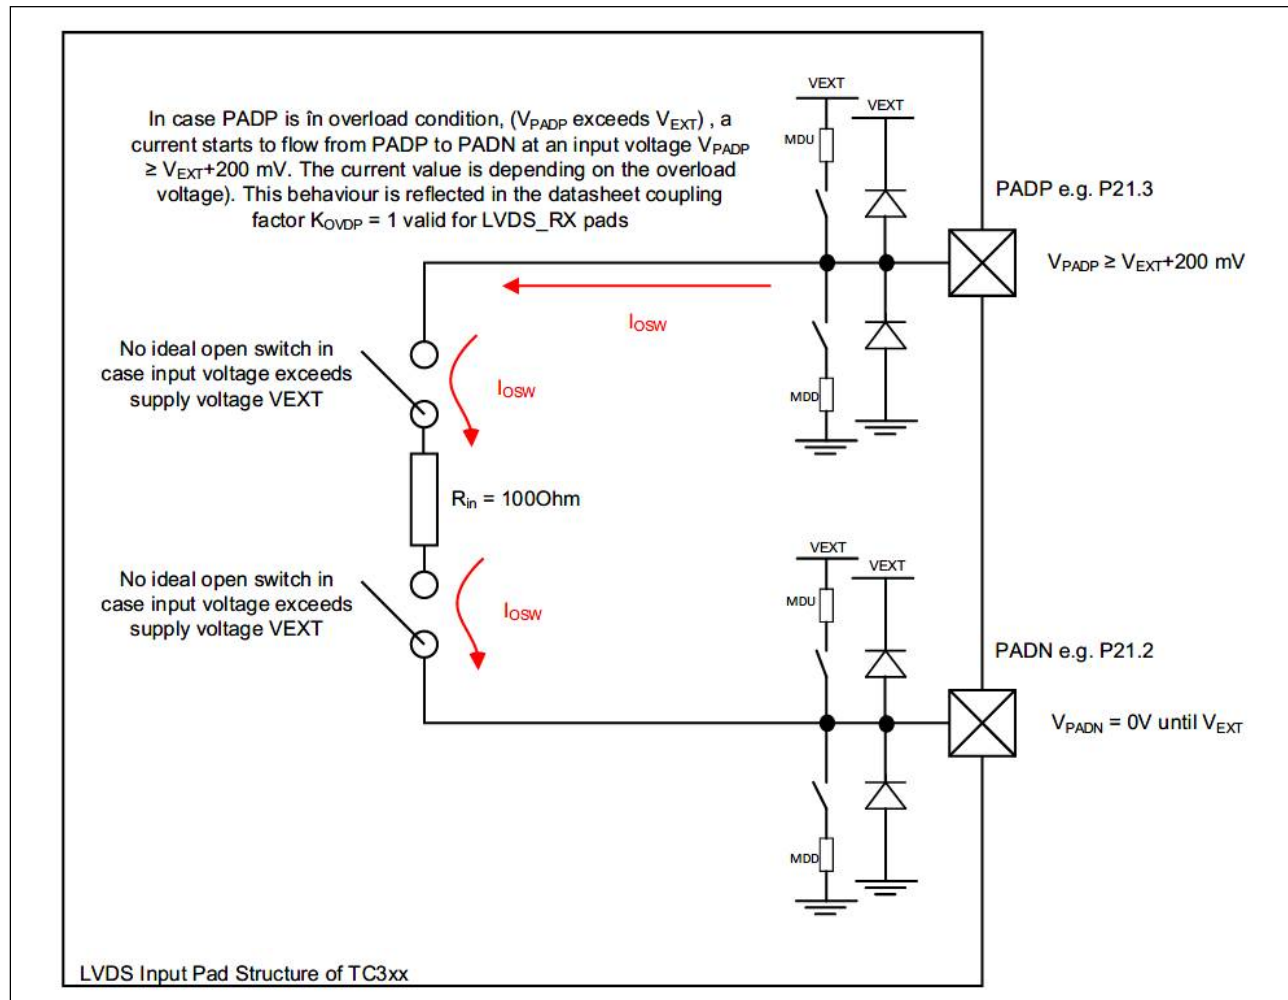
Figure 11 Positive overload on P-pad of a LVDS RX pin pair (both used as inputs)

The overload current I_{OSW} through the non-ideal open switch significantly increases when $V_{PADP} \geq V_{EXT} + 200$ mV.

Note: In general, the effect will also occur if the N-pad is used as output, or for a negative overload condition on either the P-pad or the N-pad.
