Product Change Notification / SYST-18YIFQ586

ERRATA - SmartFusion®2 Device Errata

Description of Change: Added 1.25. Avoid eNVM Page Lock and Unlock if Code is Being Executed from eNVM both in Release and Debug Mode

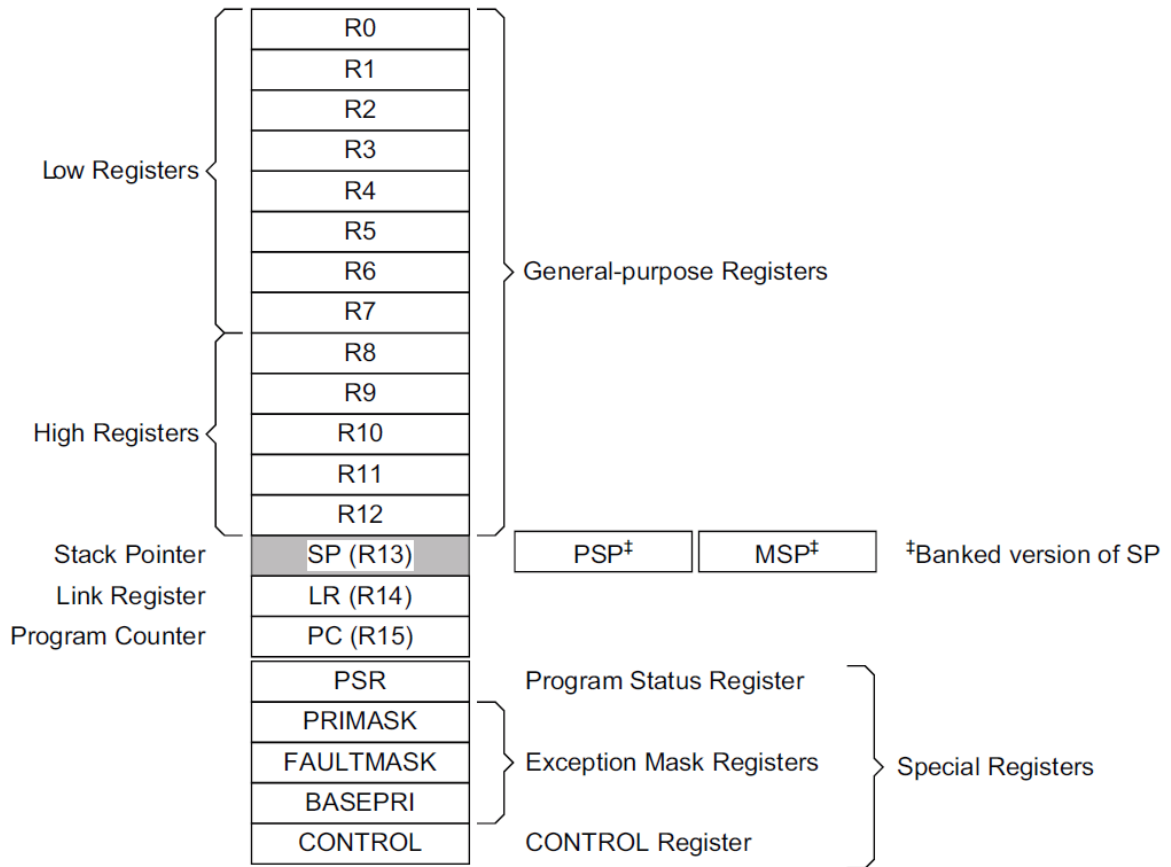
Figure 1-1. Cortex-M3 Core Register Set

Cortex-M3 internal general-purpose registers (for example R6) gets corrupted when two nested D-Bus (must be a non-64-bit-aligned access) and I-Bus cache miss cycles occur in cache controller fetching from eNVM followed immediately by a D-Bus read without cache miss.

A D-Bus read takes the precedence over an I-Bus but the data loaded into the Cortex-M3 internal register (for example, R6) is erroneously the I-Bus data which causes the corruption and consequently the application fails in an unpredictable manner.

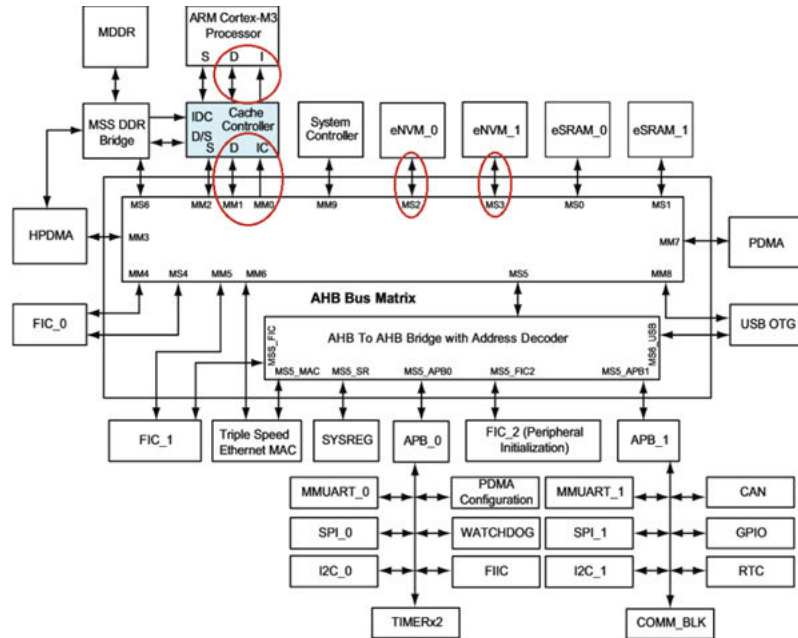
Figure 1-2. Cache Controller Interfaces and Paths Affected by CN (Red Circles)

SmartFusion2 system implements a cache controller in between Cortex-M3 and the memory subsystems (eNVM, eSRAM, Fabric sRAM, and DDR). An AHB matrix is used to arbitrate between eNVM, eSRAM, and Fabric sRAM access while a separate dedicated bus interfaces with DDR.

When the cache controller is enabled and mapped to eNVM, the following sequence of operations causes I-Bus and D-Bus accesses to be queued internally, leading to a state analogous to an I-Bus and D-Bus concurrent access.
