## Product Change Notification / SYST-01SUTS663

ERRATA - PIC18F27/47/57Q84 Silicon Errata and Data Sheet Clarifications

# PIC18F27/47/57Q84 Silicon Errata and Data Sheet Clarifications

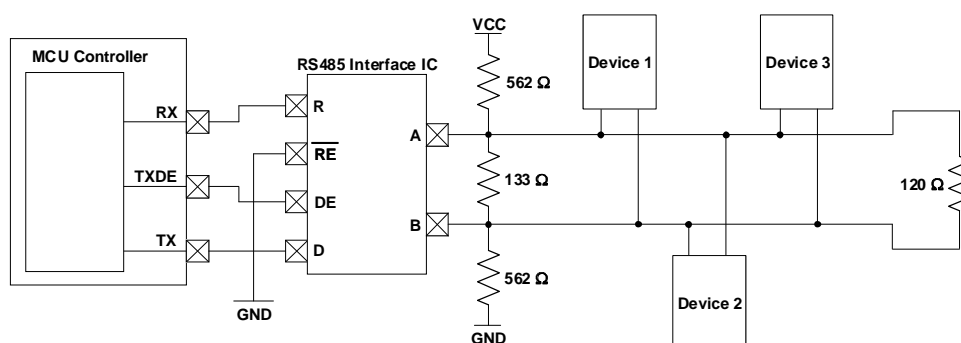
### 1.6.1 UART TXDE Signal May Go Low Before the STOP Bit Has Been Entirely Transmitted

The UART Transmit Drive Enable (TXDE) signal could potentially transition into a low state before the UART STOP bit has been entirely transmitted due to the effects of parasitic capacitance on the TX line. In some applications, this could result in communication being prematurely terminated due to the TXDE bit going low before the STOP bit has had enough time to settle.

To ensure that the STOP bit settles into its final logic state before the TXDE signal transitions low, a biasing circuit can be implemented. A biasing circuit allows the TX line to either be driven high or low, rather than being left in a floating tri-state mode where prolonged rise or fall times could lead to communication being disrupted. This bias circuit should only be implemented on one end of the serial bus, and a termination resistor should be used on the other end. The figure below show an example of a bias circuit that can be used to achieve this.

Please note that the resistor values used in this circuit are recommendations, and that the actual resistor values required may vary based on the application.
