## Product Change Notification / SYST-08DHB472

ERRATA - PIC18F26/46/56Q84 Silicon Errata and Data Sheet Clarifications

# PIC18F26/46/56Q84 Silicon Errata and Data Sheet Clarifications

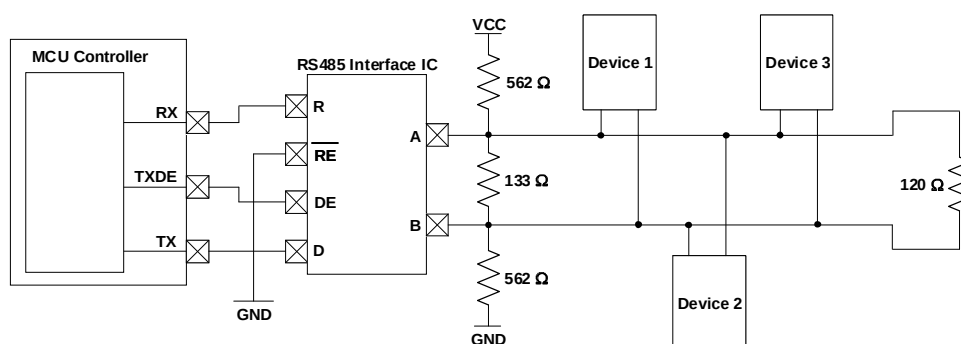
### 1.6.1 UART TXDE Signal May Go Low Before the STOP Bit Has Been Entirely Transmitted

The UART Transmit Drive Enable (TXDE) signal could potentially transition into a low state before the UART STOP bit has been entirely transmitted due to the effects of parasitic capacitance on the TX line. In some applications, this could result in communication being prematurely terminated due to the TXDE bit going low before the STOP bit has had enough time to settle.

To ensure that the STOP bit settles into its final logic state before the TXDE signal transitions low, a biasing circuit can be implemented. A biasing circuit allows the TX line to either be driven high or low, rather than being left in a floating tri-state mode where prolonged rise or fall times could lead to communication being disrupted. This bias circuit should only be implemented on one end of the serial bus, and a termination resistor should be used on the other end. The figure below show an example of a bias circuit that can be used to achieve this.

Please note that the resistor values used in this circuit are recommendations, and that the actual resistor values required may vary based on the application.
