Information note

N° 10411AERRA

Errata sheet Rev 1.0 affecting products TLE9210x

TLE9210x errata

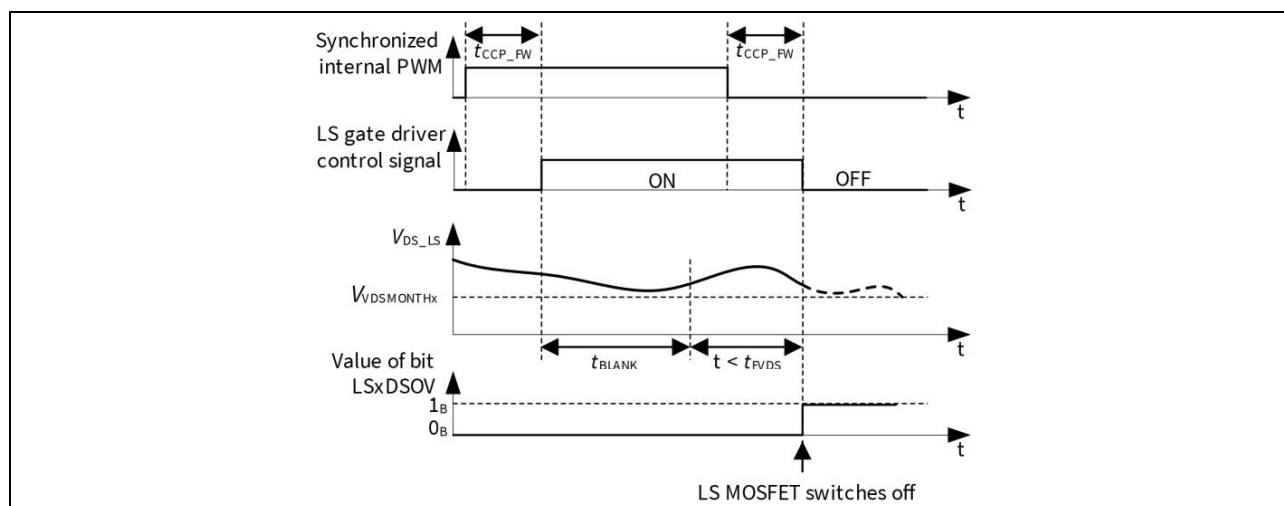
After the expiration of t_{BLANK} , a VDSOV is detected for a LS if:

- a falling edge of the internal LS control signal is generated
- while $V_{\text{DS_LS}} > V_{\text{VDSMONTHX}}$ for $t < t_{\text{FVDS}}$ (**Figure 1**)

The LS is latched off and the VDSOV status bit of the corresponding LS is set.

Figure 1 Falling edge of the internal LS control signal before the expiration of t_{FVDS}

Update the datasheets.

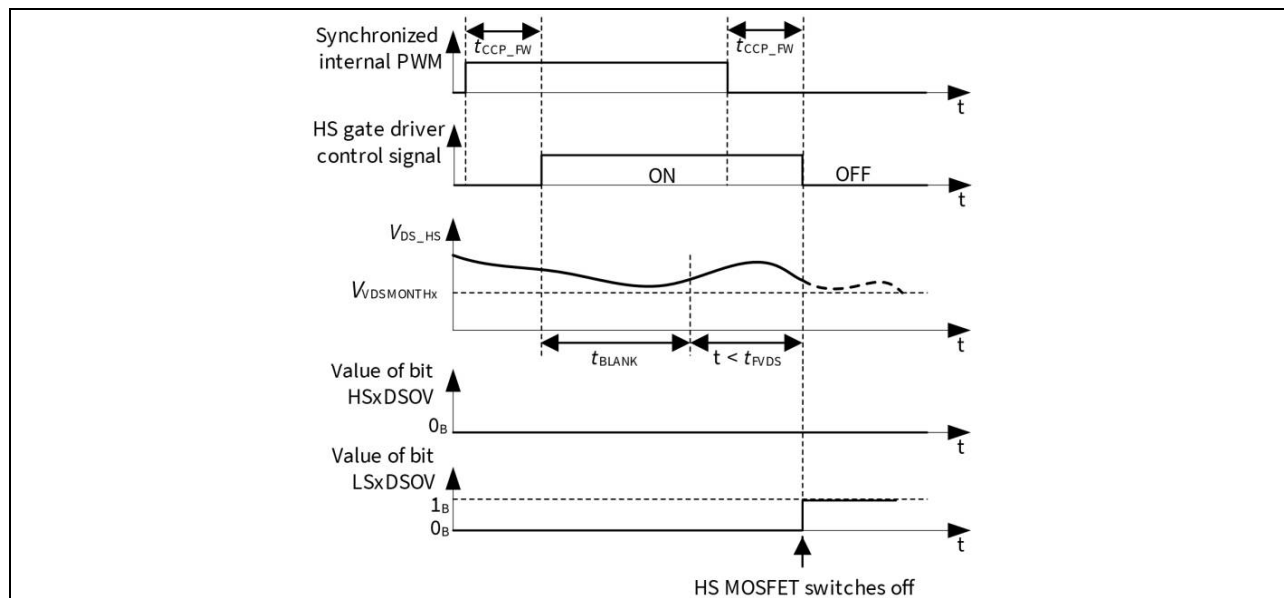
After the expiration of t_{BLANK} , a VDSOV is detected if:

- a falling edge of the internal HS control signal is generated
- while $V_{\text{DS_HS}} > V_{\text{VDSMONTHX}}$ for $t < t_{\text{FVDS}}$ (Figure 2)

The device reaction is:

- the HS is latched off
- the VDSOV status bit of the HS is not set
- the VDSOV status bit of the LS from the same half-bridge is set

Figure 2 Falling edge of the internal HS control signal before the expiration of t_{FVDS}

Whenever a VDSOV is reported, perform an off-state diagnostic to confirm which MOSFET of the half-bridge is impacted.

Update the datasheets.
